650 NORTH SAN PEDRO ROAD AMENDED FINAL EIR

STATE CLEARINGHOUSE NUMBER: 2004062004

County of Marin | October 22, 2010

DESIGN, COMMUNITY & ENVIRONMENT

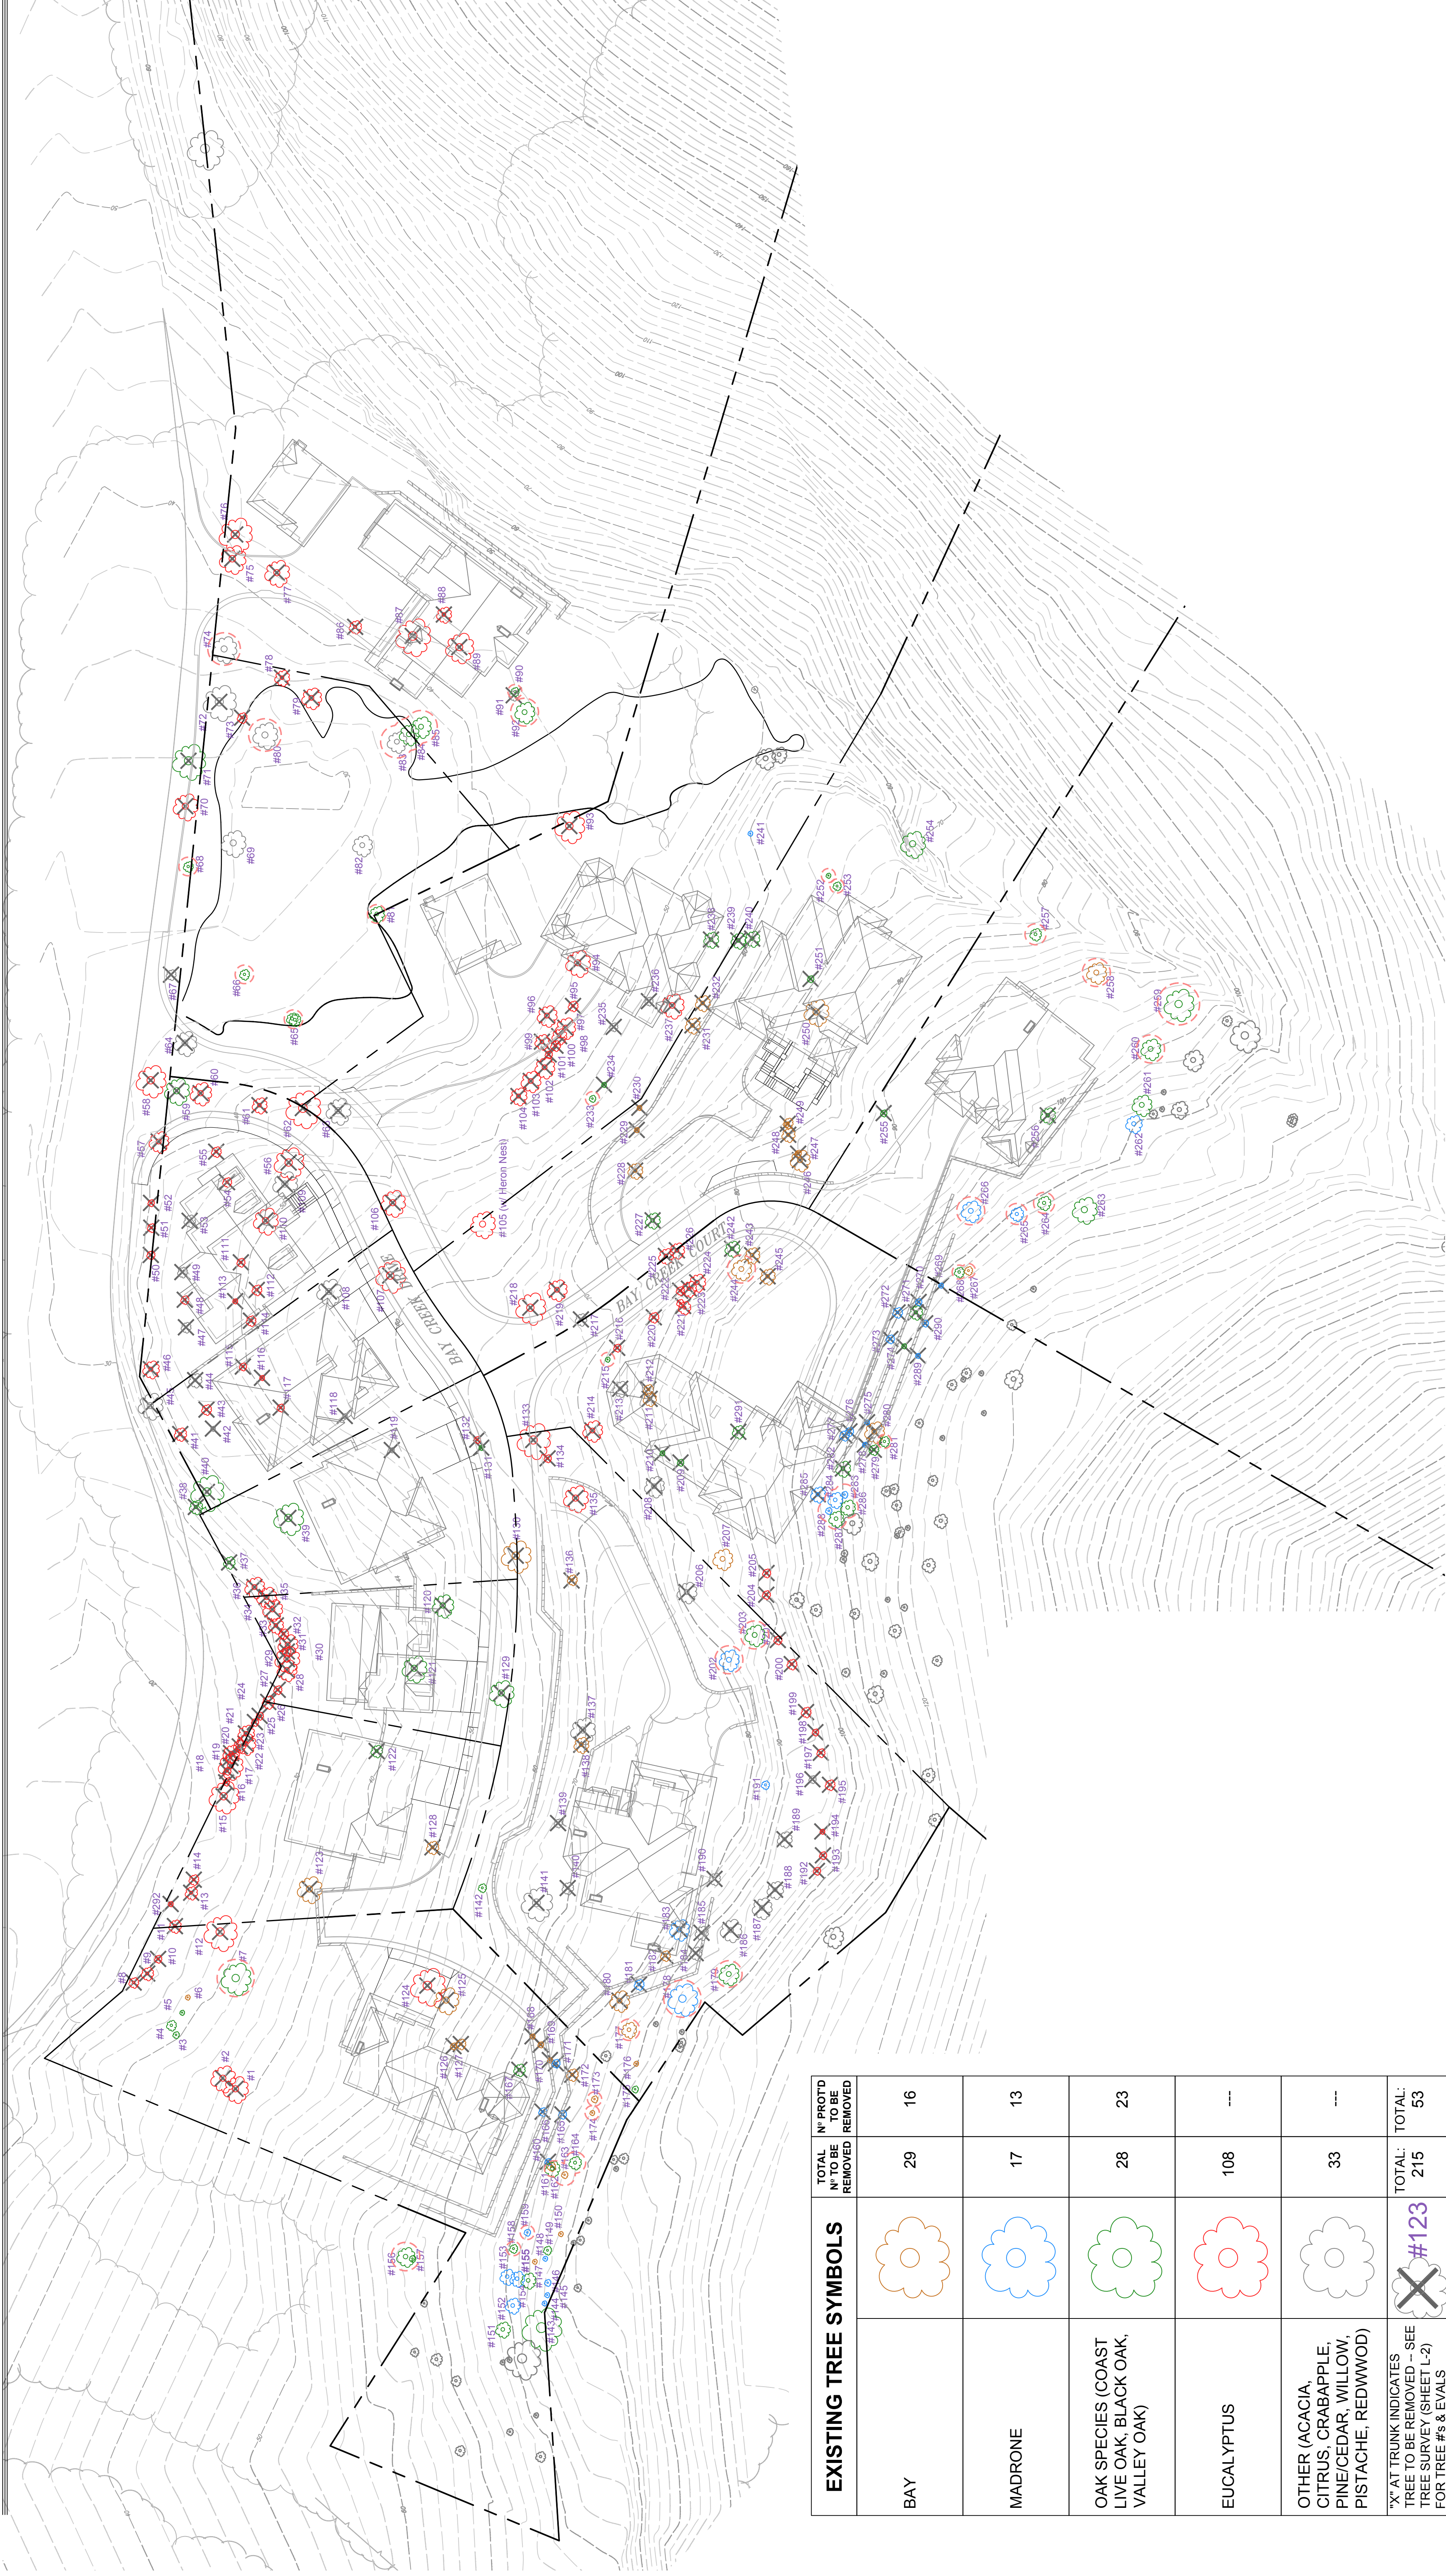
EXISTING TREE SYMBOLS		TOTAL N° TO BE REMOVED	N° PROTD N° TO BE REMOVED
BAY		29	16
		17	13
OAK SPECIES (COAST LIVE OAK, BLACK OAK, VALLEY OAK)		28	23
EUCALYPTUS		108	---
OTHER (ACACIA, CITRUS, CRABAPPLE, PINE/CEDAR, WILLOW, PISTACHE, REDWOOD)		33	---
"X" AT TRUNK INDICATES TREE TO BE REMOVED - SEE TREE SURVEY (SHEET L-2) FOR TREE #'S & EVALS		TOTAL: 215	TOTAL: 53
INDICATES TREE TO REMAIN & BE PROTECTED DURING CONSTRUCTION

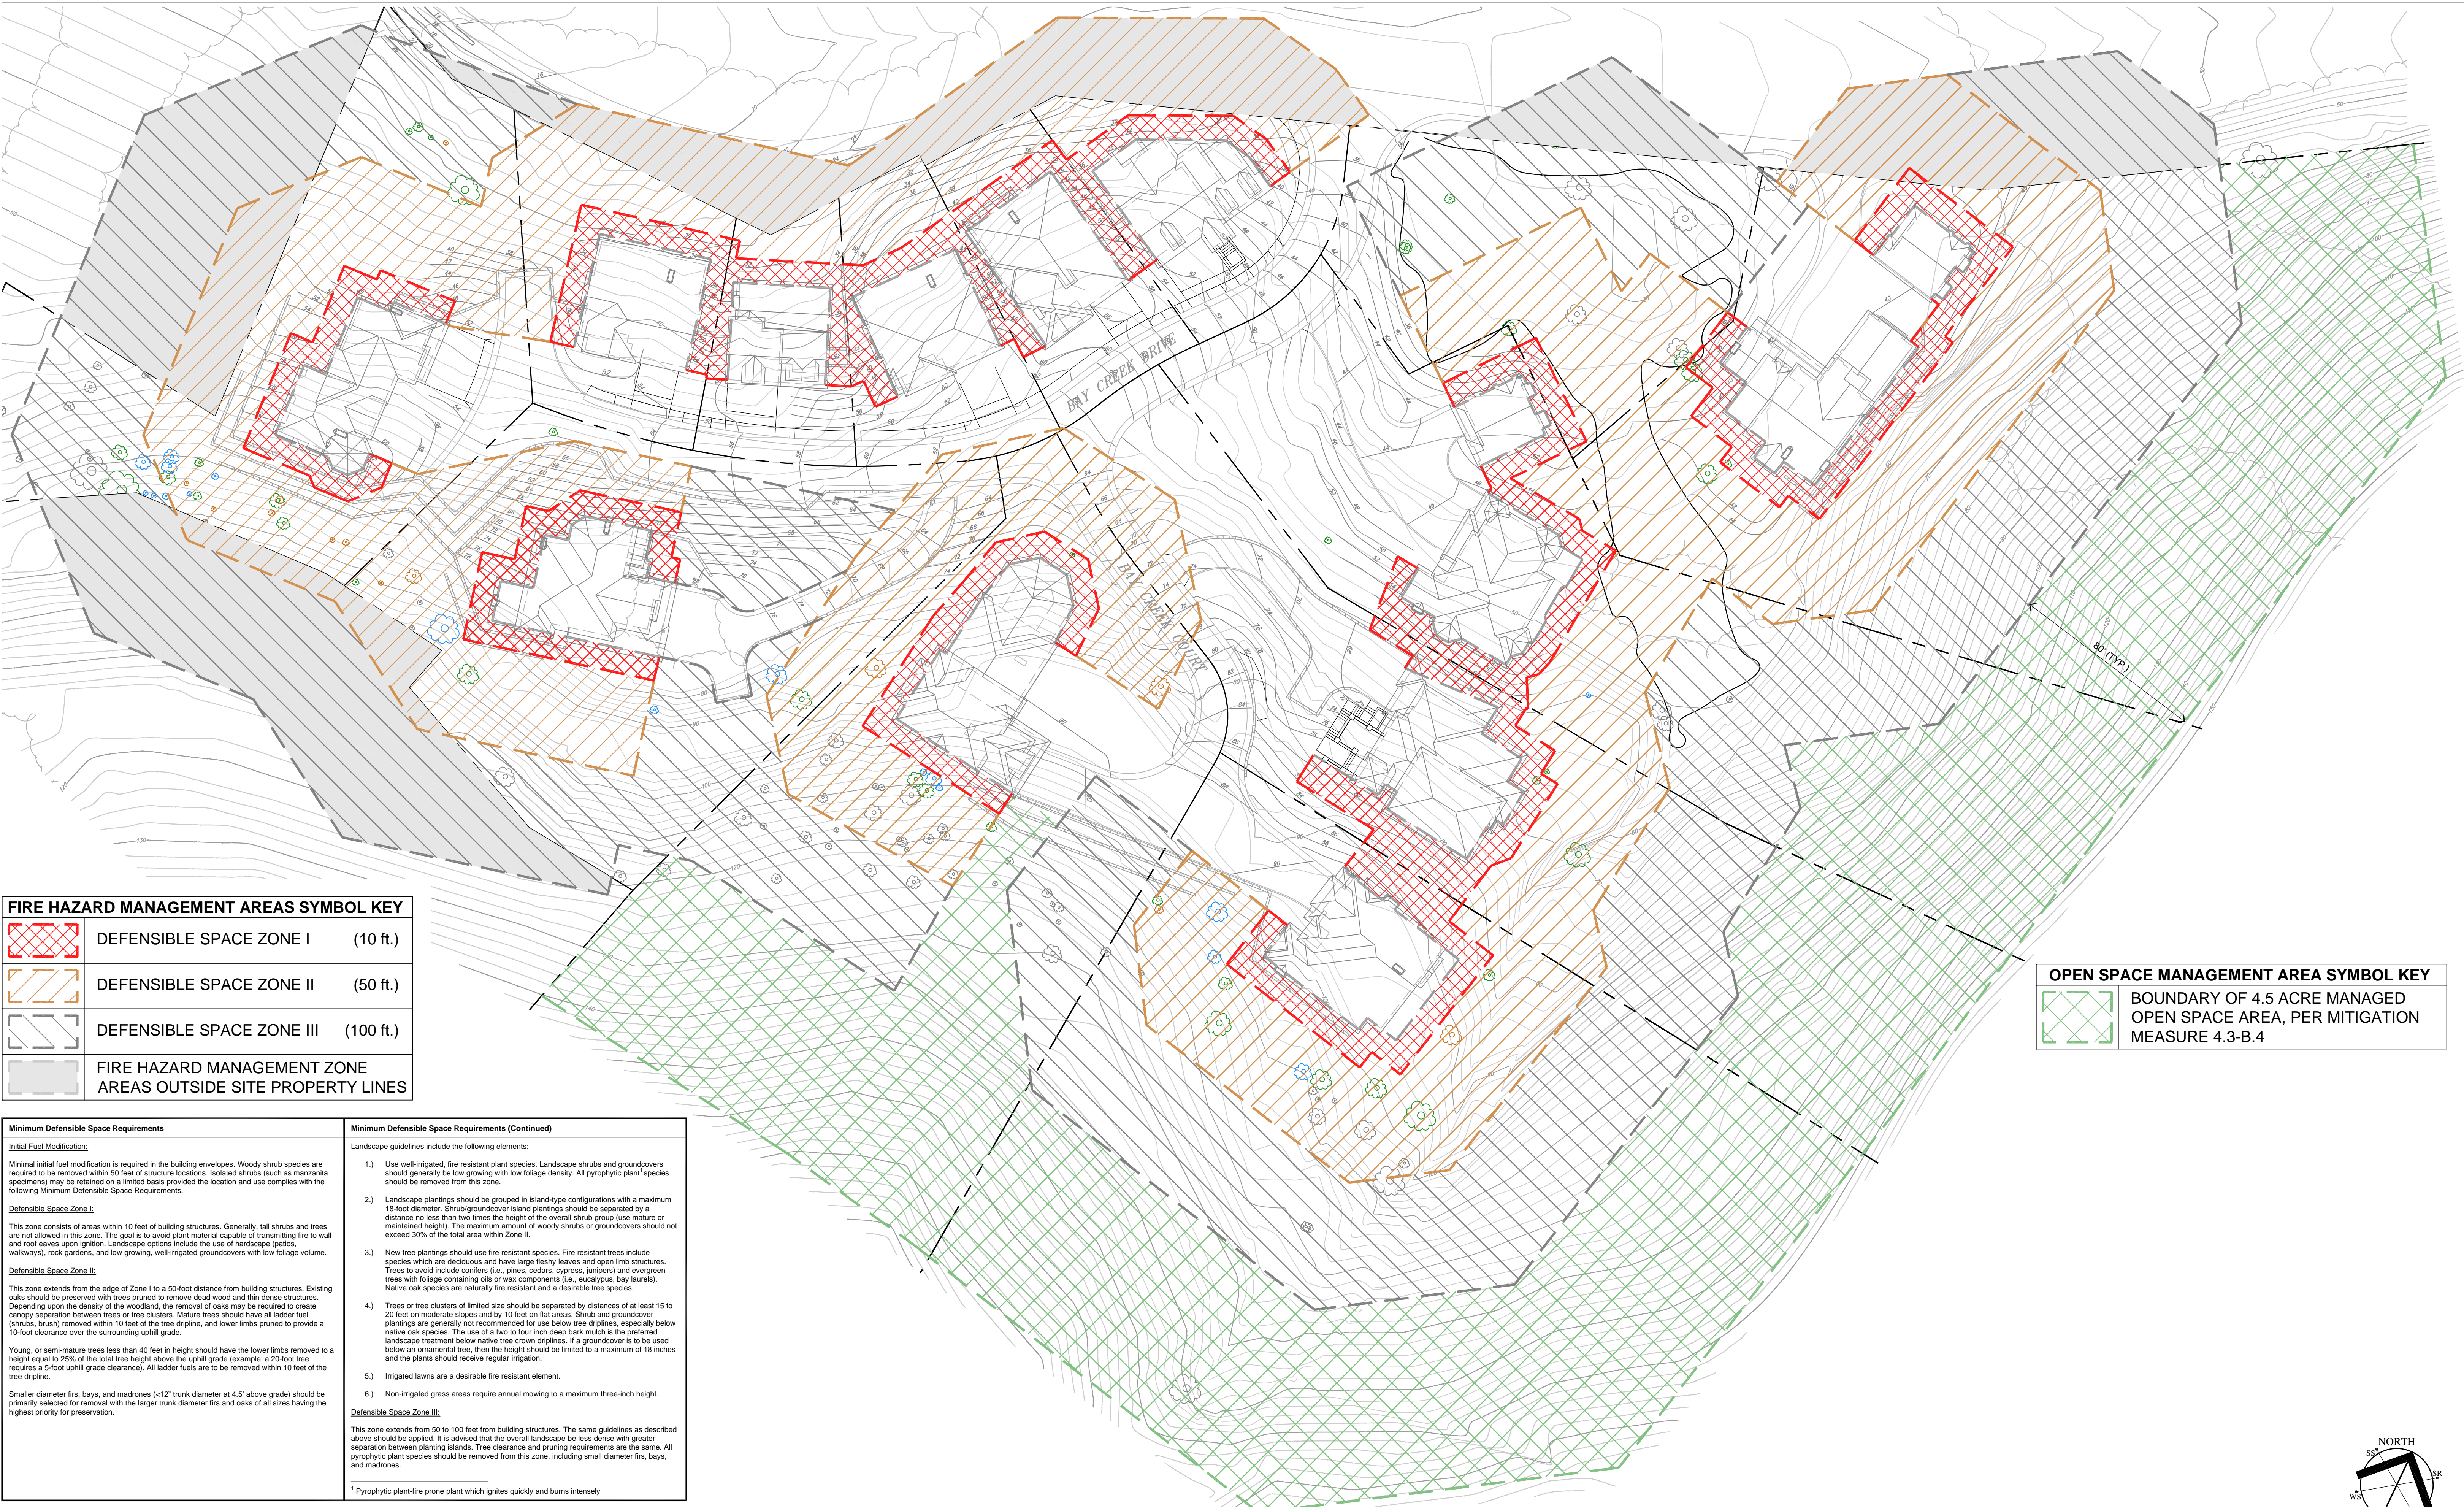
FIRE HAZARD AND OPEN SPACE MANAGEMENT PLAN

FIRE HAZARD MANAGEMENT AREAS SYMBOL KEY		
	DEFENSIBLE SPACE ZONE I	(10 ft.)
	DEFENSIBLE SPACE ZONE II	(50 ft.)
	DEFENSIBLE SPACE ZONE III	(100 ft.)
	FIRE HAZARD MANAGEMENT ZONE AREAS OUTSIDE SITE PROPERTY LINES

OPEN SPACE MANAGEMENT AREA SYMBOL KEY	
	BOUNDARY OF 4.5 ACRE MANAGED OPEN SPACE AREA, PER MITIGATION MEASURE 4.3-B.4

As discussed below, the Fire Hazard and Open Space Management Plan (included in Appendix H) shows the open space within the project site in relation to defensible space.

As shown on the Fire Hazard and Open Space Management Plan, the boundary of the 4.5-acre managed open space (as per Mitigation Measure 4.3-B.4) is

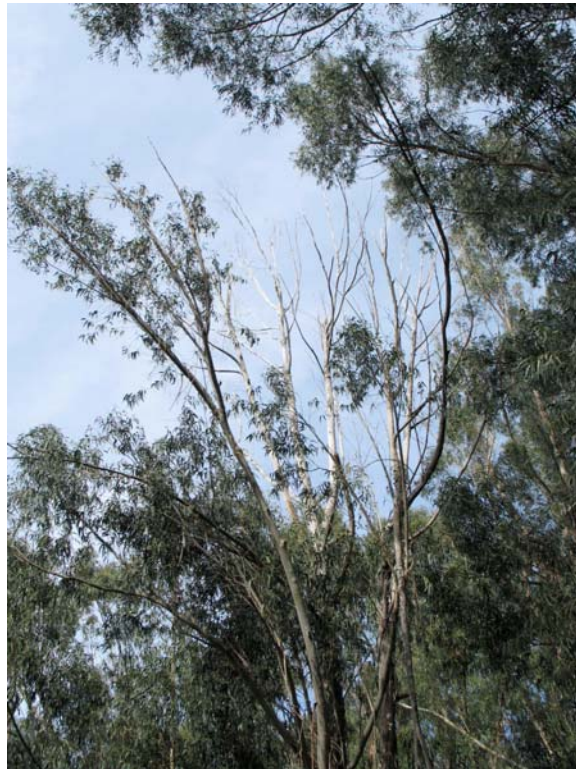
Limb dieback in blue gum eucalyptus. Both the eucalyptus tortoise beetle and the eucalyptus long-horned borer are active on the site.

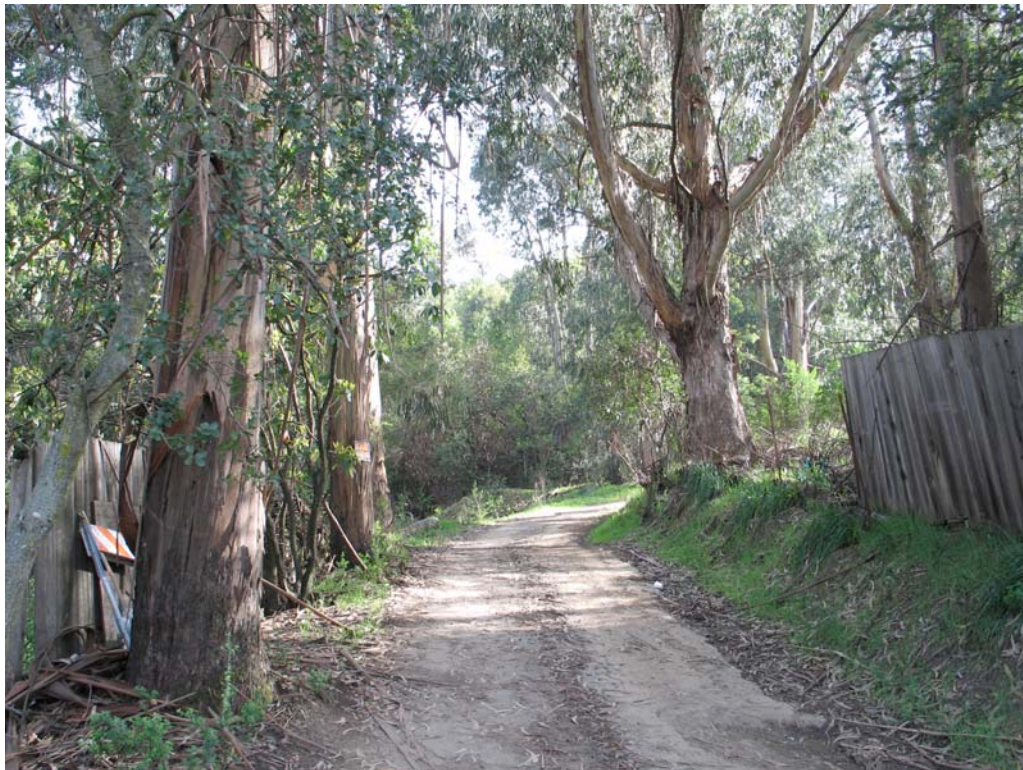
Mature eucalyptus along existing driveway.

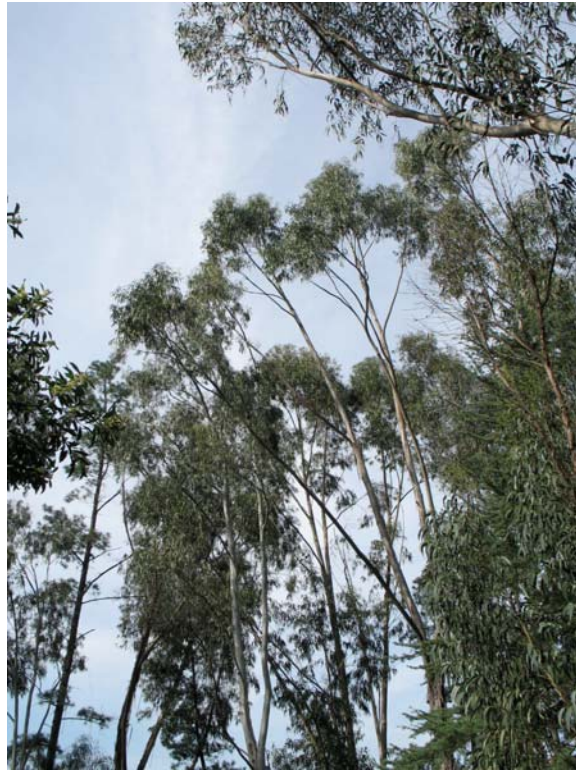
Young blue gums with high-branched structures and low trunk taper.

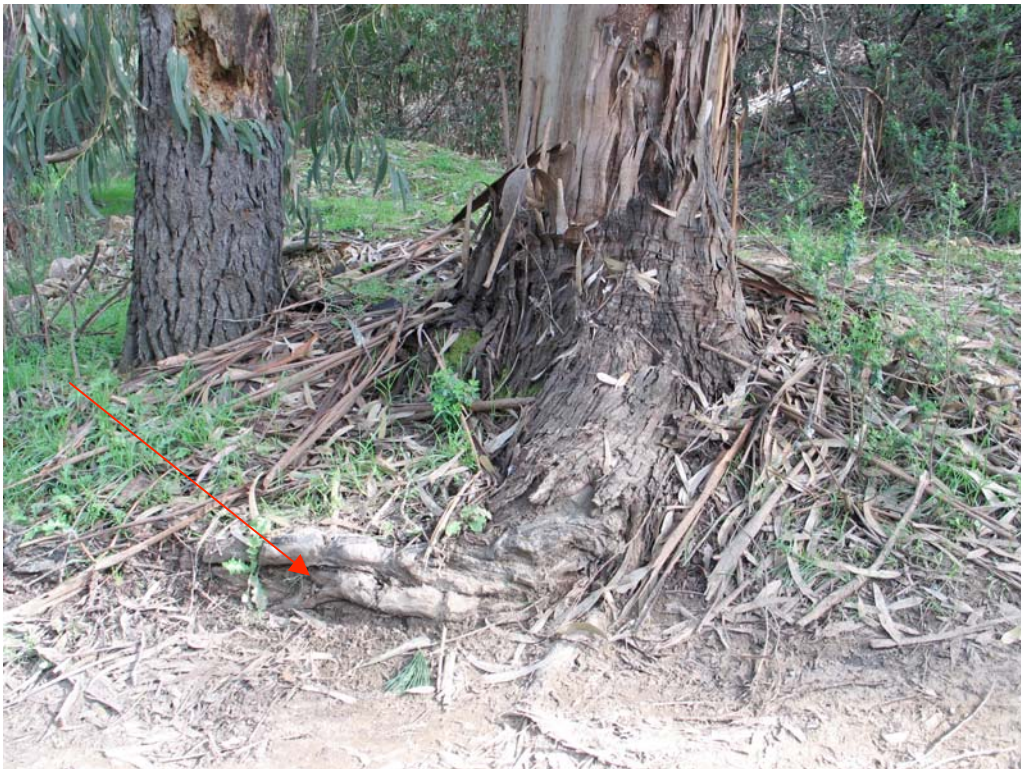
Base of blue gum with reported heron nest. Primary structural root has been damaged at edge of existing driveway (arrow).

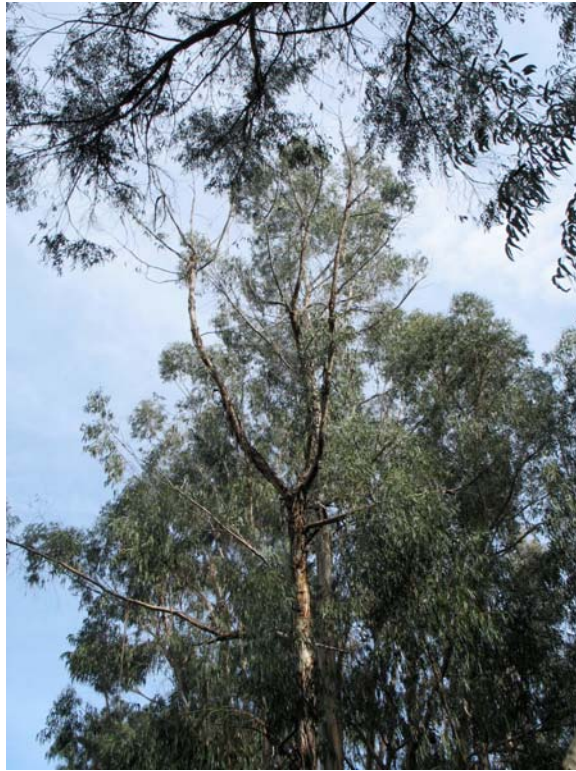
Upper canopy dieback in blue gum. Note thinning and notched foliage on branches in foreground from eucalyptus tortoise beetle.

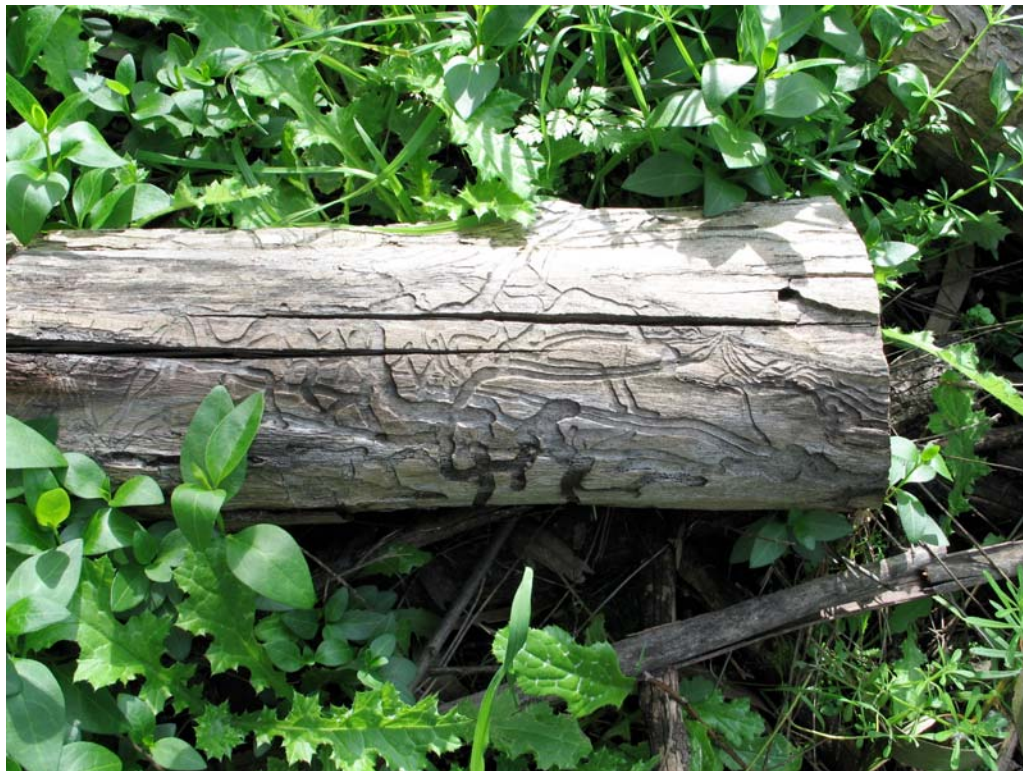
Galleries of eucalyptus long-horned borer in heartwood of dead eucalyptus.

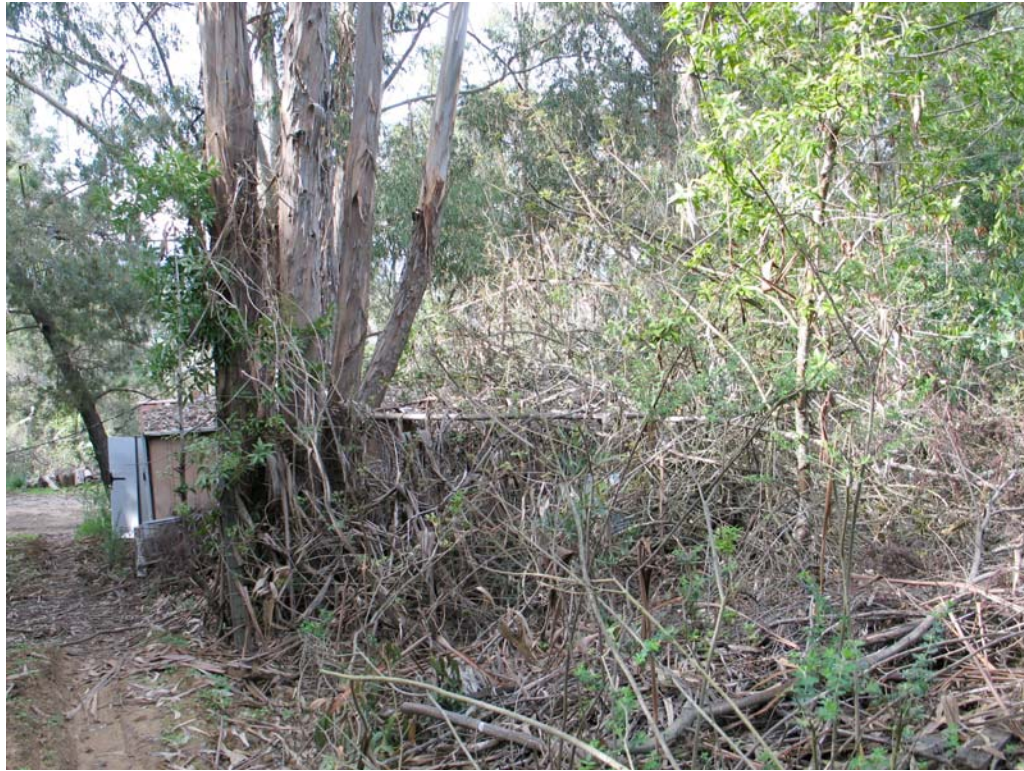
Multiple trunk form of blue gum and debris accumulation at base of tree.

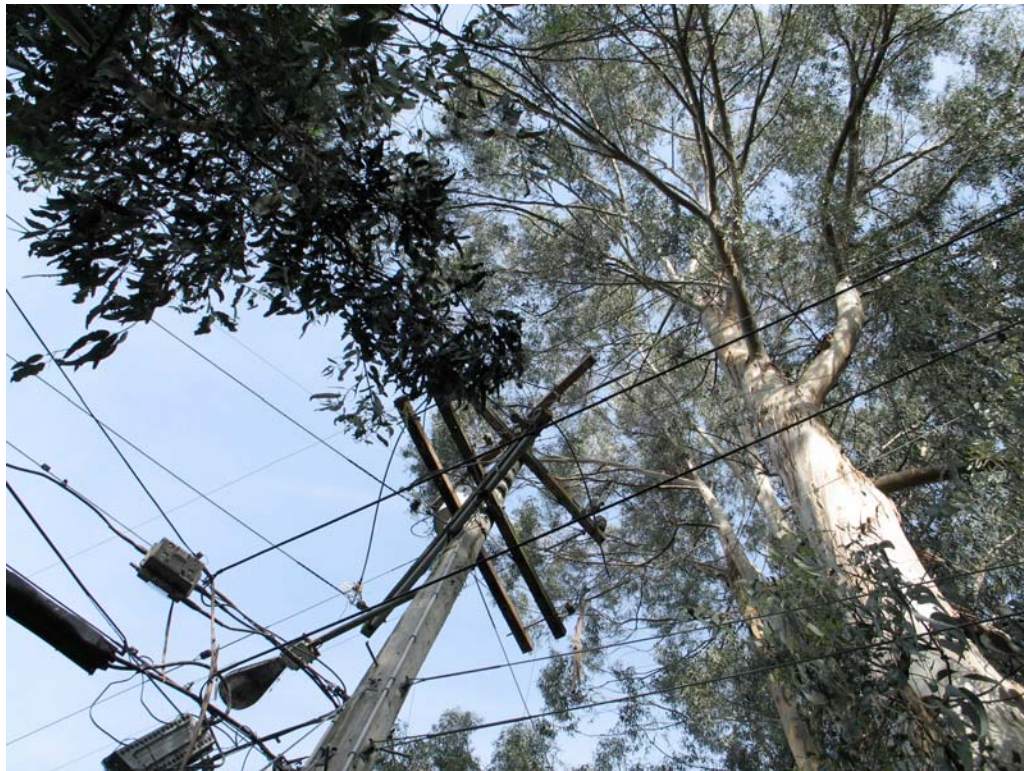
Mature blue gum overhanging high voltage lines along North San Pedro Road.

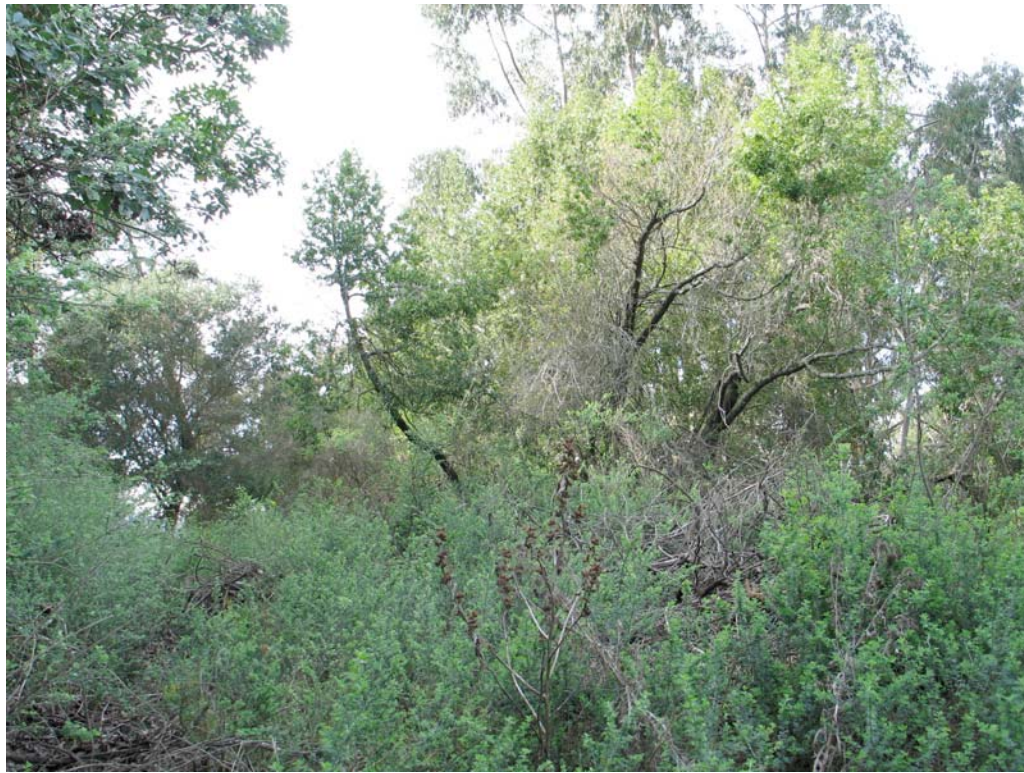
Semi-mature bay laurel with dense stand of French broom.

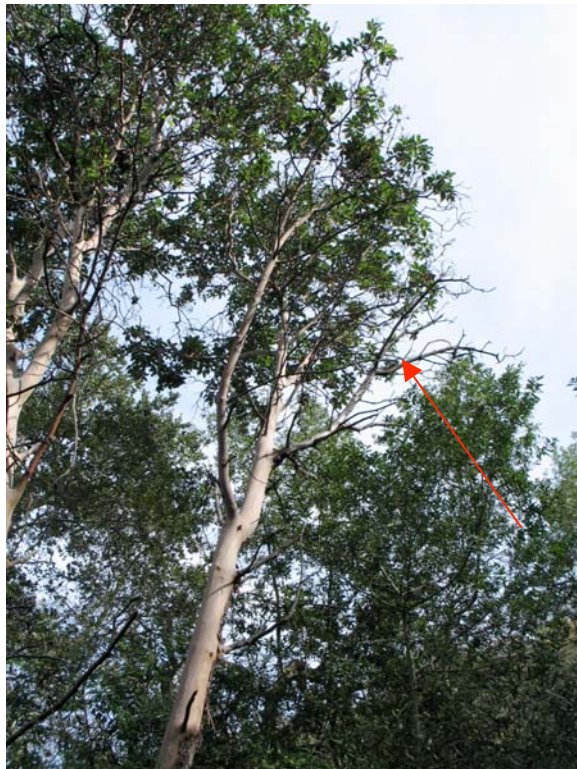
Young madrone with high-branched structure due to shading and branch dieback from Botryosphaeria infection (arrow).

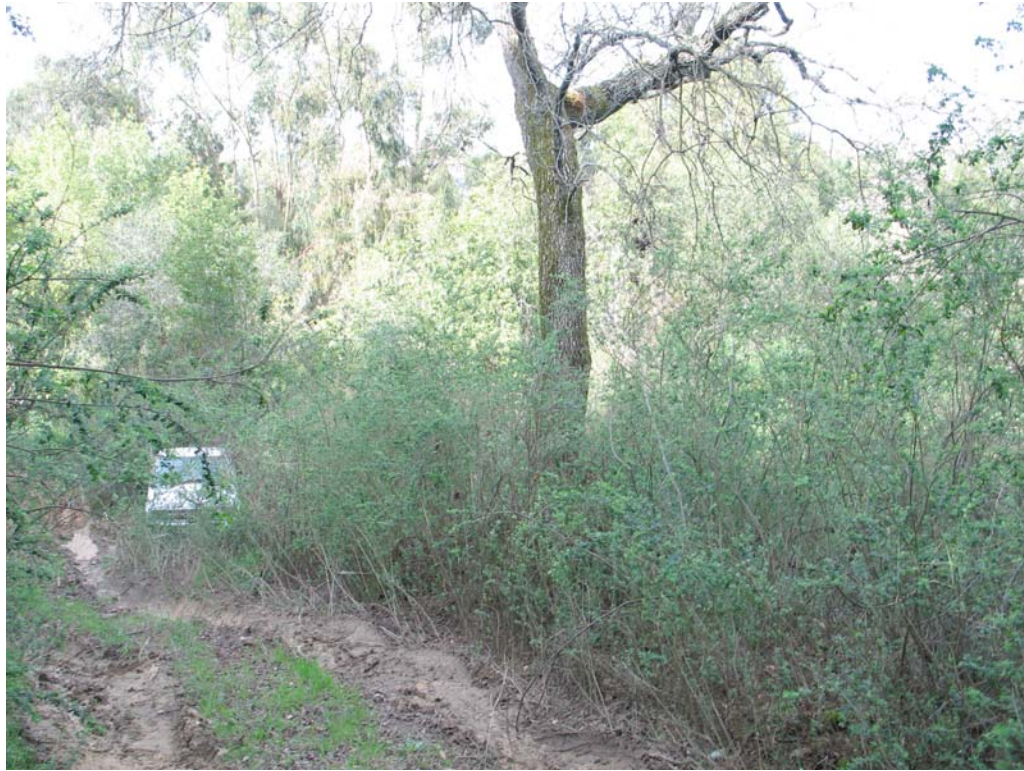
Semi-mature valley oak in dense stand of broom.

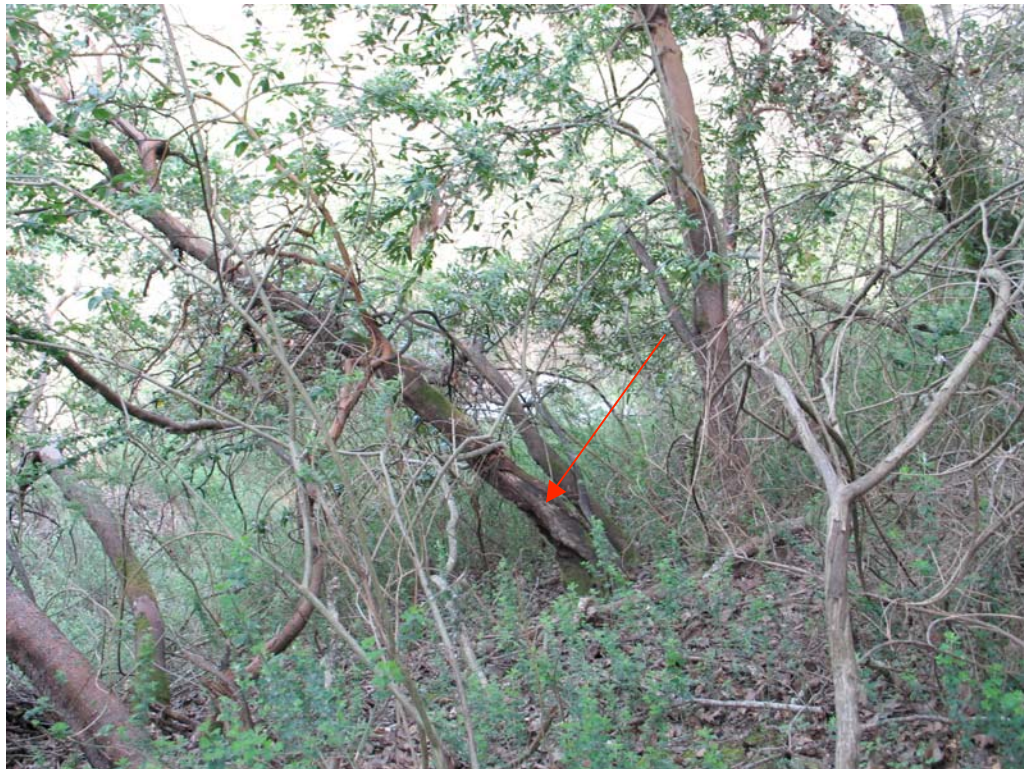
Upper portion of site with dense stands of small diameter trees, poison oak, and French broom. Madrone in this area are generally shaded suppressed with old fire damage and Botryosphaeria

infections. There has also been a significant loss of oaks in this zone. Arrow is at old fire damage.

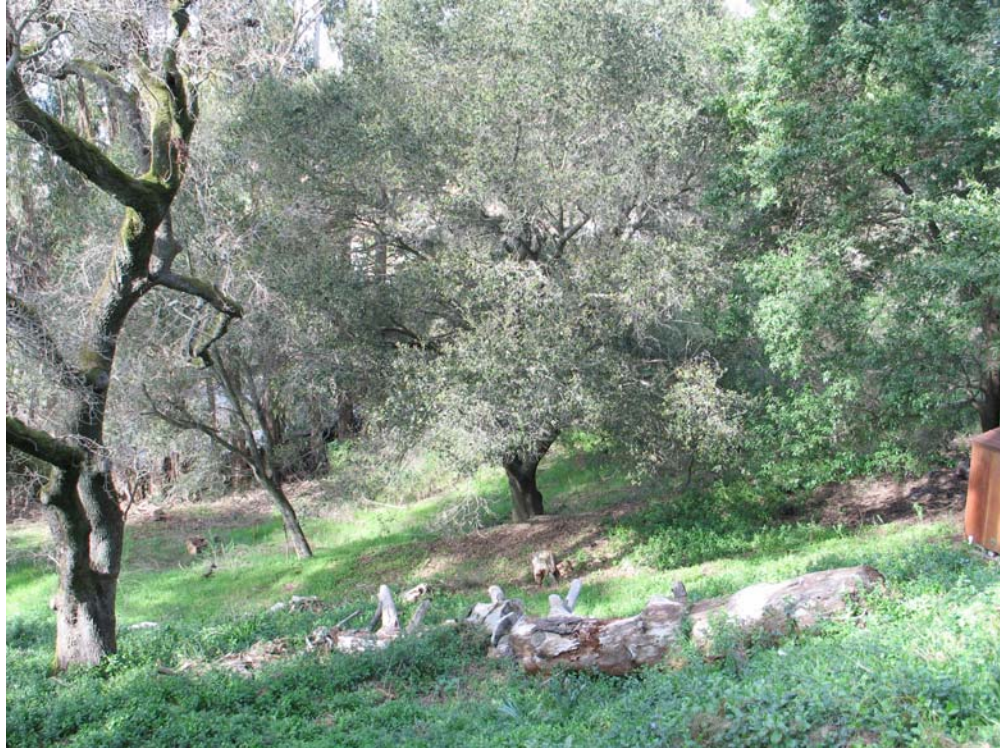
Lower portion of site above eucalyptus row along North San Pedro. Mature valley oak and coast live oak are in moderate to good condition.

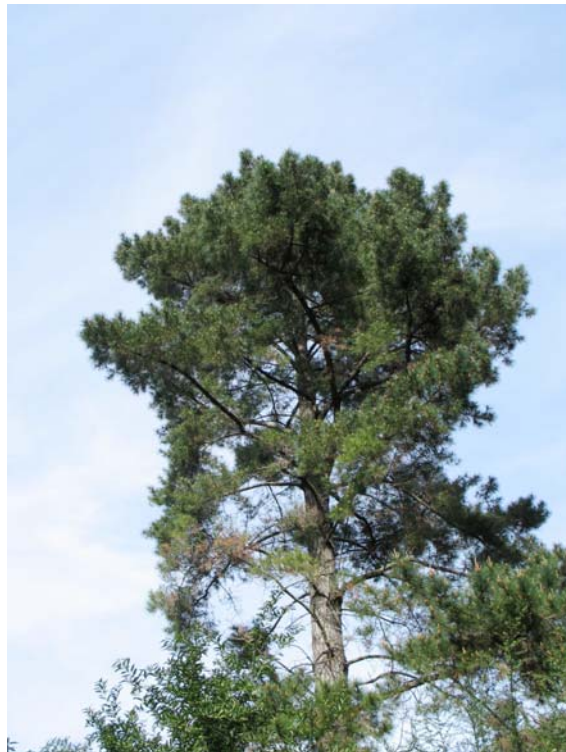
Mature Monterey pine. Limited bark beetle damage is occurring.

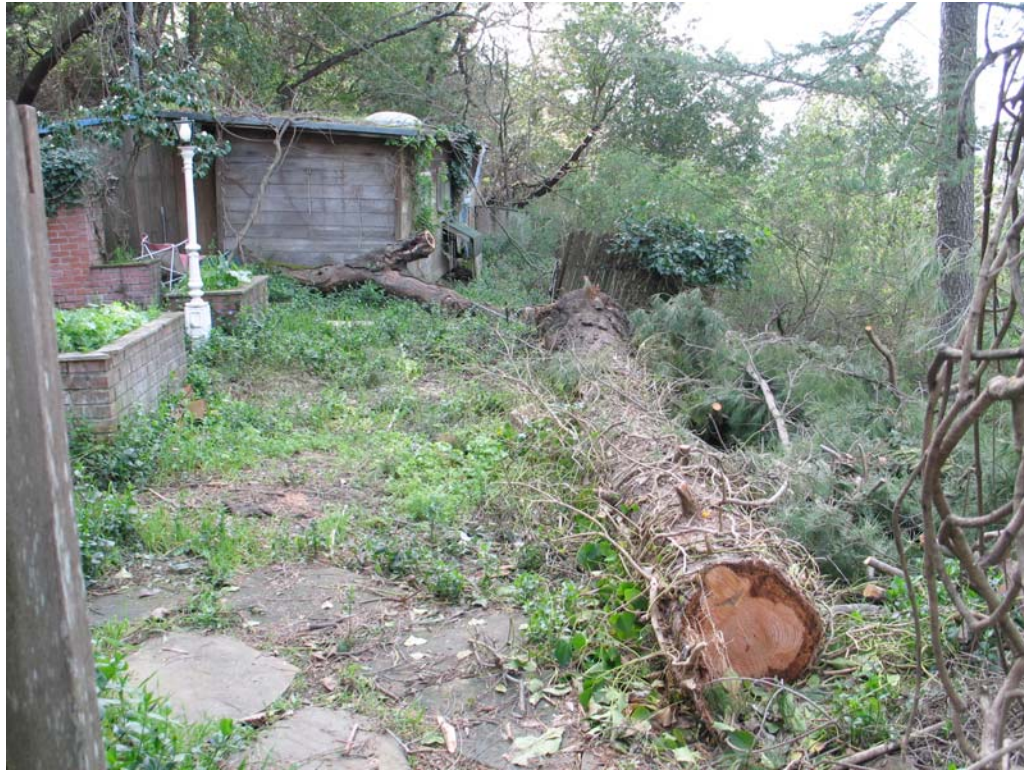
Recent failure of mature Monterey pine near existing residence.

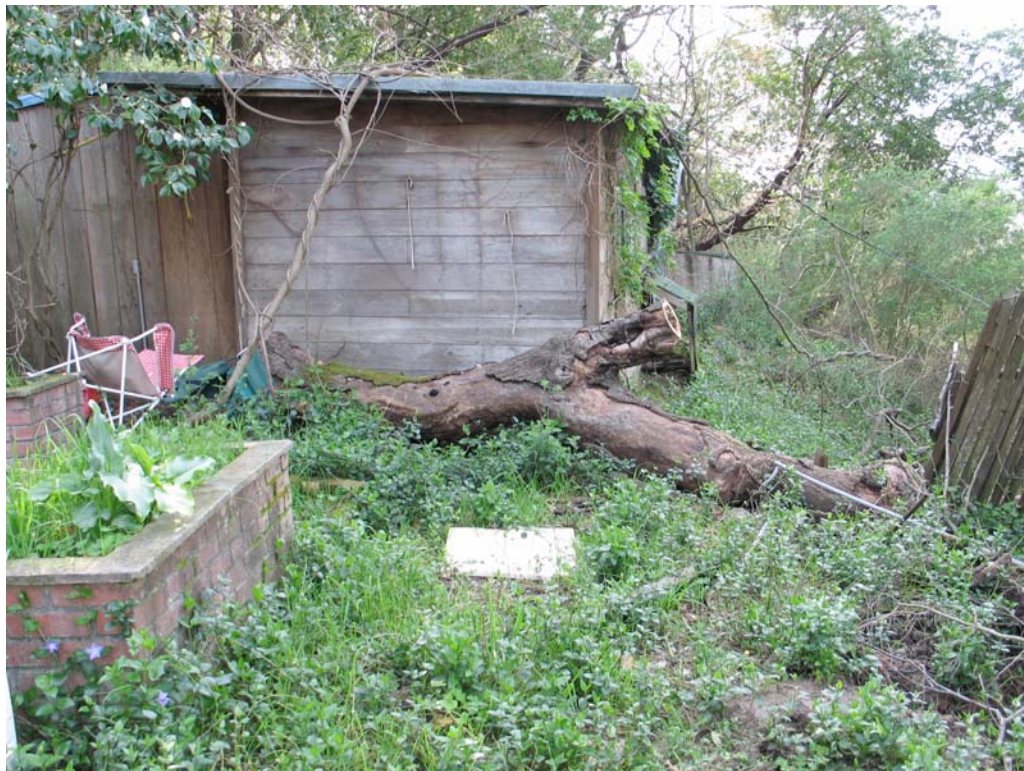
Collapsed mature coast live oak with decline likely due to SOD infection.

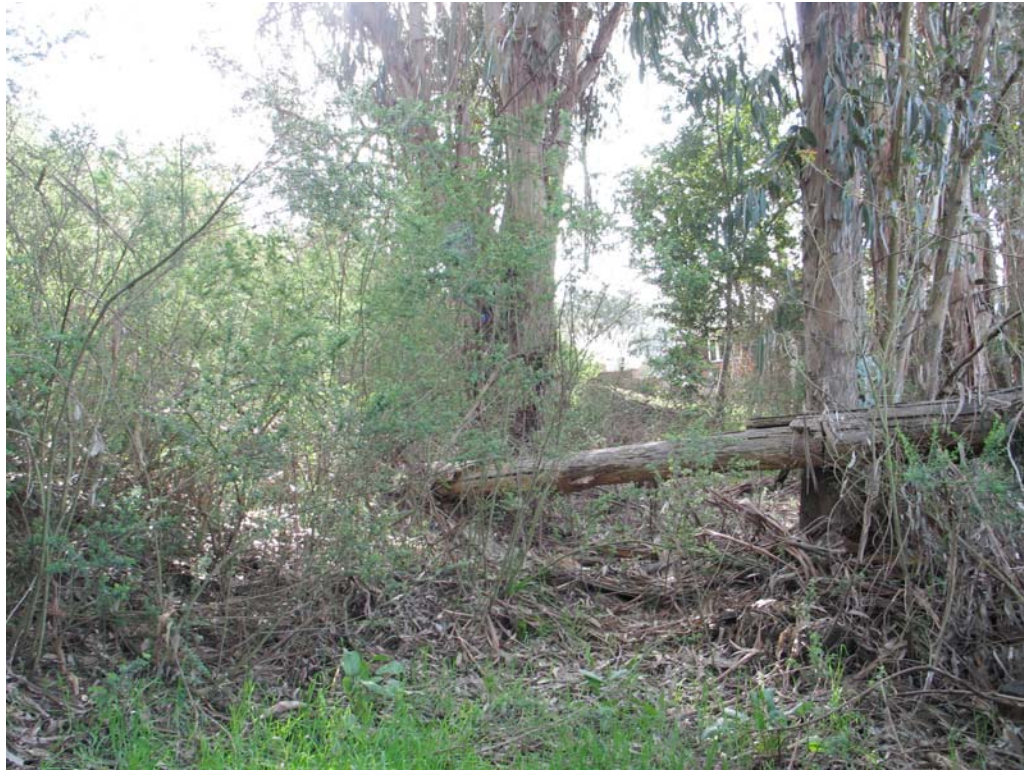
Collapsed blue gum near North San Pedro Road.

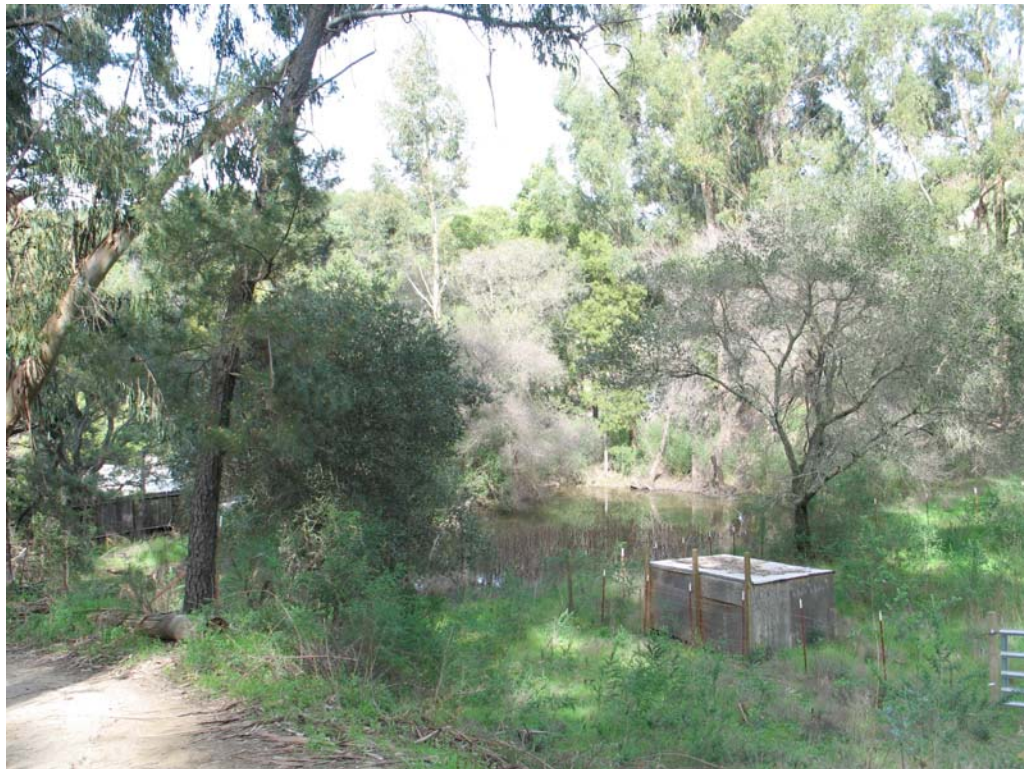
Lower pond area with willows, coast live oak, eucalyptus, and Monterey pine.

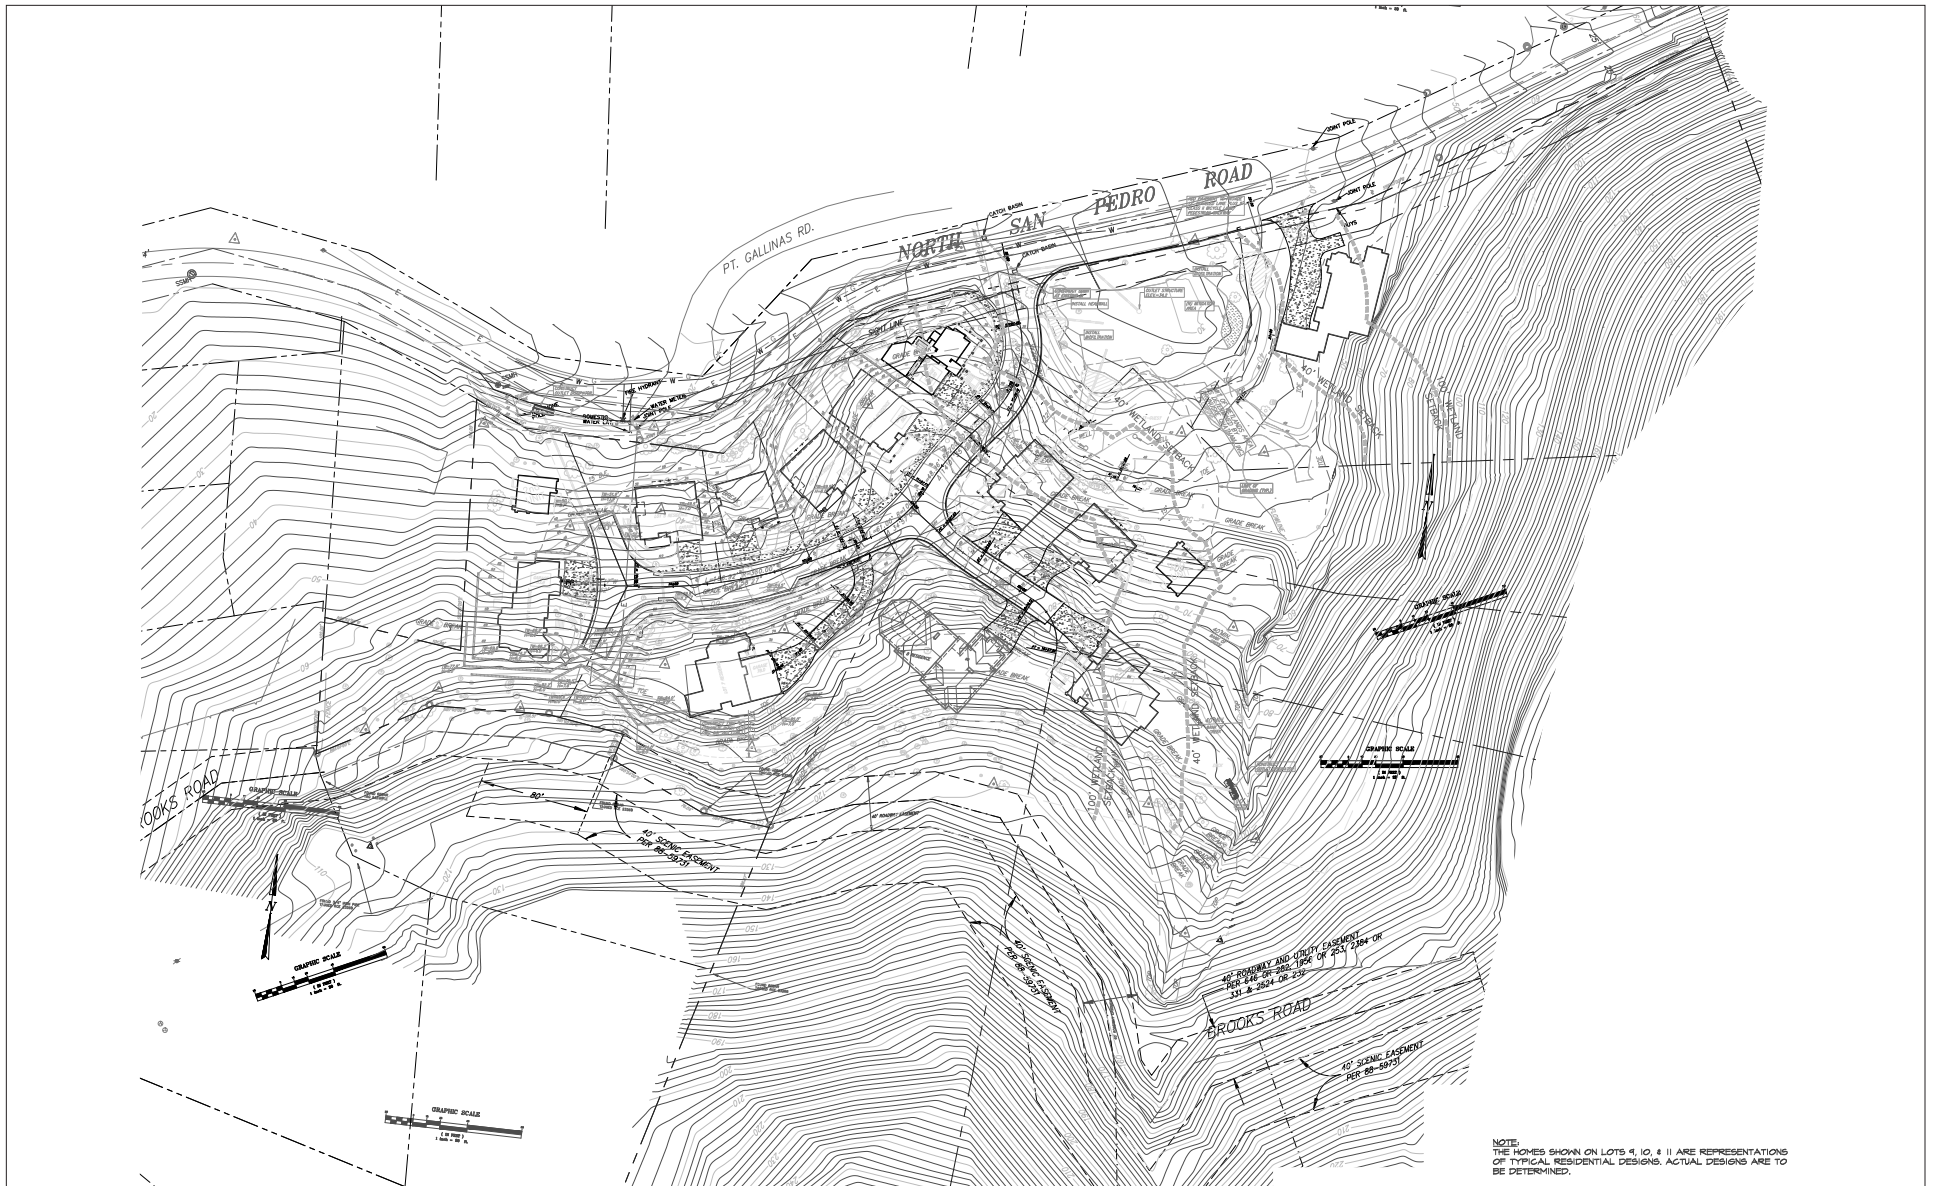
FIGURE 1
SITE PLAN SHOWING RECONFIGURED LOT 1

Appendix L, Sight Distance and Lot 1, has been added to the Final EIR to provide additional information. In Appendix L, Figure 1 shows the project site plan with Mitigation Measure 4.6-E.1 pertaining to sight distance incorporated into Lot 1. The footprint for the proposed residence has been relocated to allow for grading and adequate sight distance. Figures 2 shows the sight line from Bay Creek in a westerly direction and Figure 3 shows the sight line profiles from Bay Creek Drive, in a westerly direction. The profiles show sight distance resulting from recontouring the hillside on Lot 1. The diagrams validate the assertion in Mitigation Measure 4.6-E.1 that site distance would be possible subsequent to recontouring of the hillside on Lot 1. Additionally, new photo simulations were created to show what Lot 1 would look like from North San Pedro Road. The photo simulations are now included in the Final EIR as Figures 5-6, 5-7a and 5-7b, and are discussed in this amendment in Section C.2.
