650 NORTH SAN PEDRO ROAD AMENDED FINAL EIR

STATE CLEARINGHOUSE NUMBER: 2004062004

County of Marin | October 22, 2010

DESIGN, COMMUNITY & ENVIRONMENT

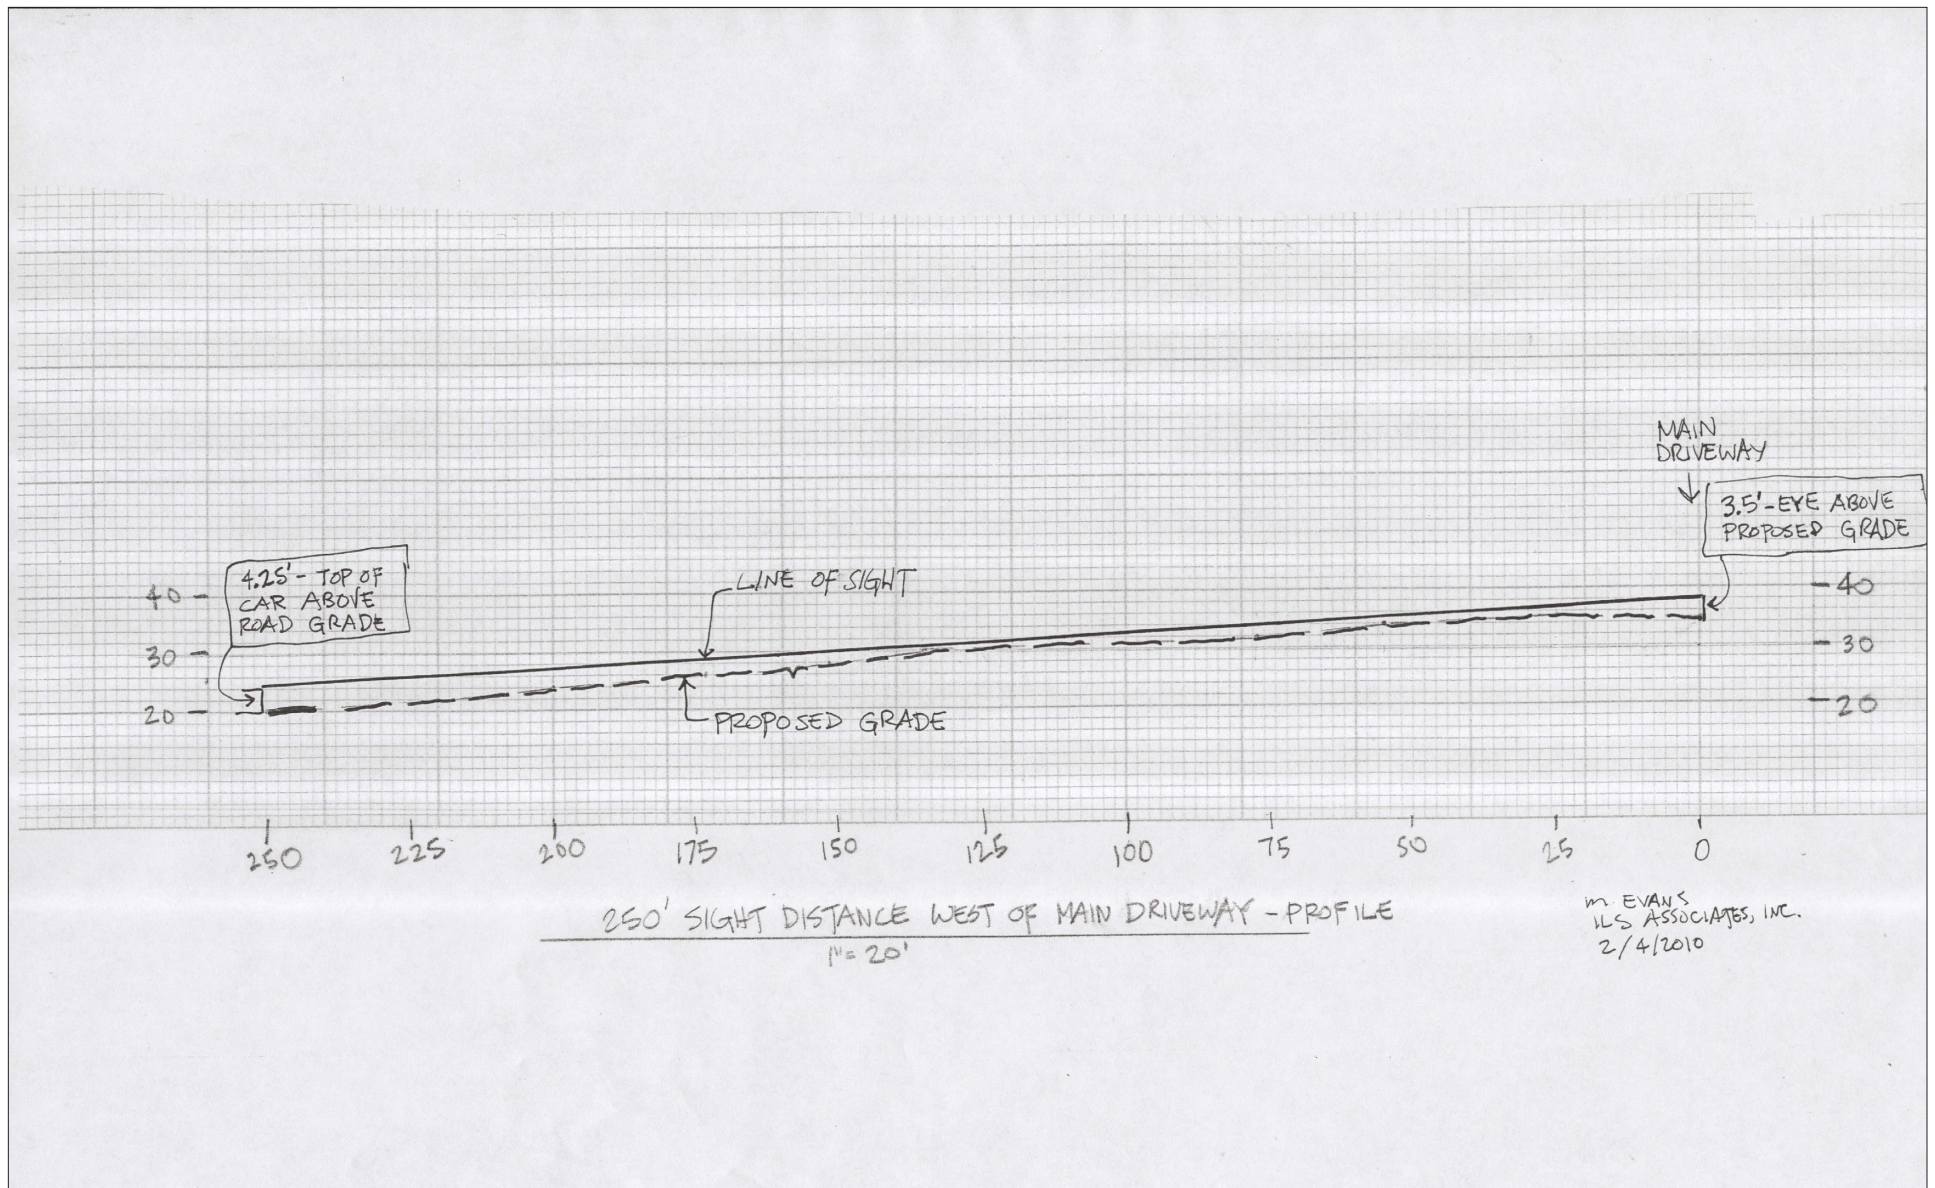
FIGURE 3

SIGHT DISTANCE PROFILE TO WEST FROM MAIN DRIVEWAY

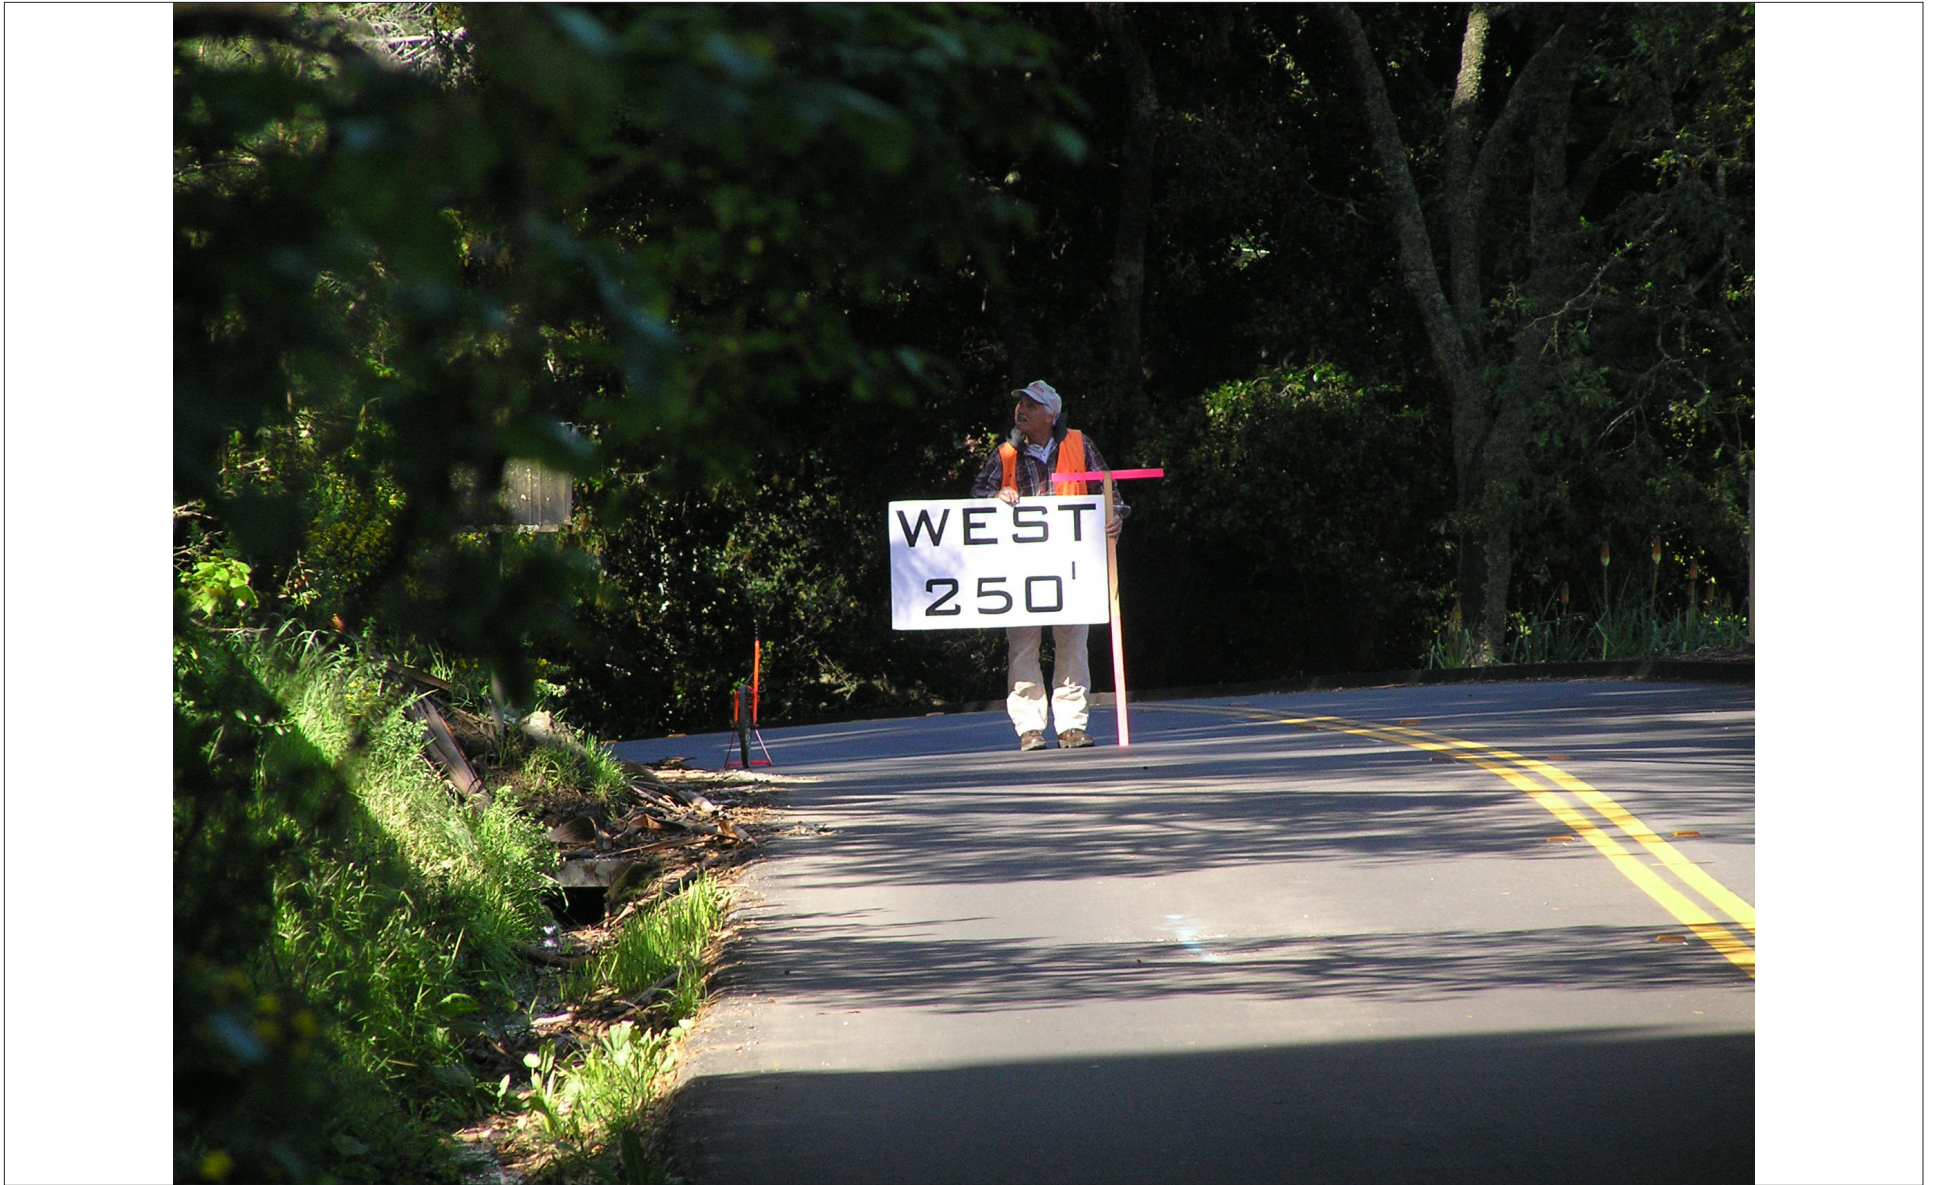
FIGURE 4
PHOTO TO WEST FROM LOT 12 DRIVEWAY

Figures 4 and 5 in Appendix L, show photos of markers demonstrating a direct line of sight 250 feet in each direction from the exit point of the driveway to Lot 12. Figure 6 shows the sight distance line from the Lot 12 driveway. Figures 7 and 8 show sight line profiles from Lot 12. Additional language,

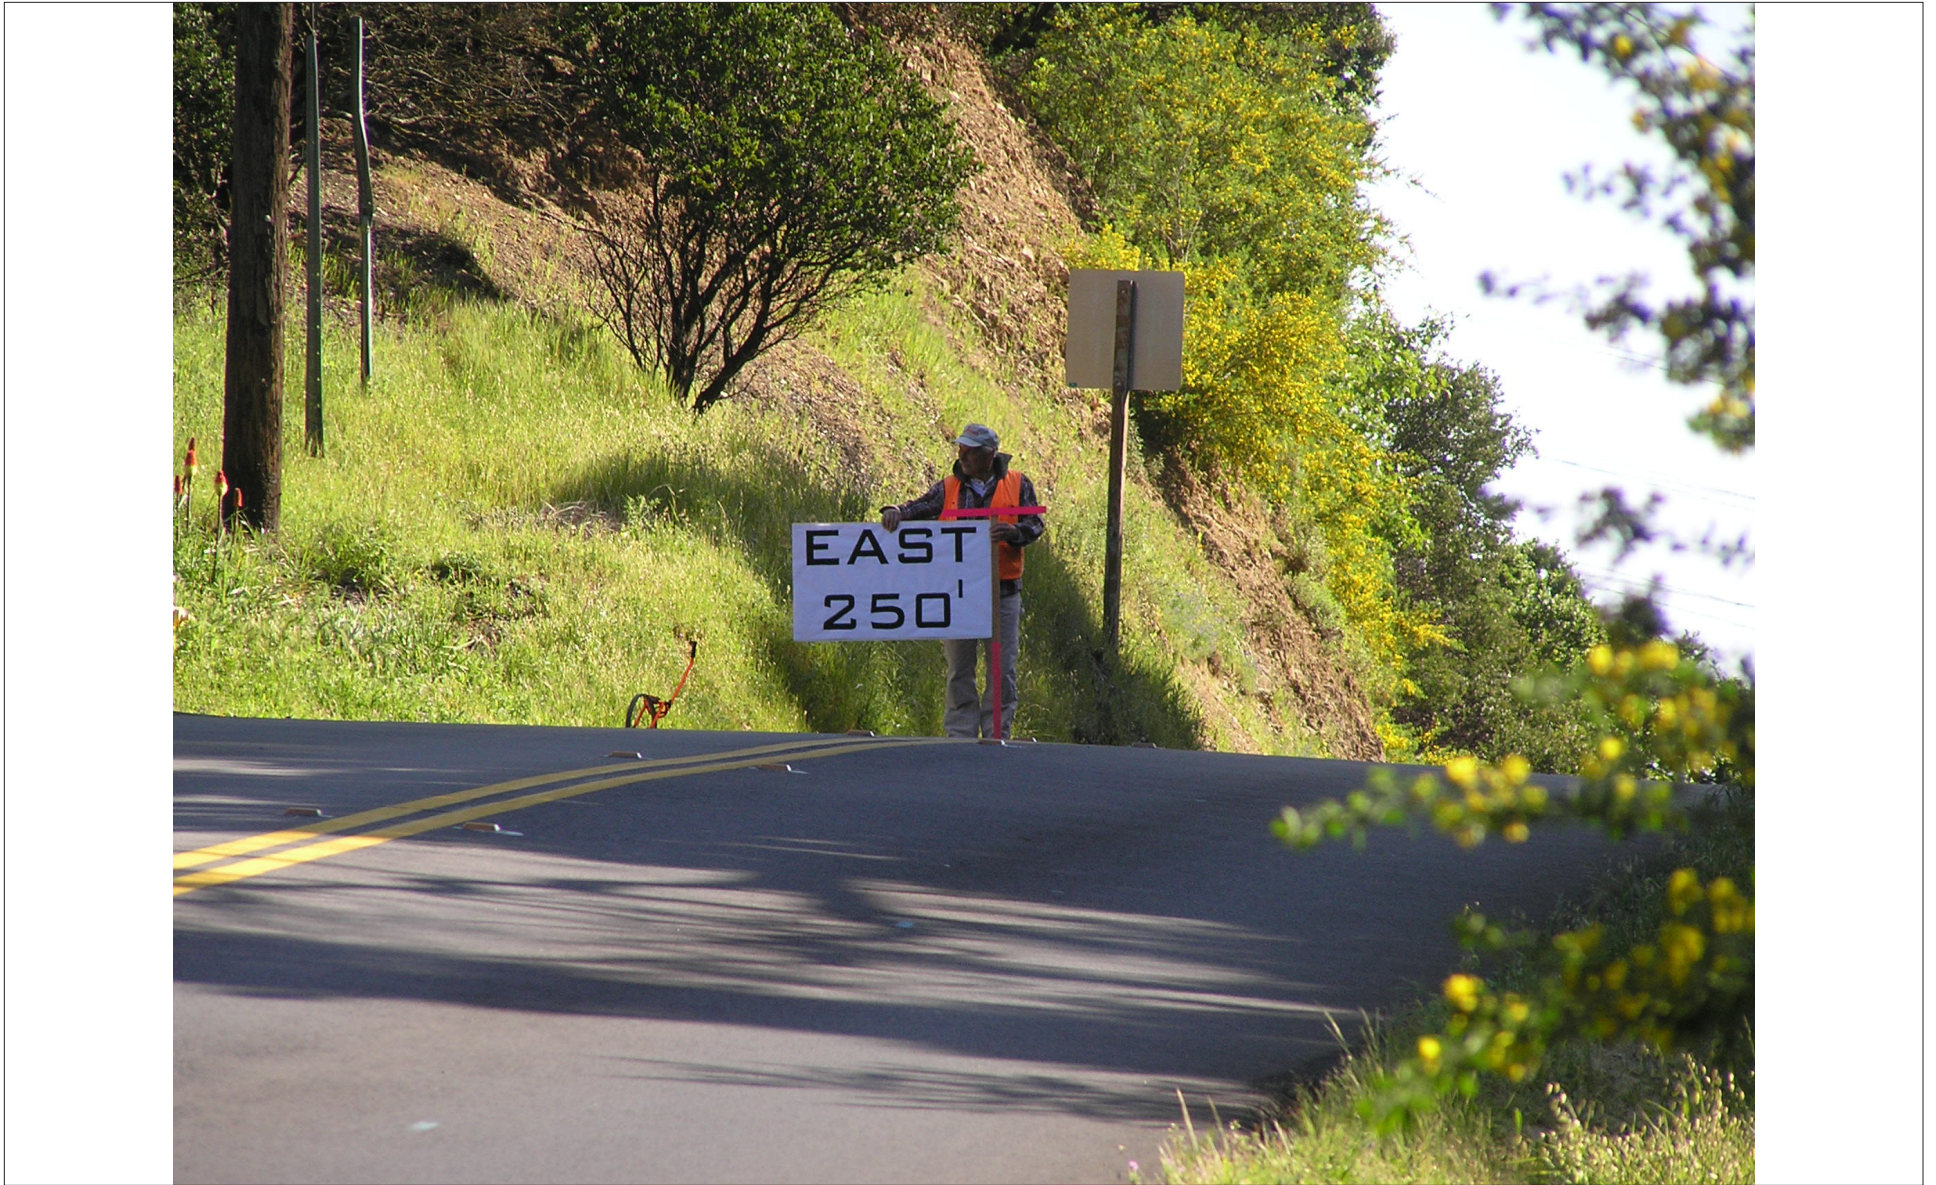
FIGURE 5
PHOTO TO EAST FROM LOT 12 DRIVEWAY

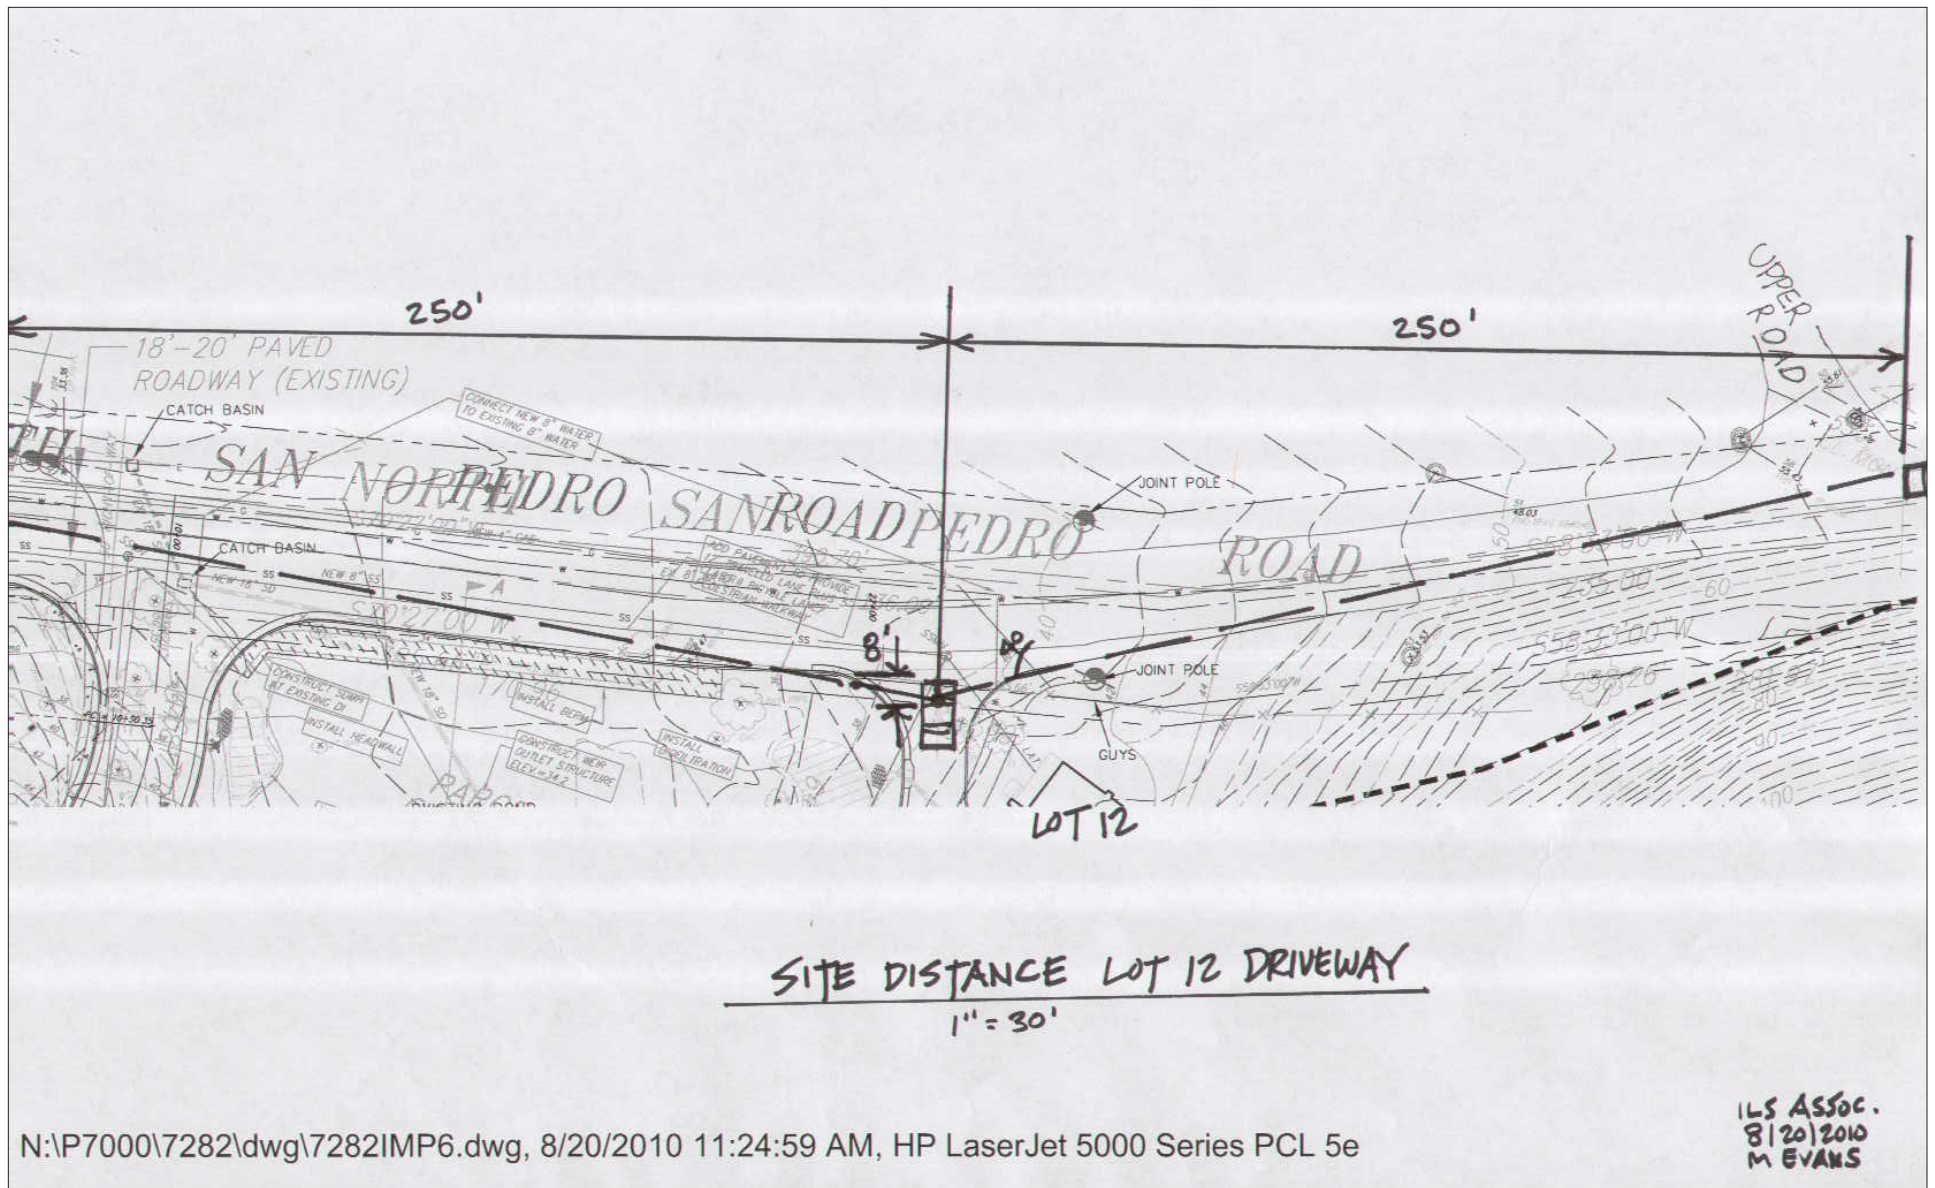
FIGURE 6
SITE DISTANCE FROM LOT 12 DRIVEWAY

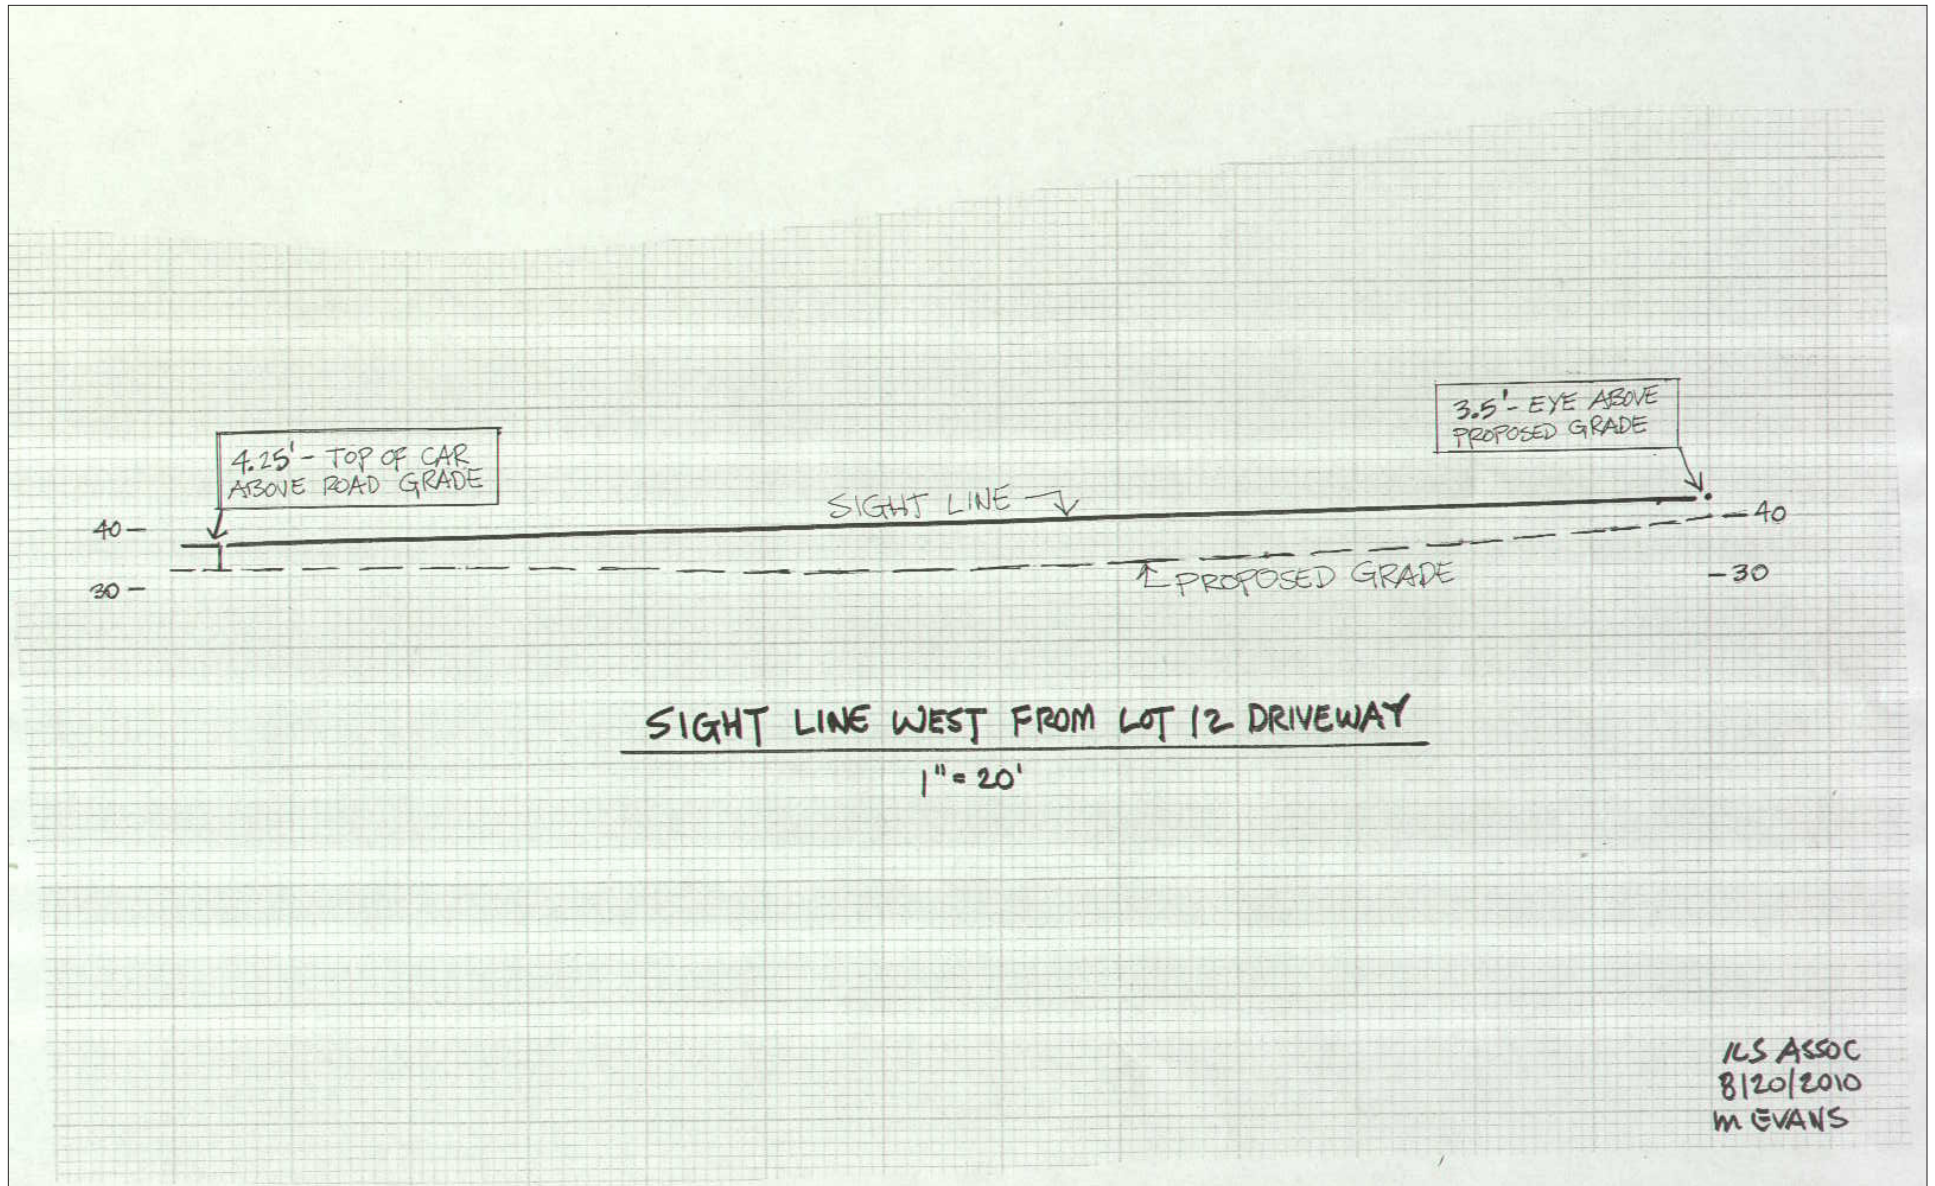
FIGURE 7
SIGHT DISTANCE PROFILE TO WEST FROM LOT 12 DRIVEWAY

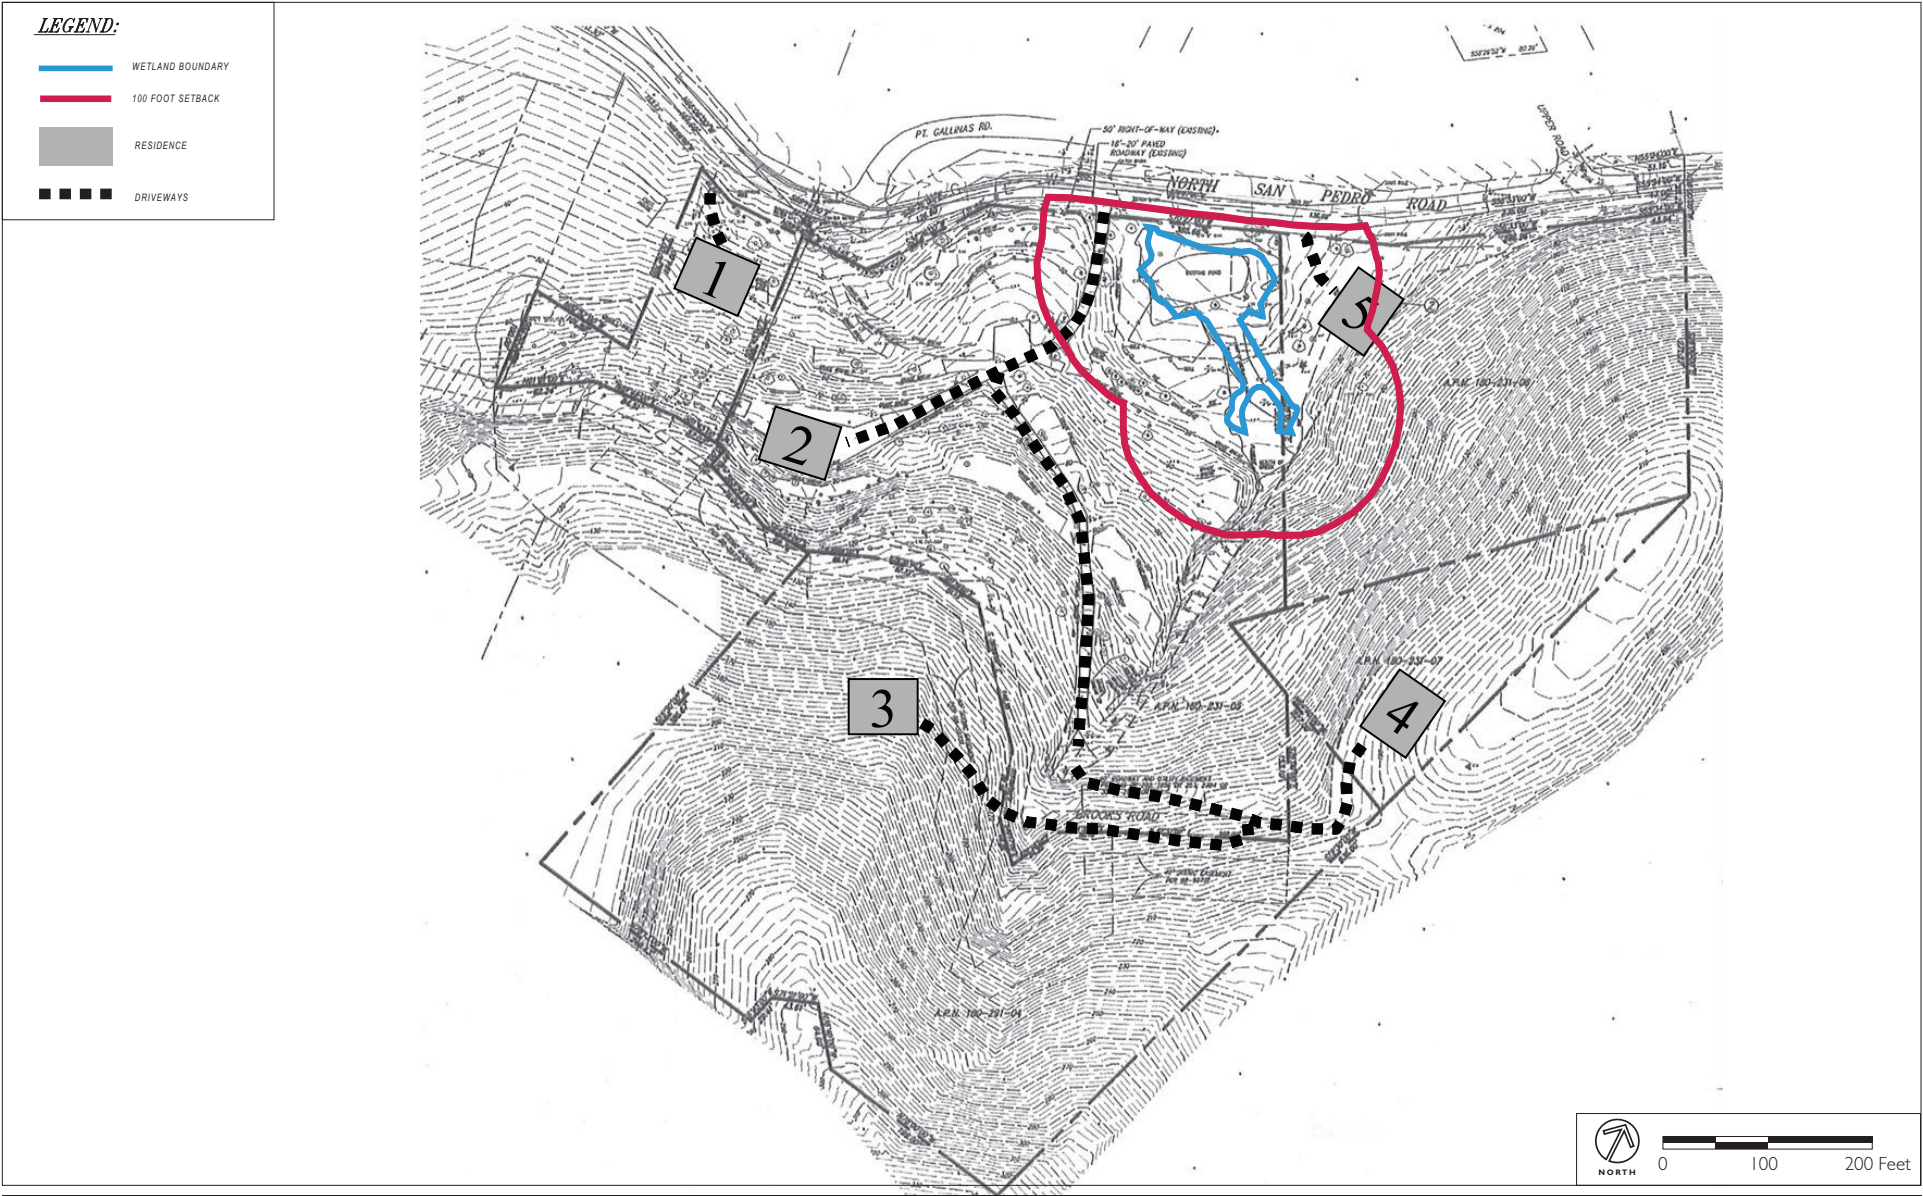
FIGURE I
WETLAND CONSERVATION AREA AND NO PROJECT ALTERNATIVE

Figure 1 in Appendix M shows the Wetland Conservation Area (WCA) on the 5-lot subdivision plan to show which lots would encroach into the WCA.

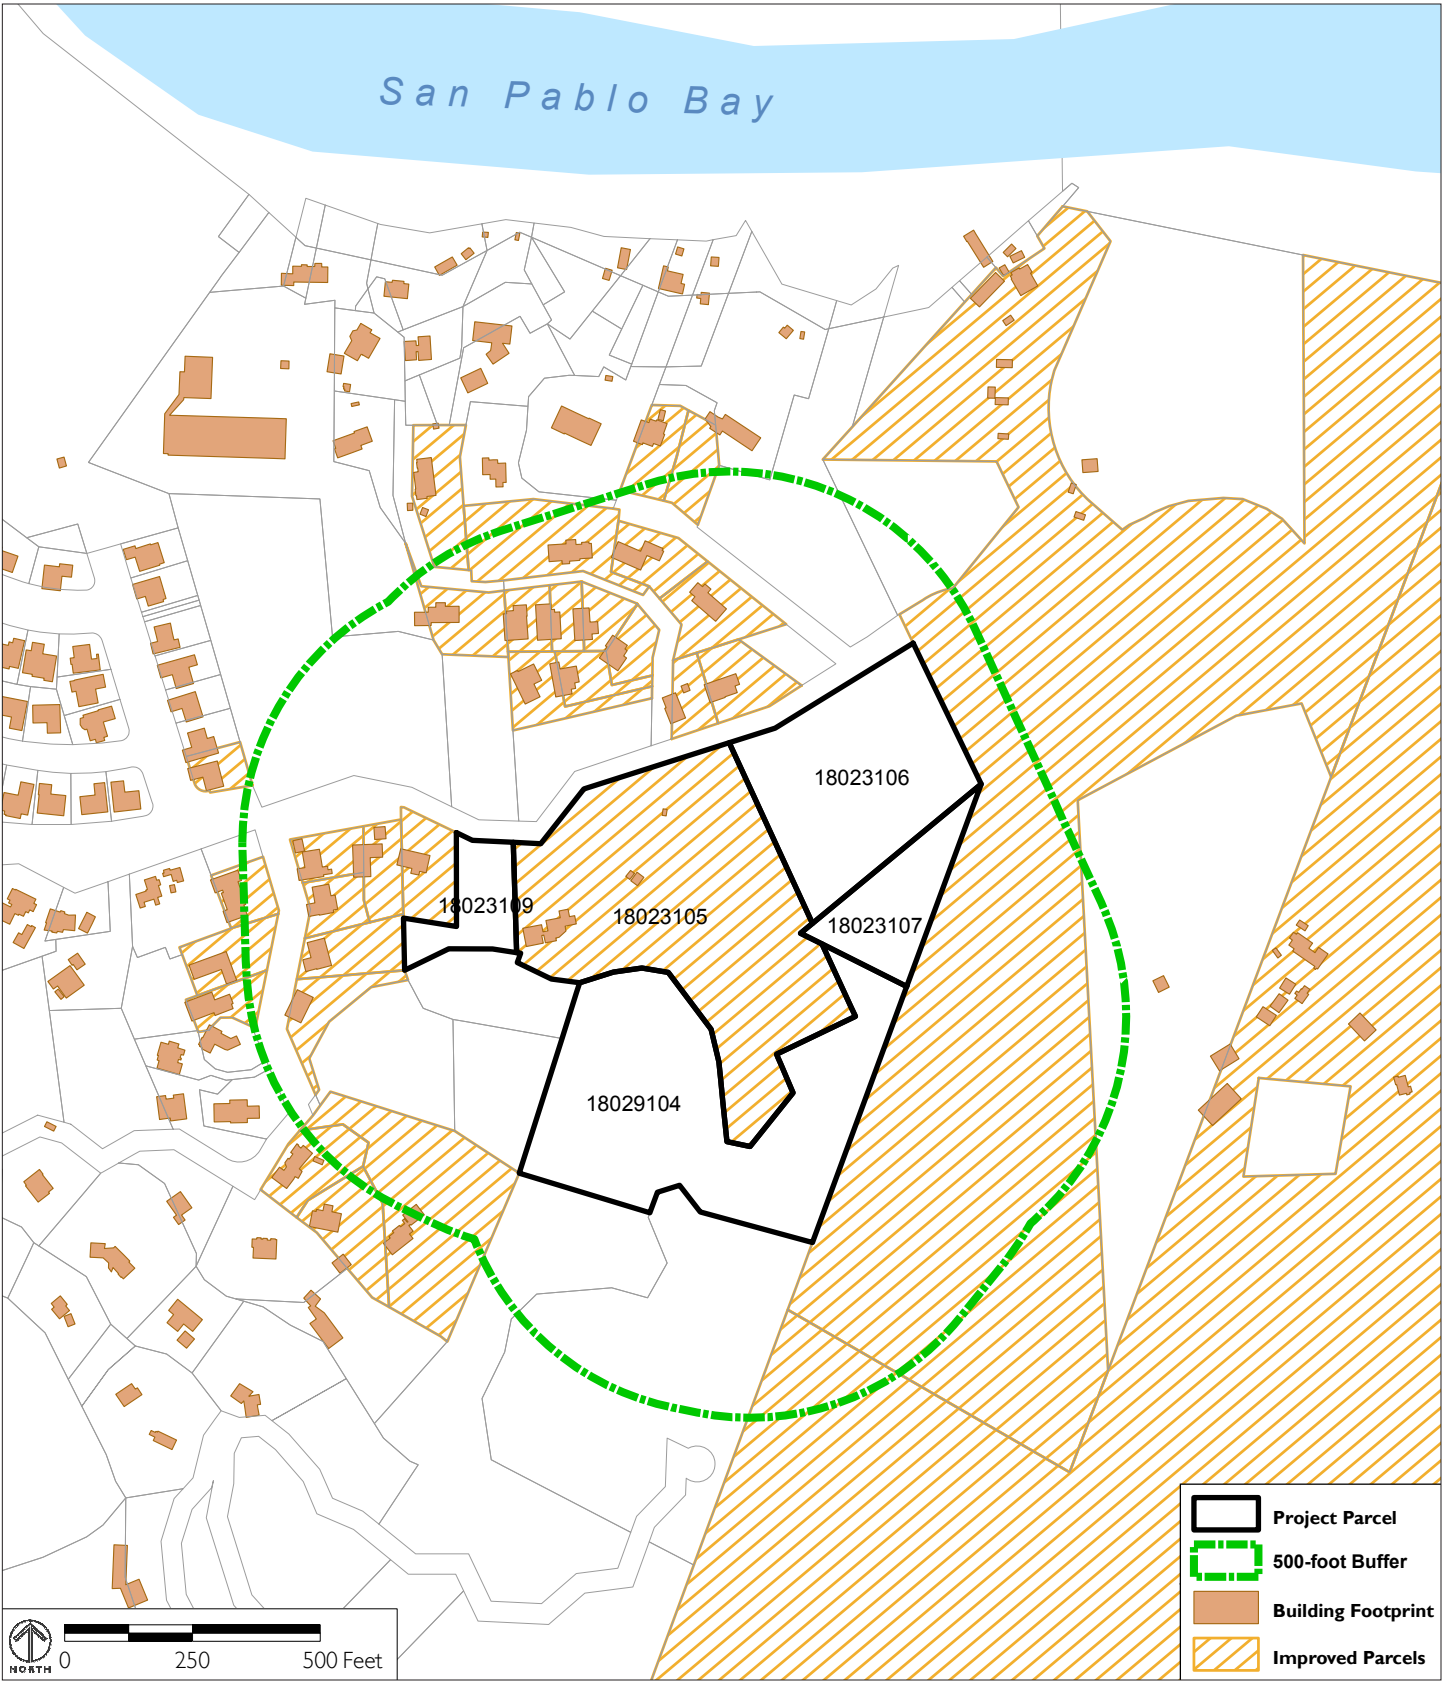
FIGURE I
LAND USE COMPATIBILITY ANALYSIS MAP

The GIS map used in this analysis is provided in Figure 1 of Appendix N to show the parcels compared to the project site.
