Stream and Valley Floor Restoration Vision

Balance Hydrologics, Inc.

November 19, 2009

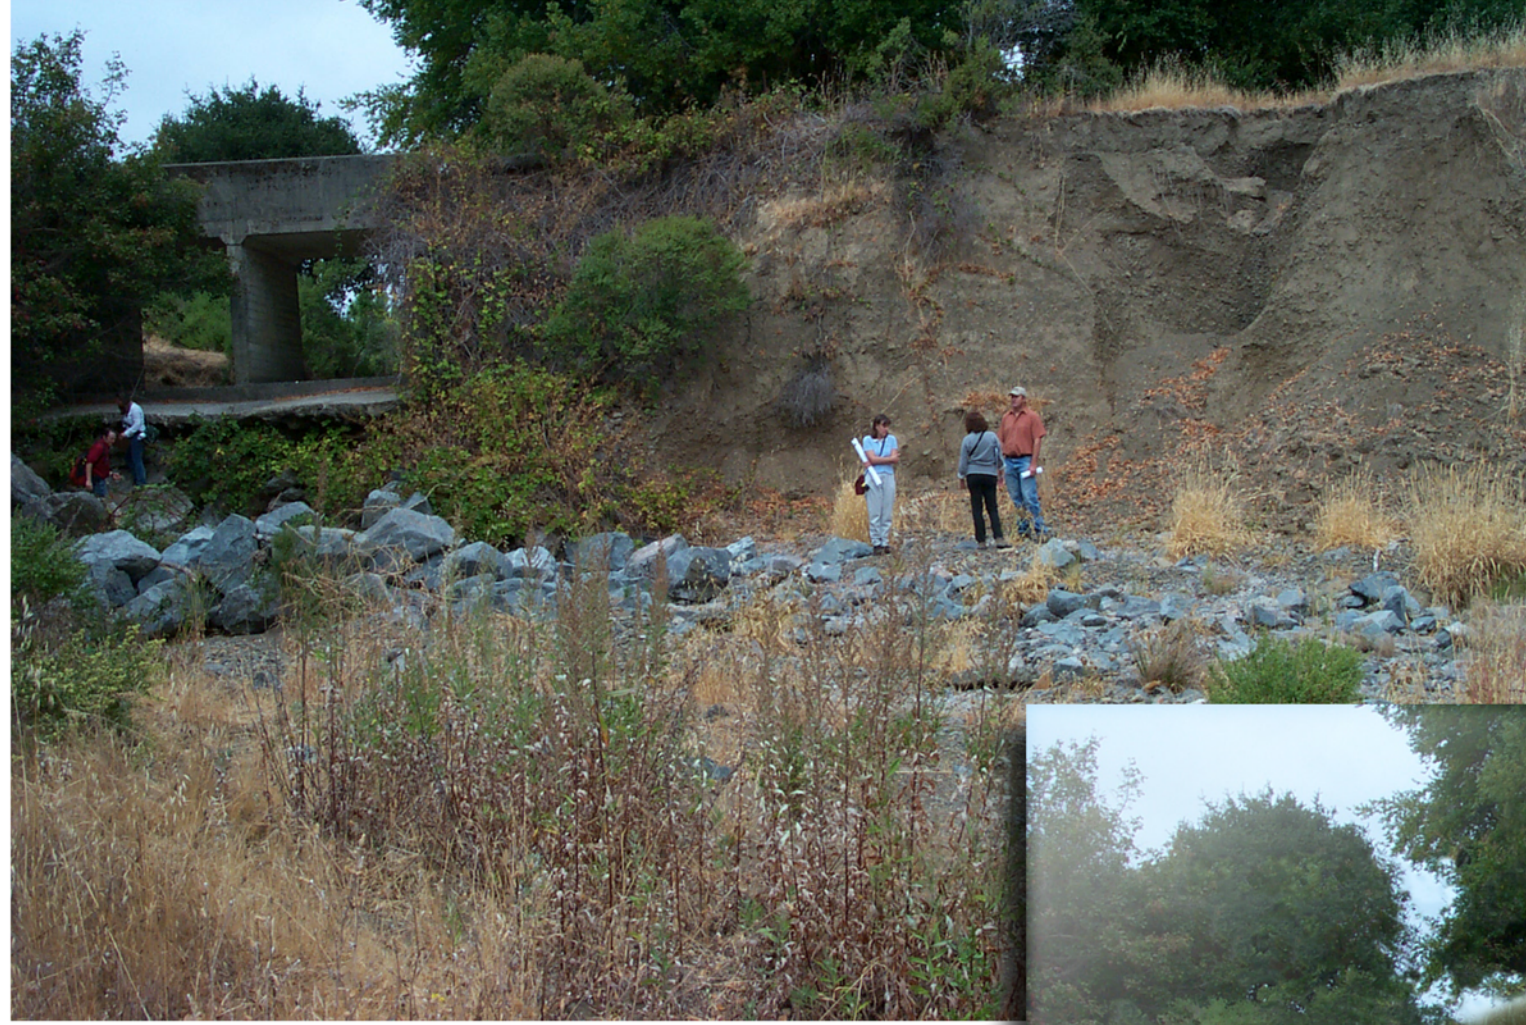
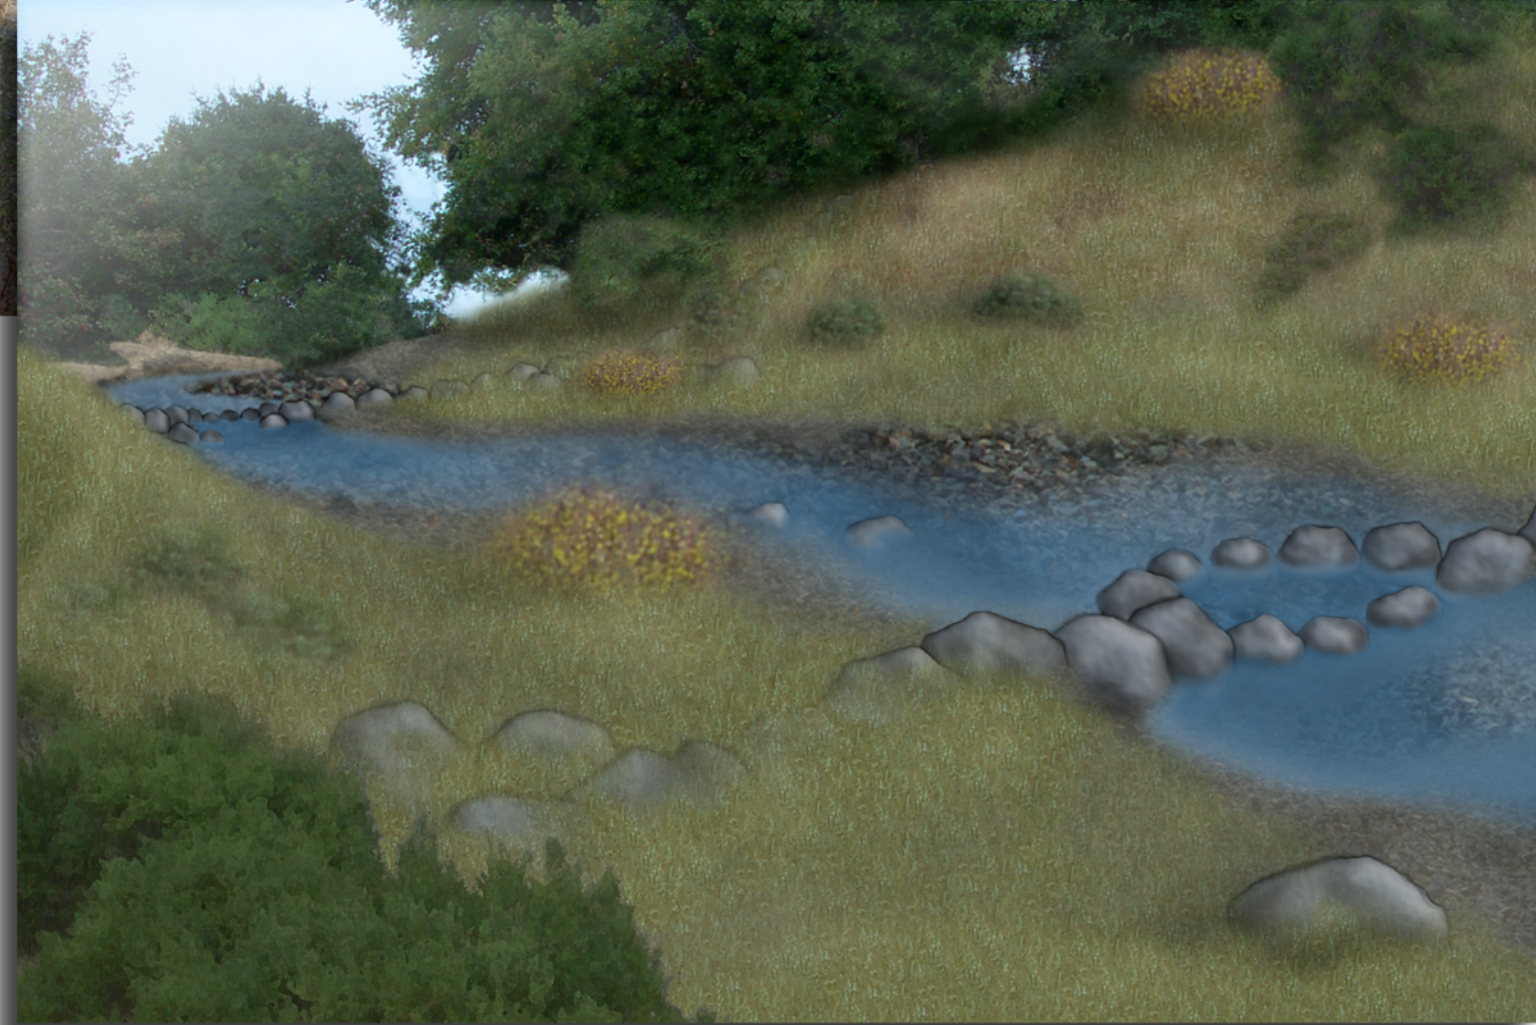
Miller Creek looking upstream at bridge, existing conditions, photograph taken August 2008. Boulders are riprap placed to protect bridge.

Proposed improvements, including raised bed and floodplain elevations, boulder weirs with steps and bridge removal.

Figure 2. Conceptual view of existing conditions and 10 years following construction of boulder weirs at Miller Creek and valley floor system.

Figure is schematic, showing representative elements and examples of likely arrangement in the channel. Additional design criteria are expected and will inform development of a permittable conceptual model.

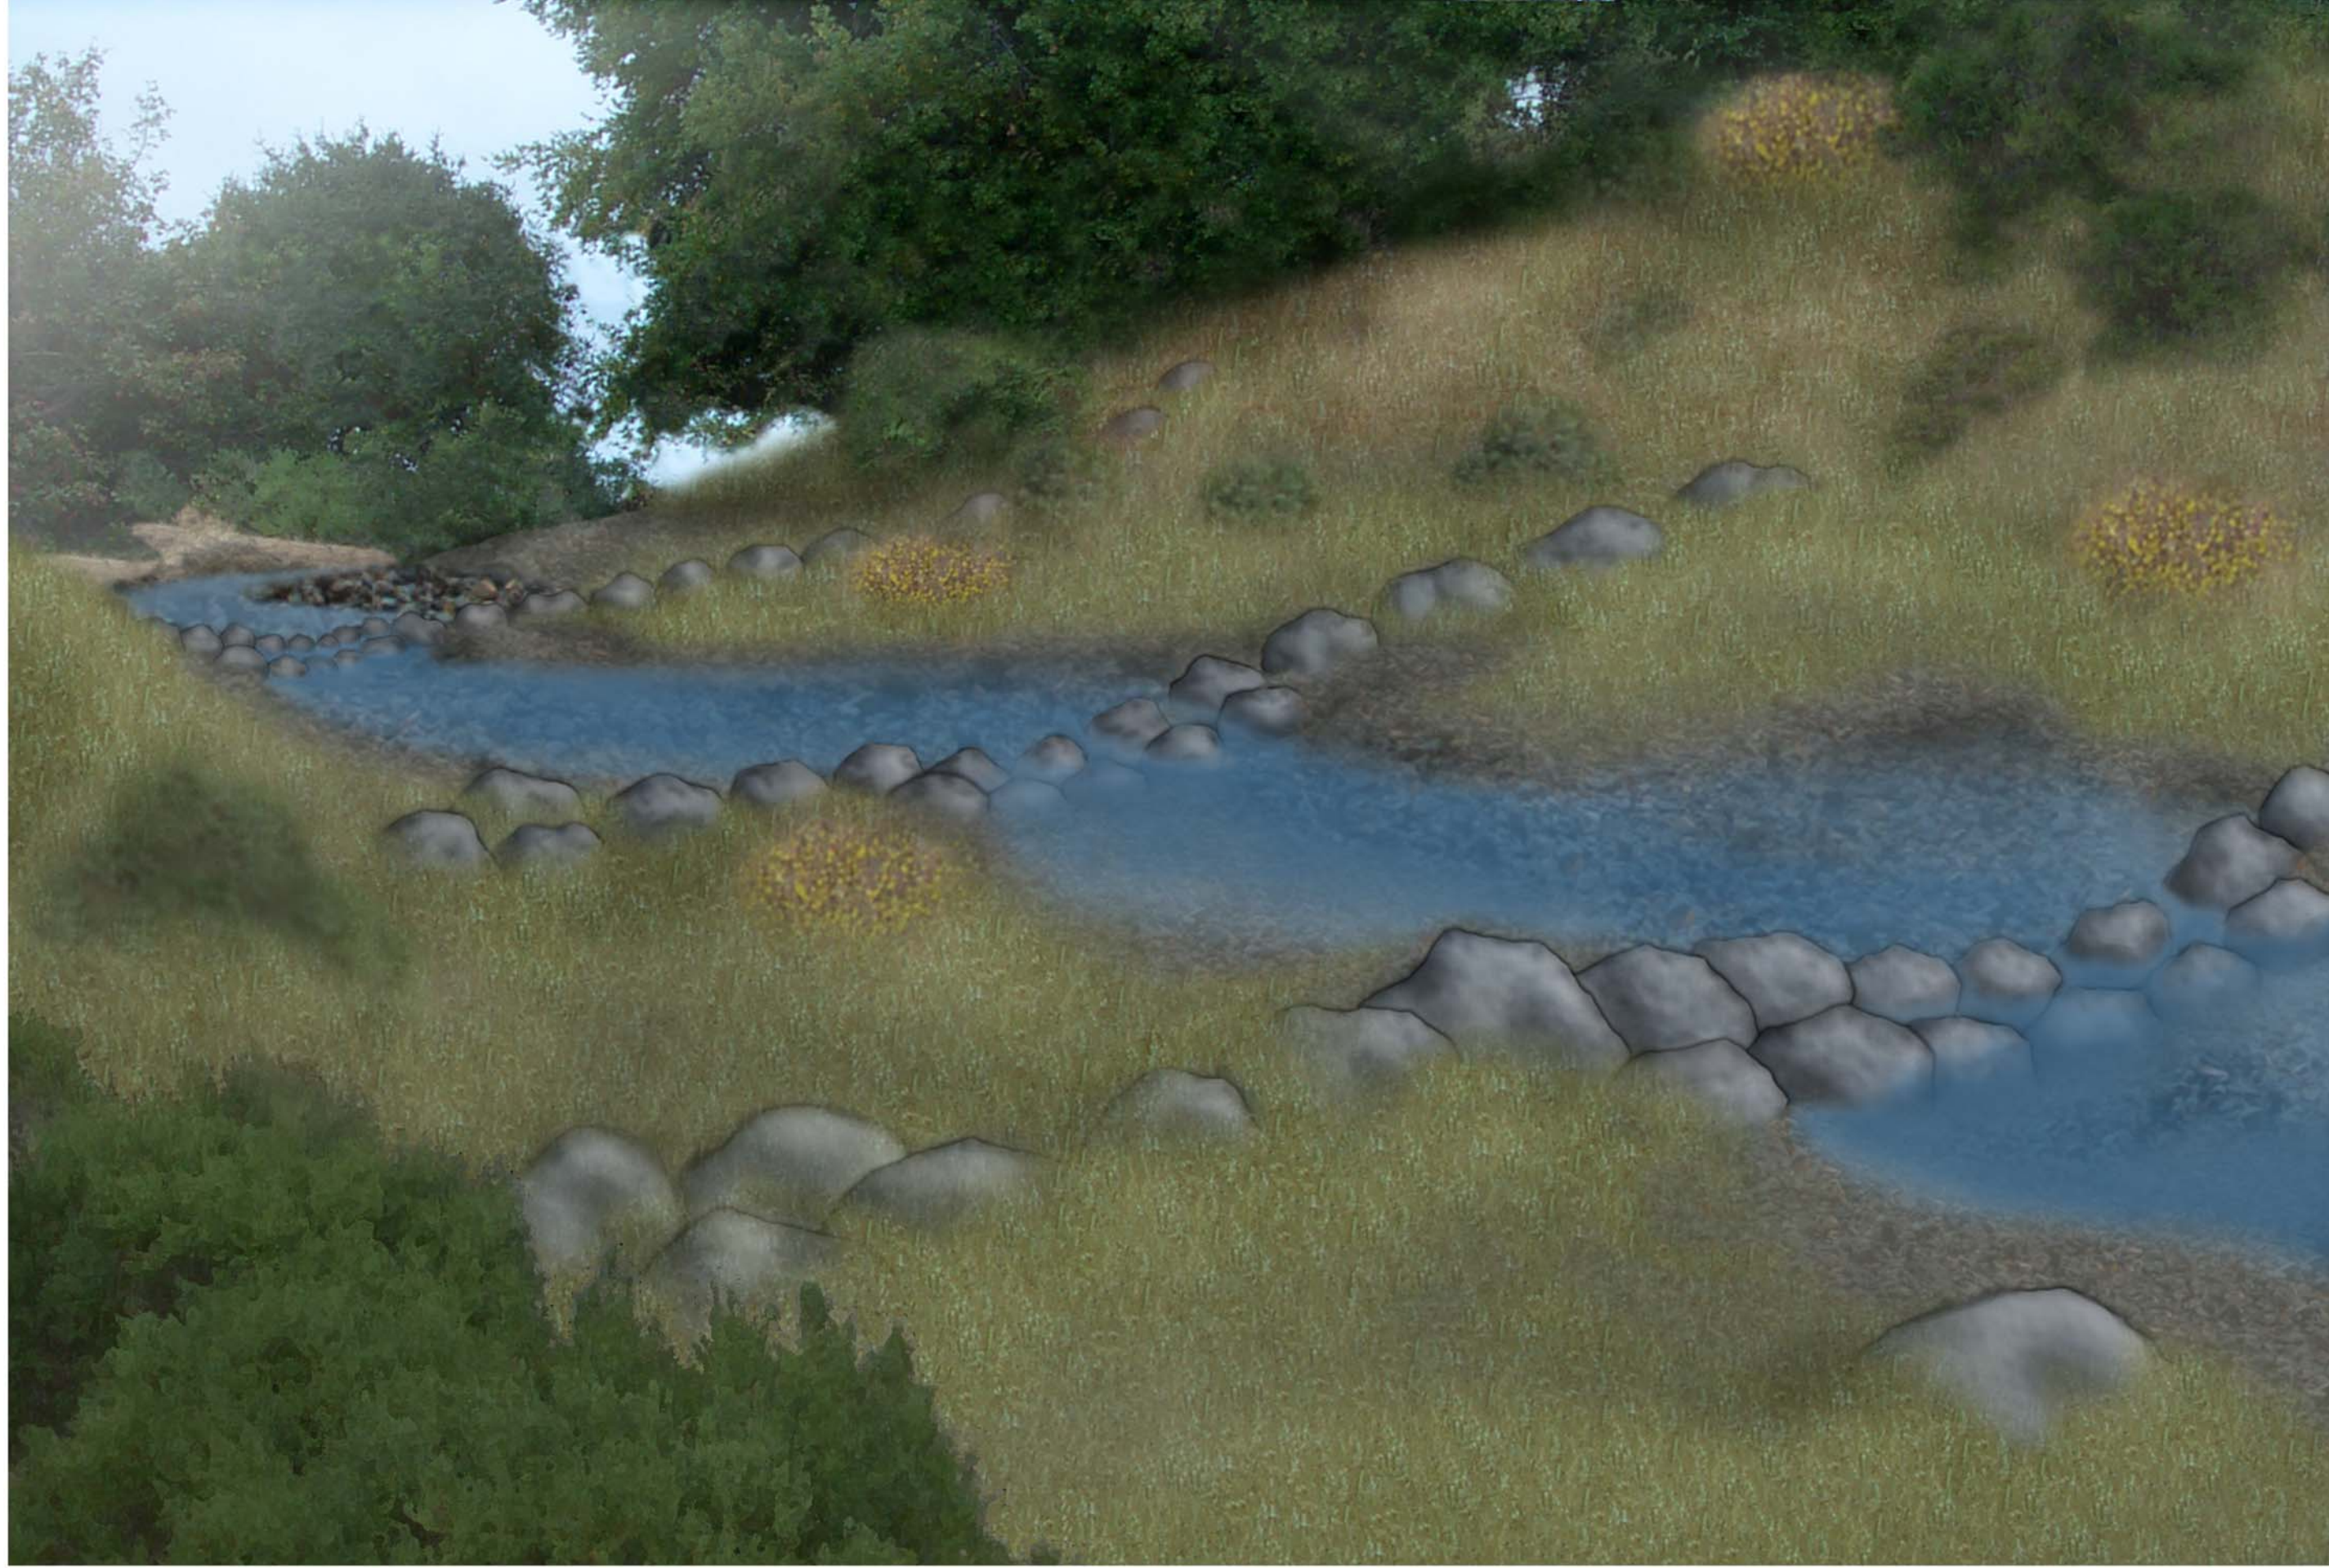
Figure 3. Conceptual view of proposed step pool weirs at Miller Creek, Marin County, California.

Figure is schematic, showing representative elements and examples of likely arrangement in the channel. Additional design criteria are expected and will inform development of a permittable conceptual model.

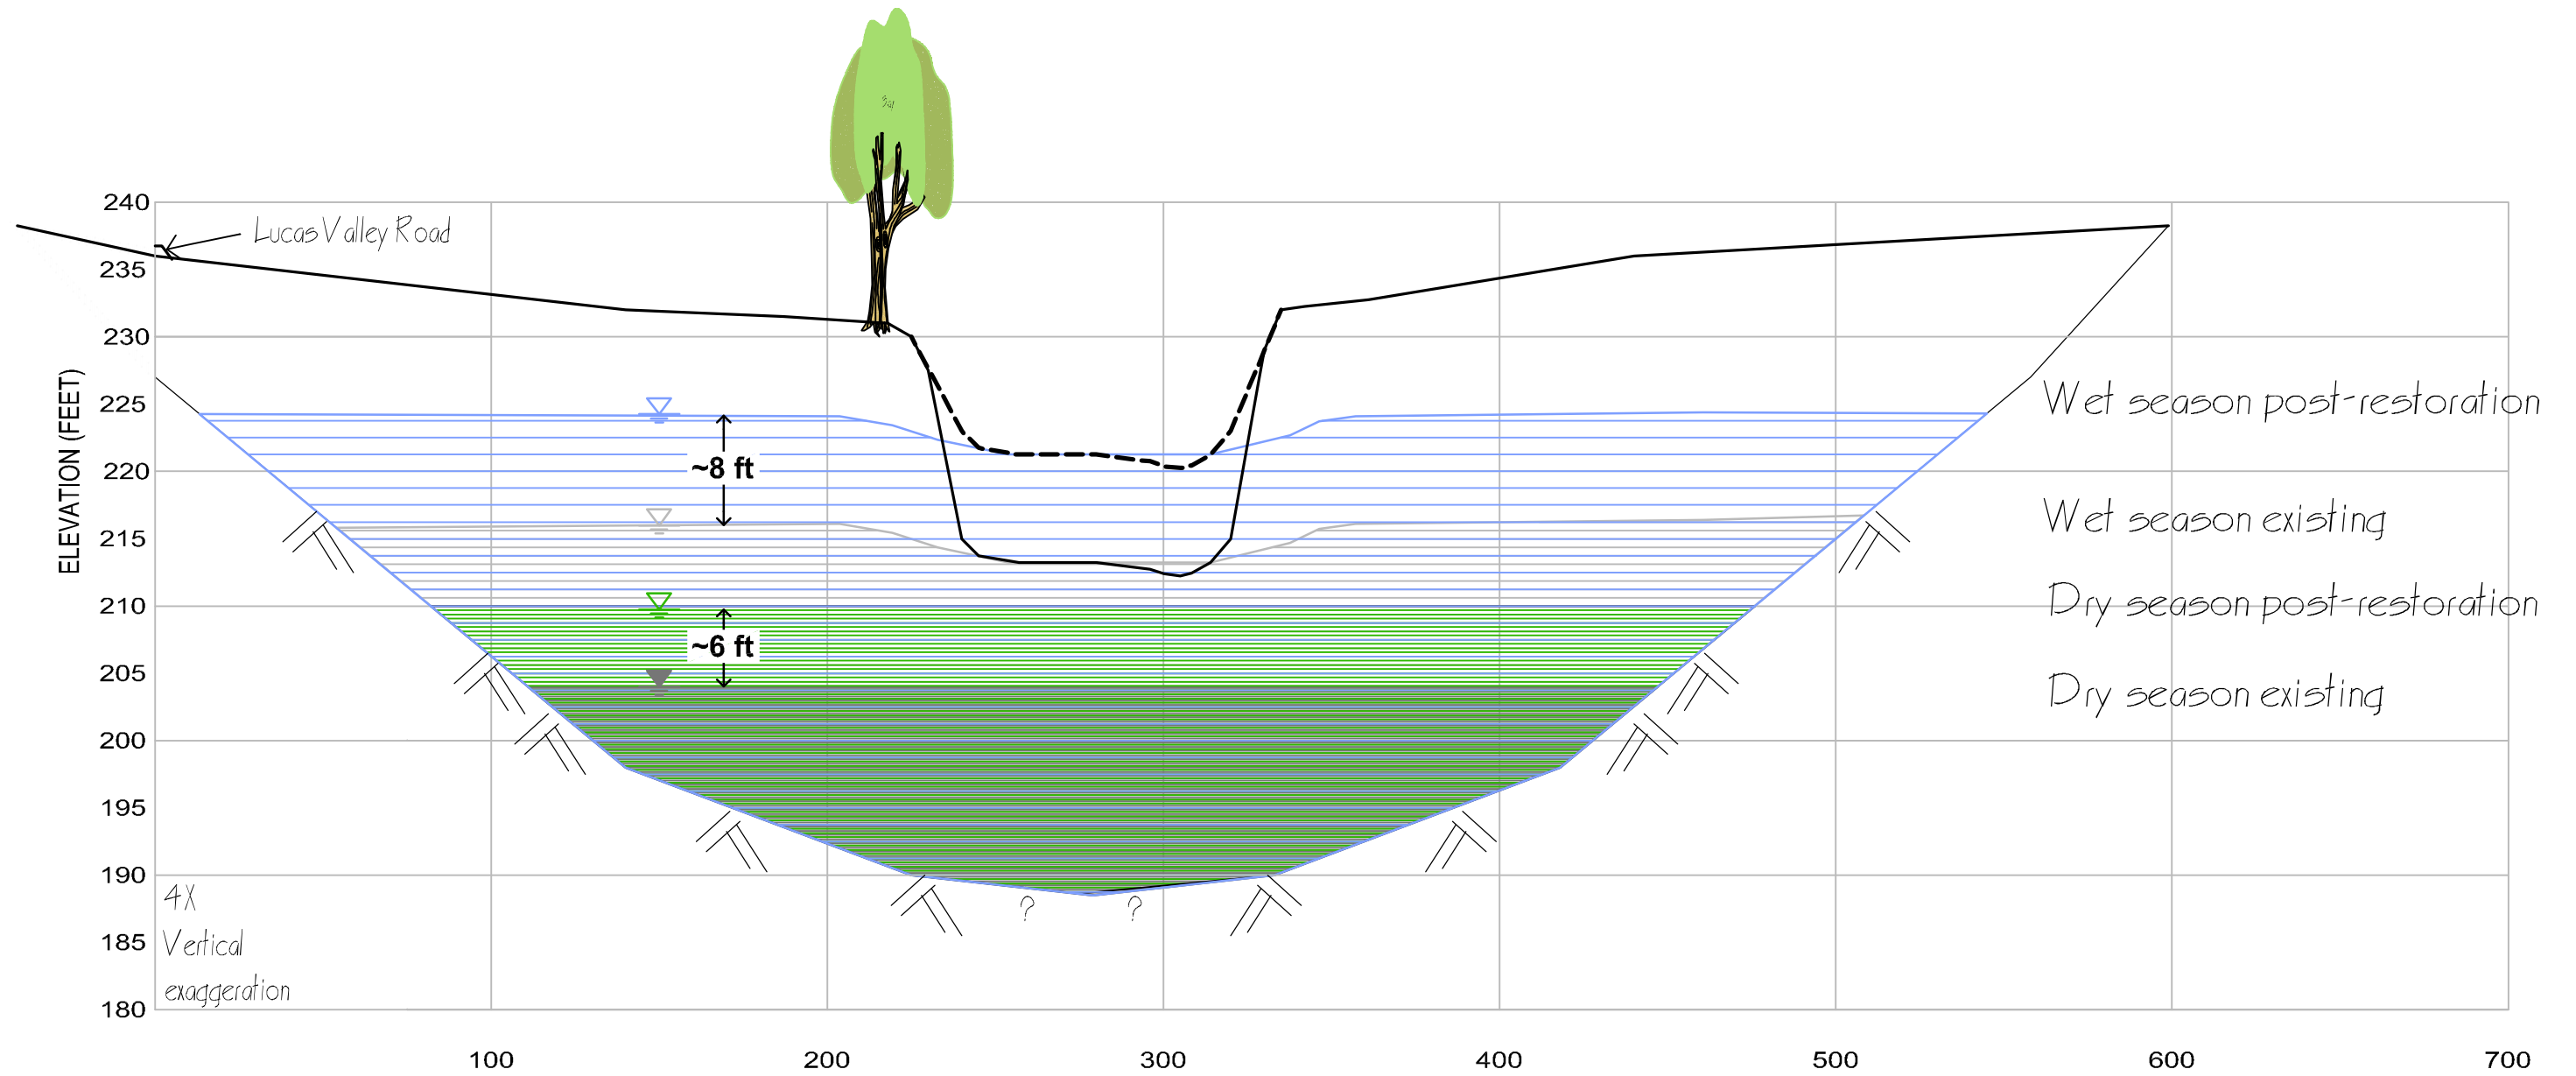
Figure 7. Idealized cross section of the Miller Creek Valley just downstream from the confluence with Grady Creek. This is the only location where groundwater levels are presently known. Restoration of the valley system is expected to raise the winter and summer water tables, with more aquifer storage available to sustain downstream flows in Miller Creek, especially during April and May.

Reactivation of inset terrace surfaces will provide an area for storm flows to spread out, allowing some additional water to infiltrate into the alluvial aquifer. This water will be stored within the alluvium and either discharge to Miller Creek within the project site to extend the baseflow recession (likely during mid-winter and early spring periods), or migrate within the aquifer down-valley, to support baseflows in those reaches (late-spring through summer, or possibly longer).
