## Memorandum

**Subject: Regional Analogs to Proposed Restoration of Miller Creek, Grady Ranch, Marin County, California**

### 1.0 Introduction

#### 1.2 Elements of proposed restoration

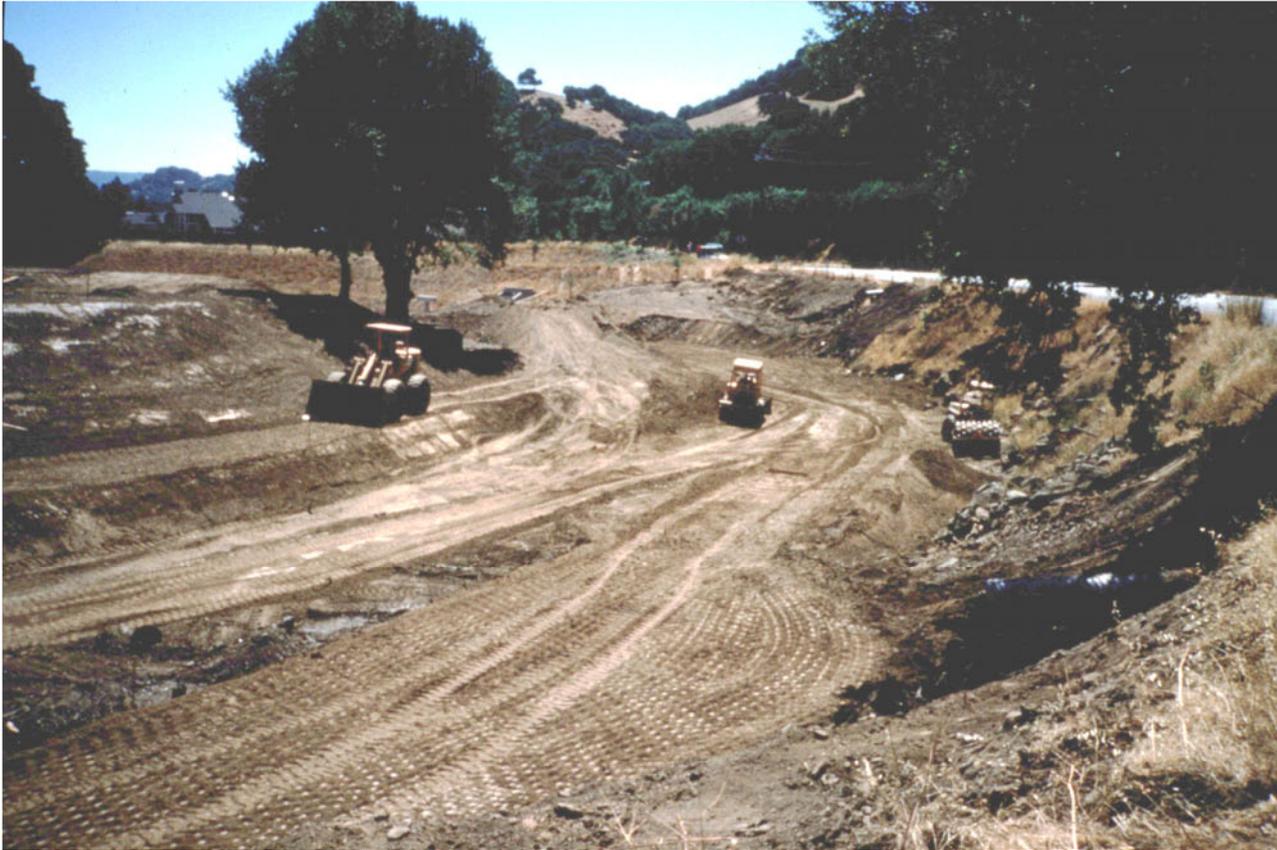
ca. 1985

**PHOTOS OF RESTORATION AT LUCAS VALLEY ESTATES**

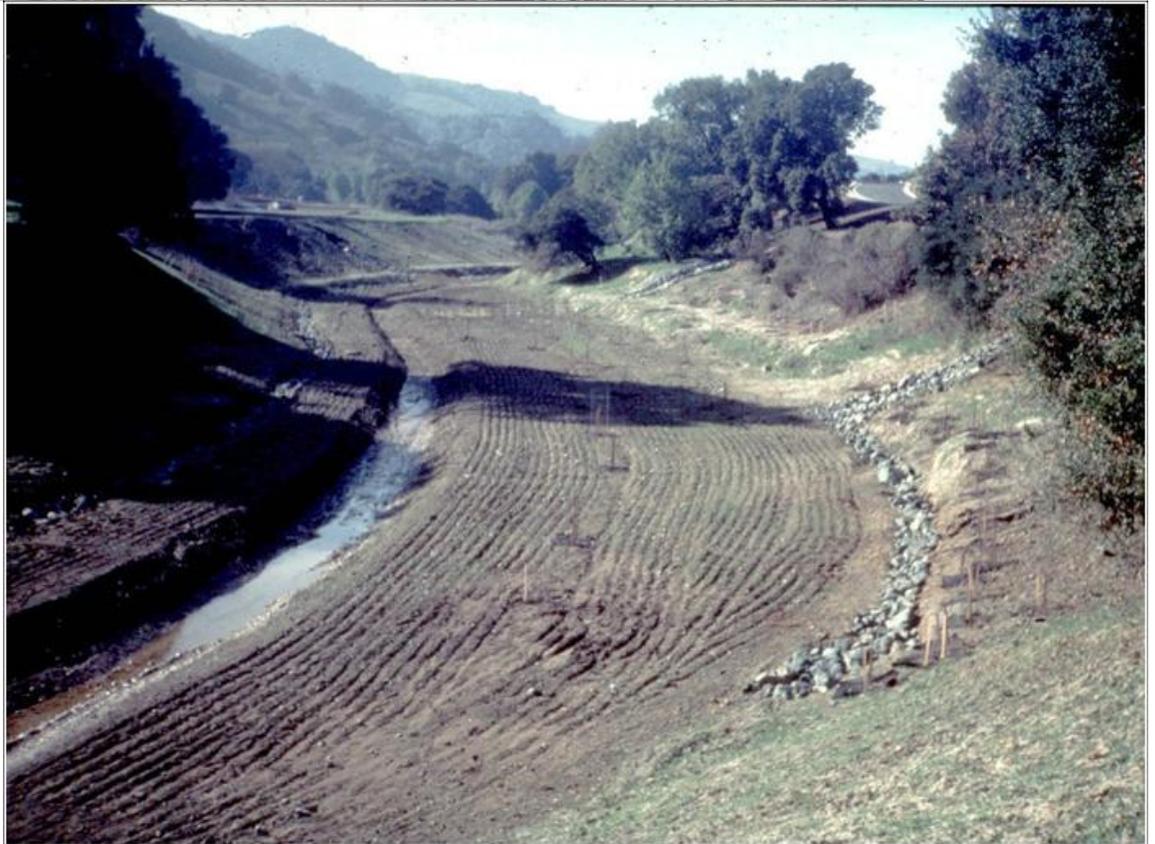
**Figure 5. Floodplain design in Lucas Valley Estates reach of Miller Creek, Marin County, California.** Source: Yin and Pope-Daum, 2004

Marin County analogs described below have weathered the high-flow years of the mid-1990s and the episodic storm of Dec. 31, 2005. The oldest analogs have also persisted through the storm of January 4, 1982 and the high flows of 1982, 1983, and 1986 and the mid-1990s. A useful portrayal of historical streamflow peaks, years with large storms, and periods of drought can be found in Hecht and others (2010), Fig. 4 (since 1974, for Lagunitas Creek, which has many reservoirs) and Fig. 5 (since 1979, for unregulated San Geronimo Creek)<sup>4</sup>.

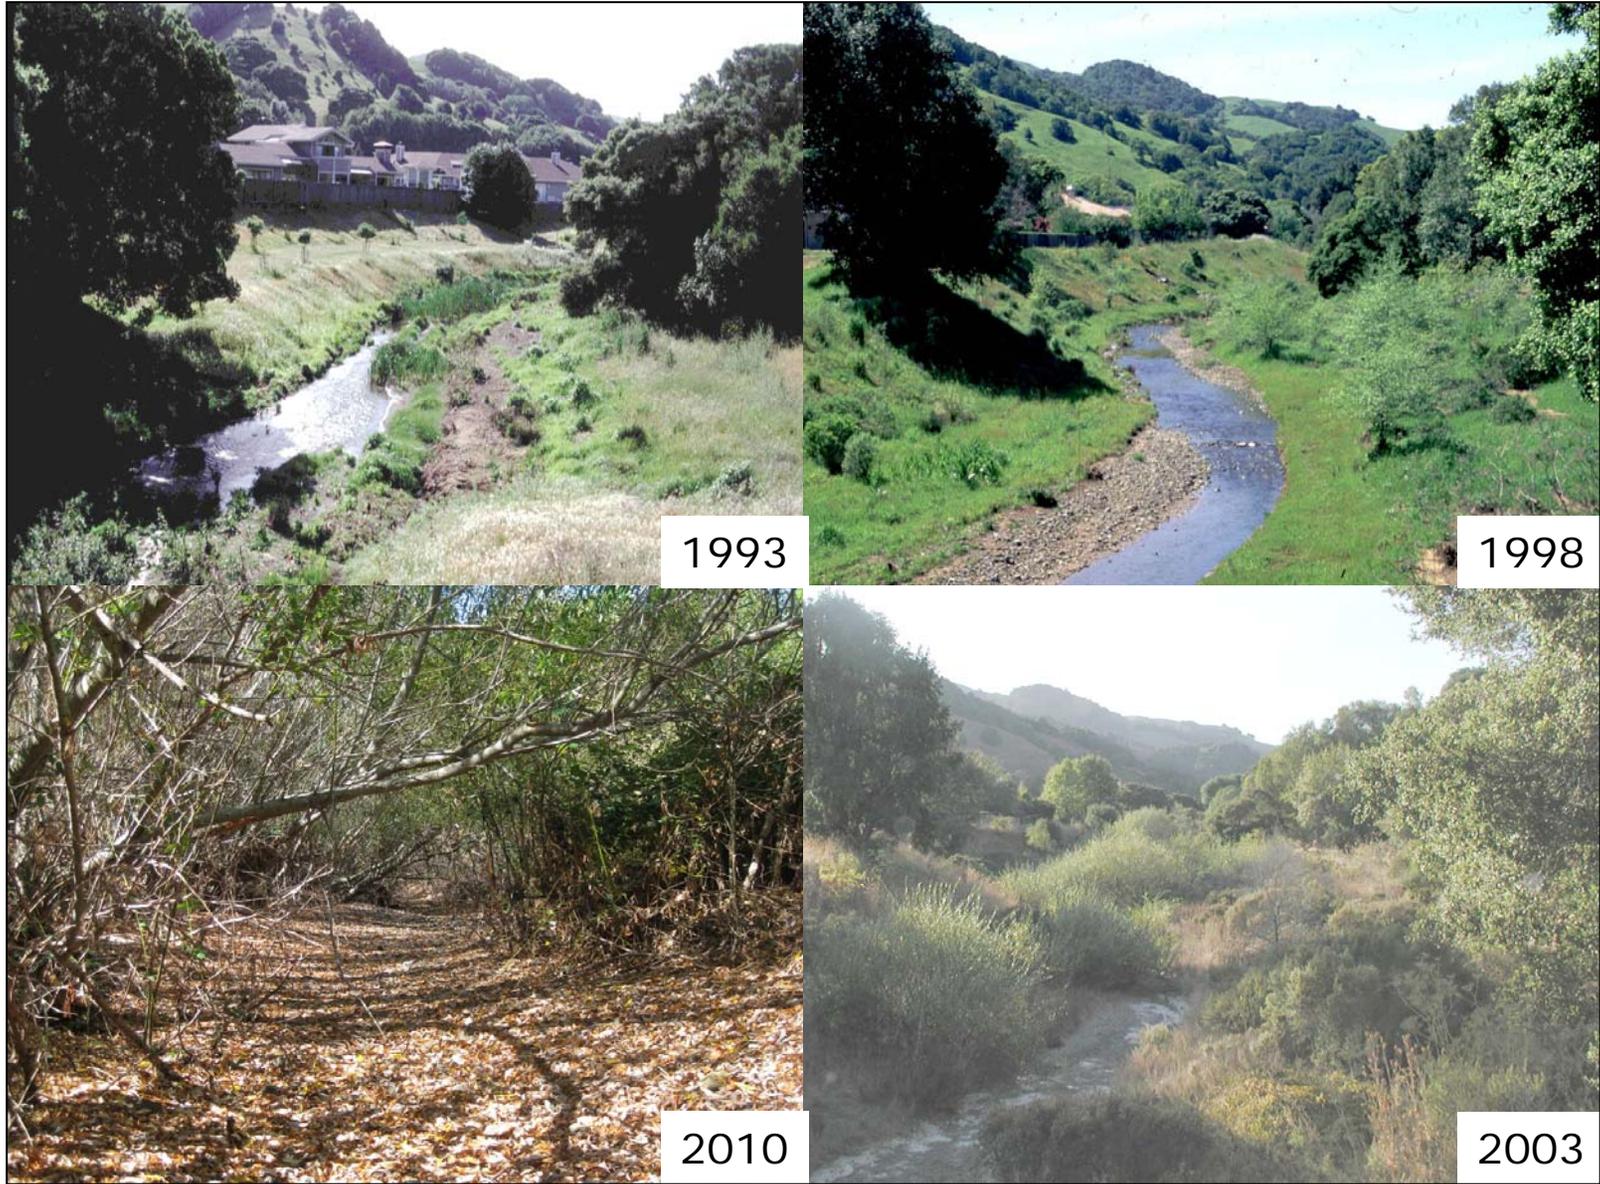
**Figure 6. After construction of stream restoration in Lucas Valley Estates reach of Miller Creek, Marin County, California.** Following drought years 1987 through 1992, a re-worked channel and willow propagation potentially responded to 1990's El Nino wet-year cycle (1993, 1995 and 1998), and then to moderately wet years 2005 and 2006. Photo source: Yin and Pope-Daum, 2004

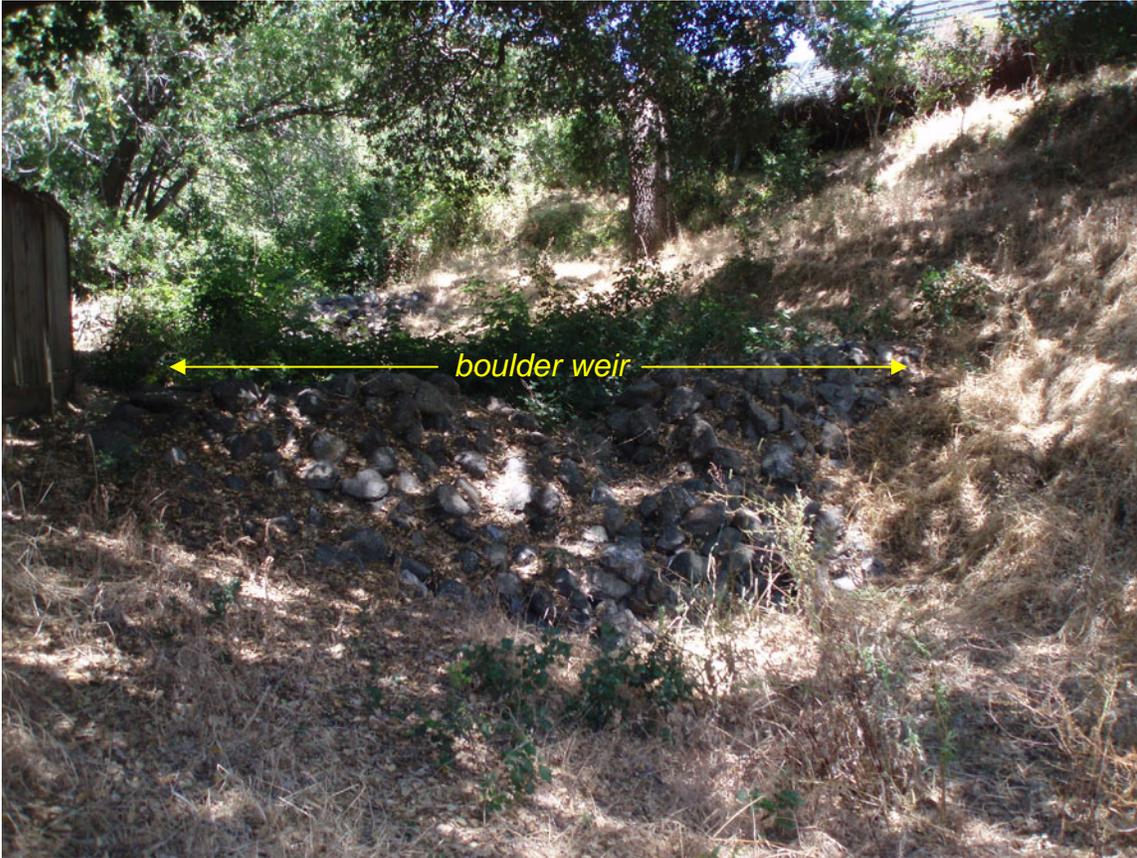
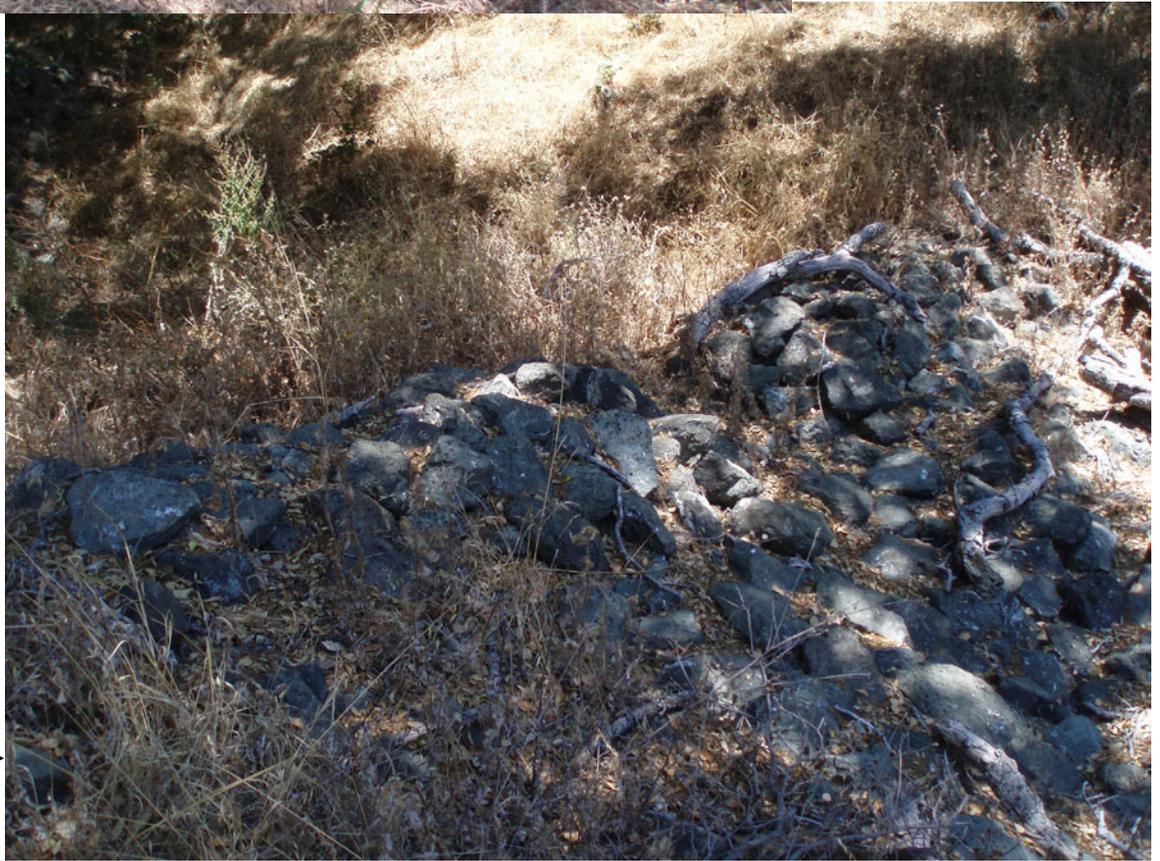
Looking further  
upstream

Lower most  
boulder weir

**Figure 7. Tributary channel stability in Lucas Valley Estates reach, Marin County, California.** Boulder-weir check dams were installed as part stream restoration to arrest incision.

In addition, it is important to note that the boulder weirs that were installed as part of the Lucas Valley Estates restoration remain stable, and have effectively held grade in the upstream reaches (Attachment A, Figures 7 and 10).

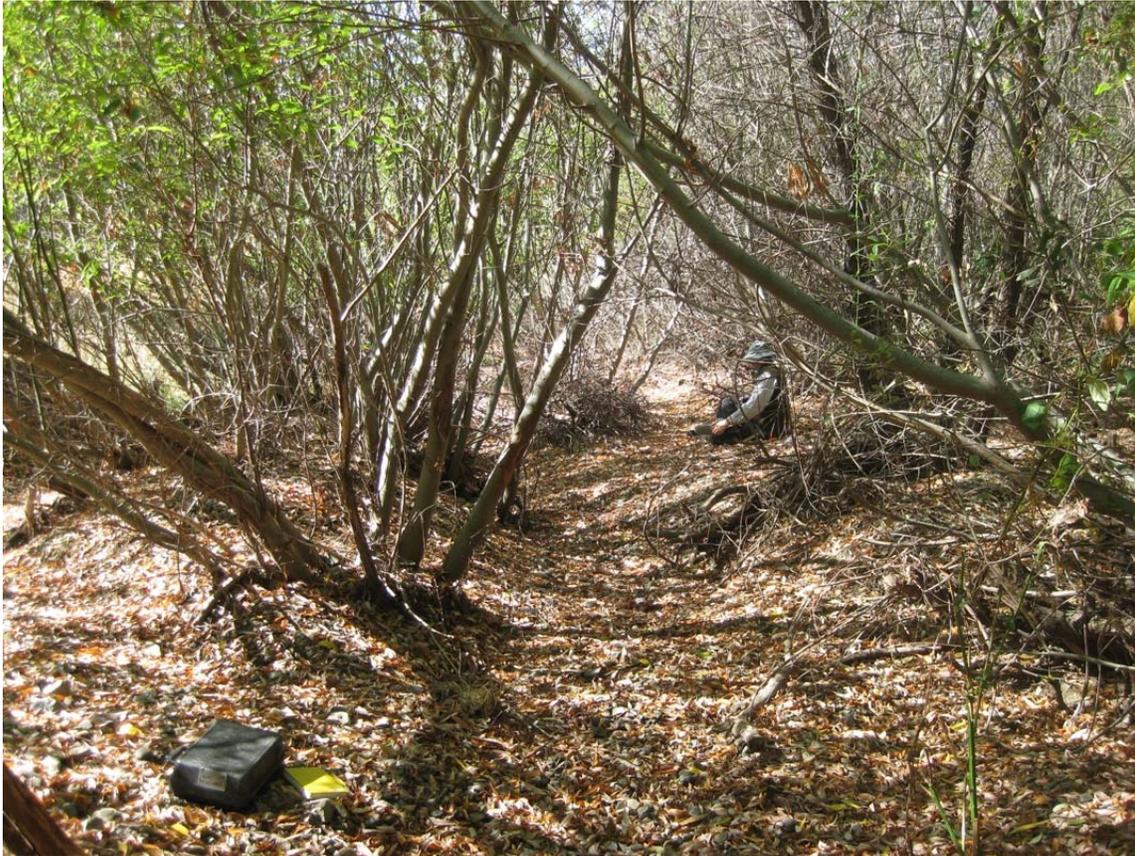
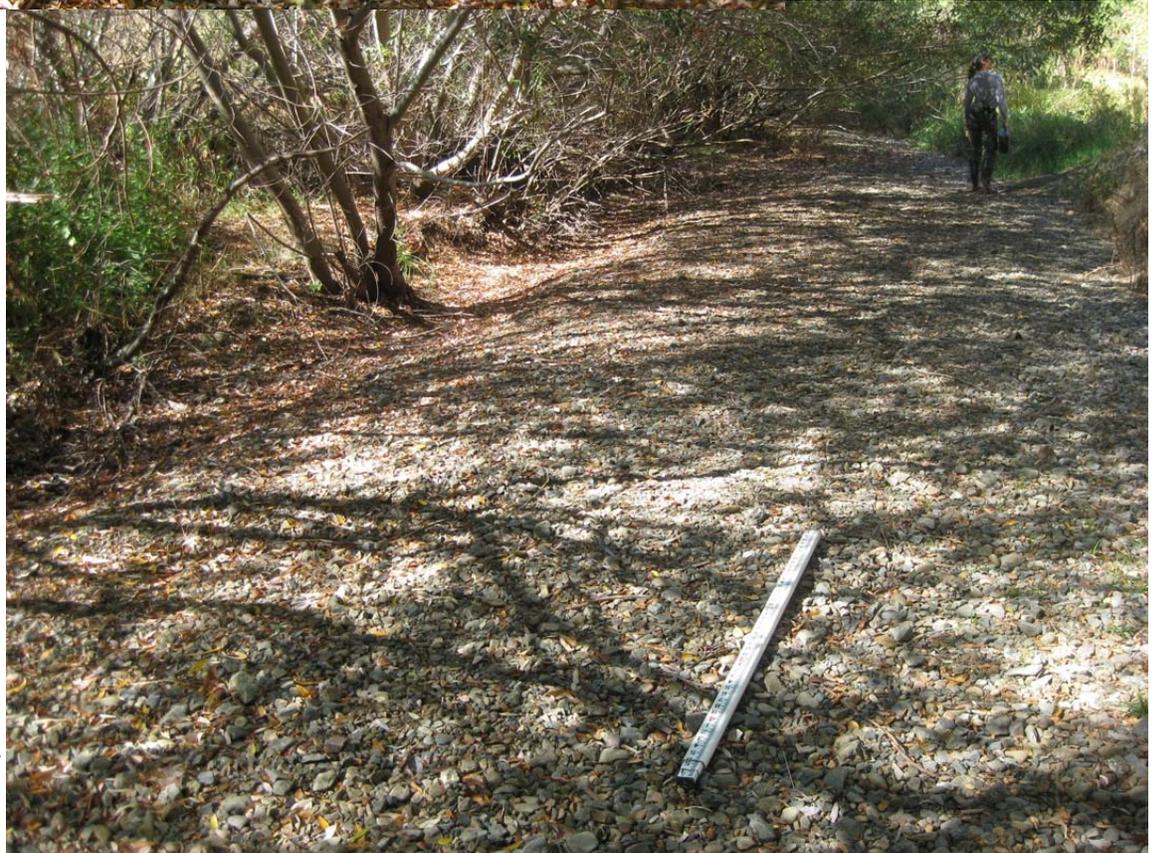
Looking further  
upstream

Large bar upstream  
of community park

**Figure 8. Miller Creek in Lucas Valley Estates reach, upper portion of creek restoration, Marin County, California.** Sediment storage and willow thickets are abundant, and an alternate channel with bar-pool morphology typical.

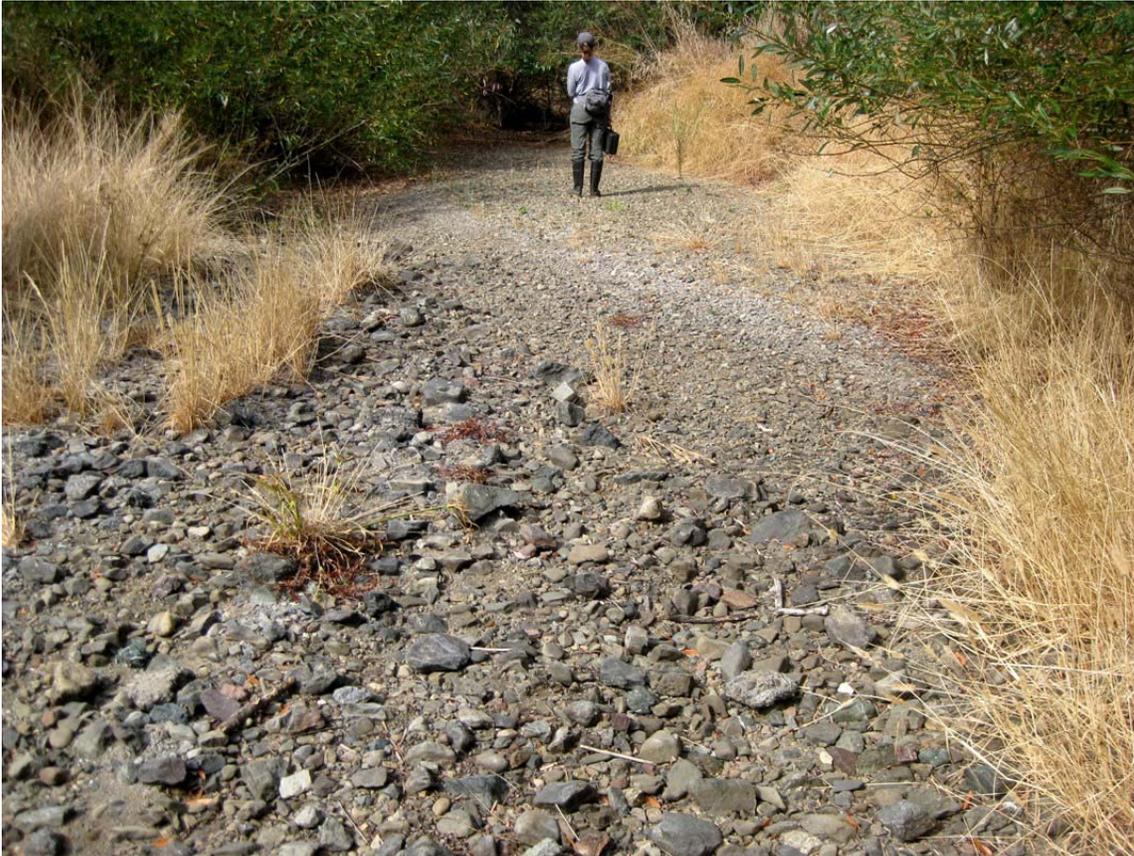
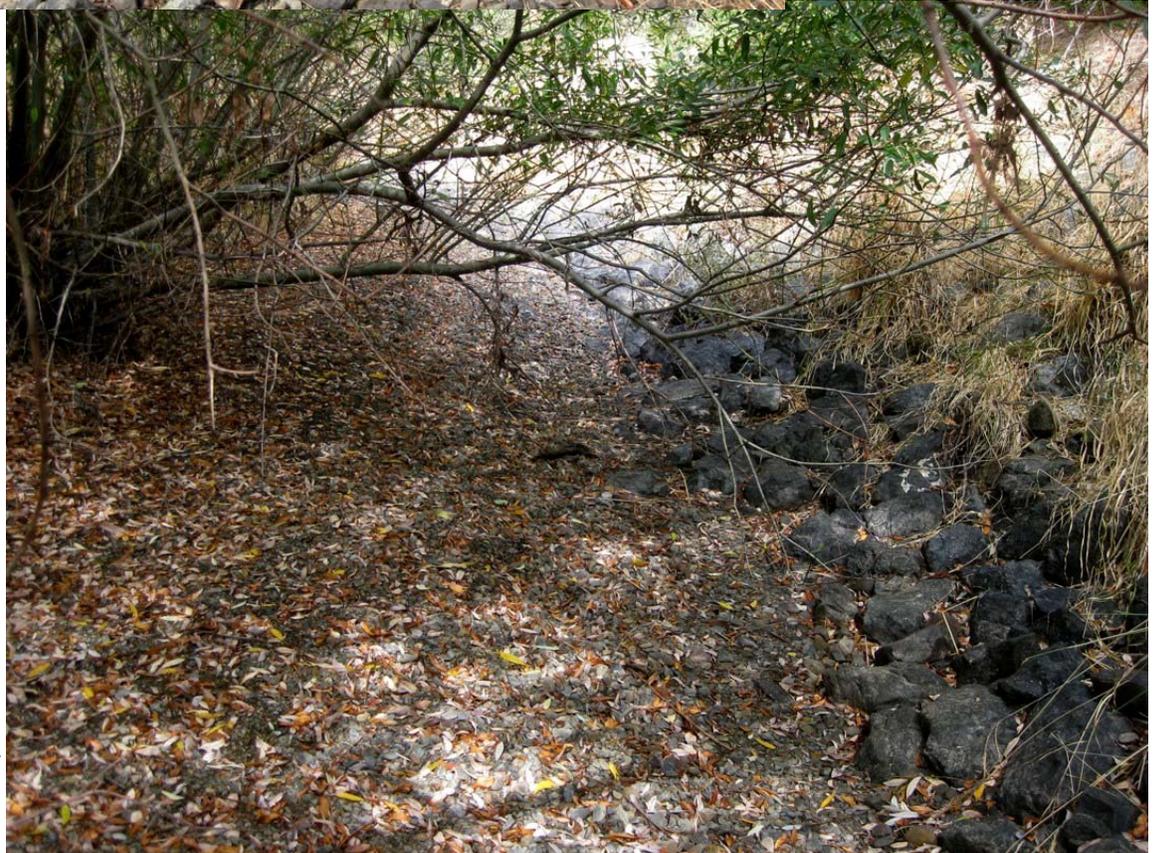
Re-worked stream bed  
near community park

Downstream of  
community park  
(looking upstream)

**Figure 9. Miller Creek in Lucas Valley Estates reach middle portion of creek restoration, Marin County, California.** A re-worked bed and designed channel cobble/boulder banks are key features since restoration.

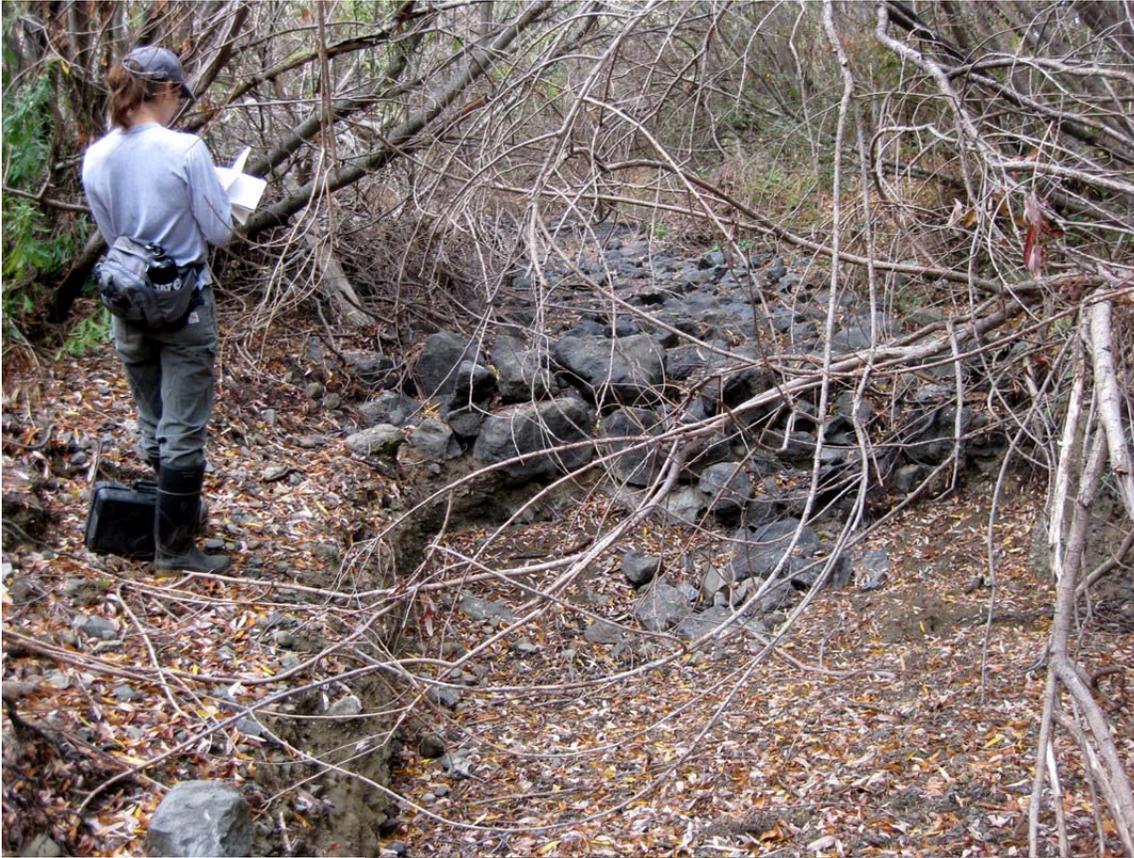
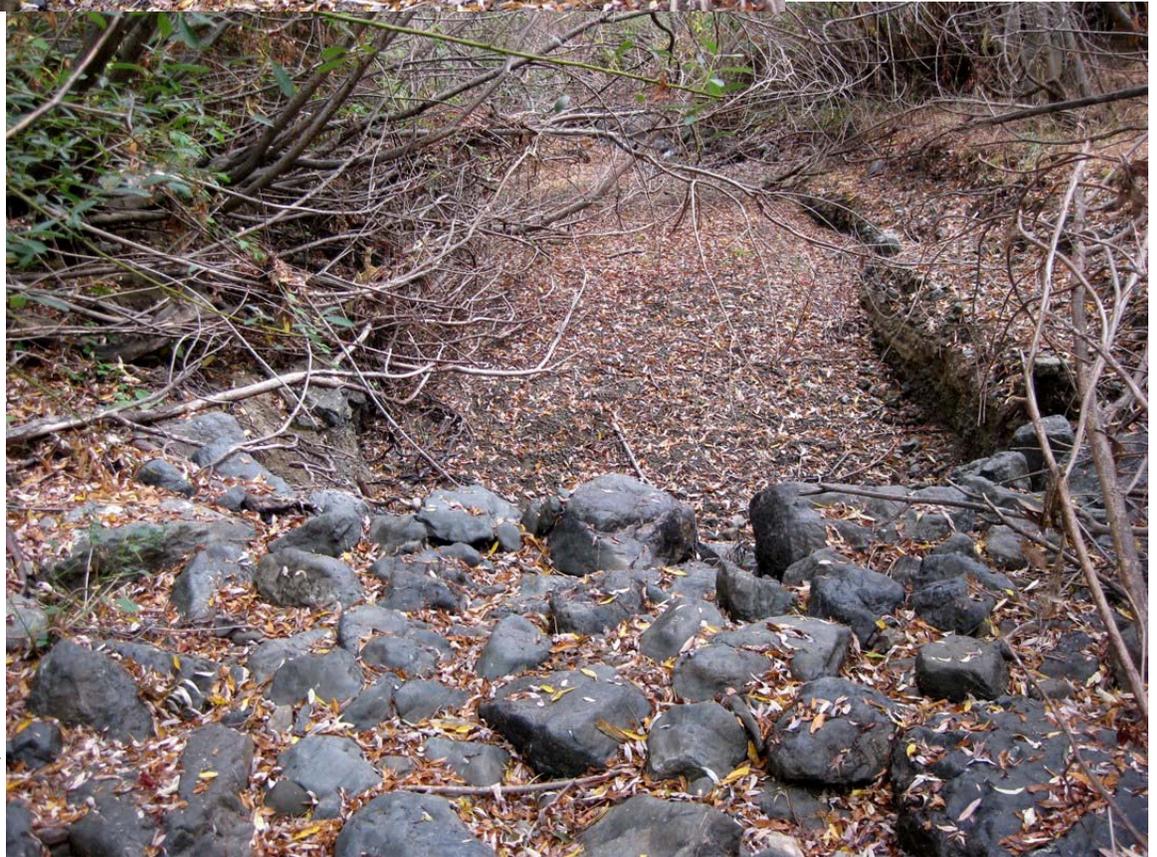
← Looking upstream

Looking downstream →

**Figure 10. Grade control on Miller Creek in Lucas Valley Estates reach restoration, located at pedestrian bridge, Marin County, California.**

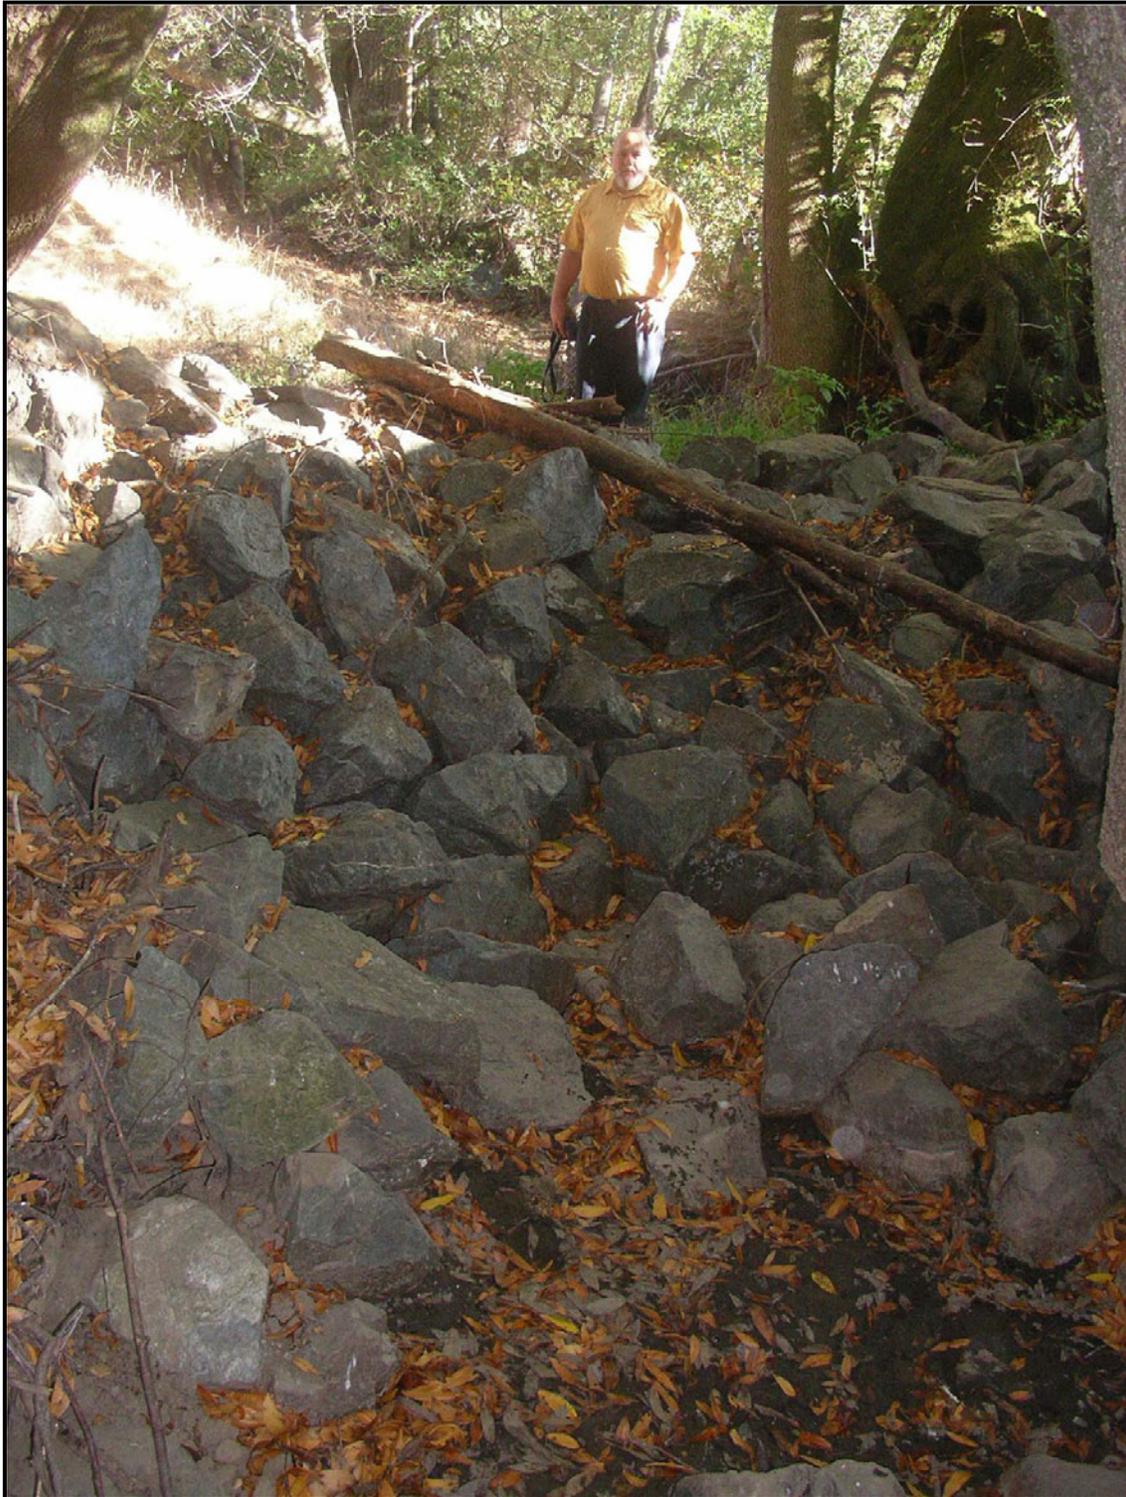
**Figure B1. Photograph of a boulder weir at the Spirit Rock property, San Geronimo Creek watershed, Marin County, California.** The weir has been in place for over 20 years and shows no sign of instability. Note the raised bed elevation behind the weir, on which the person in the background is standing.

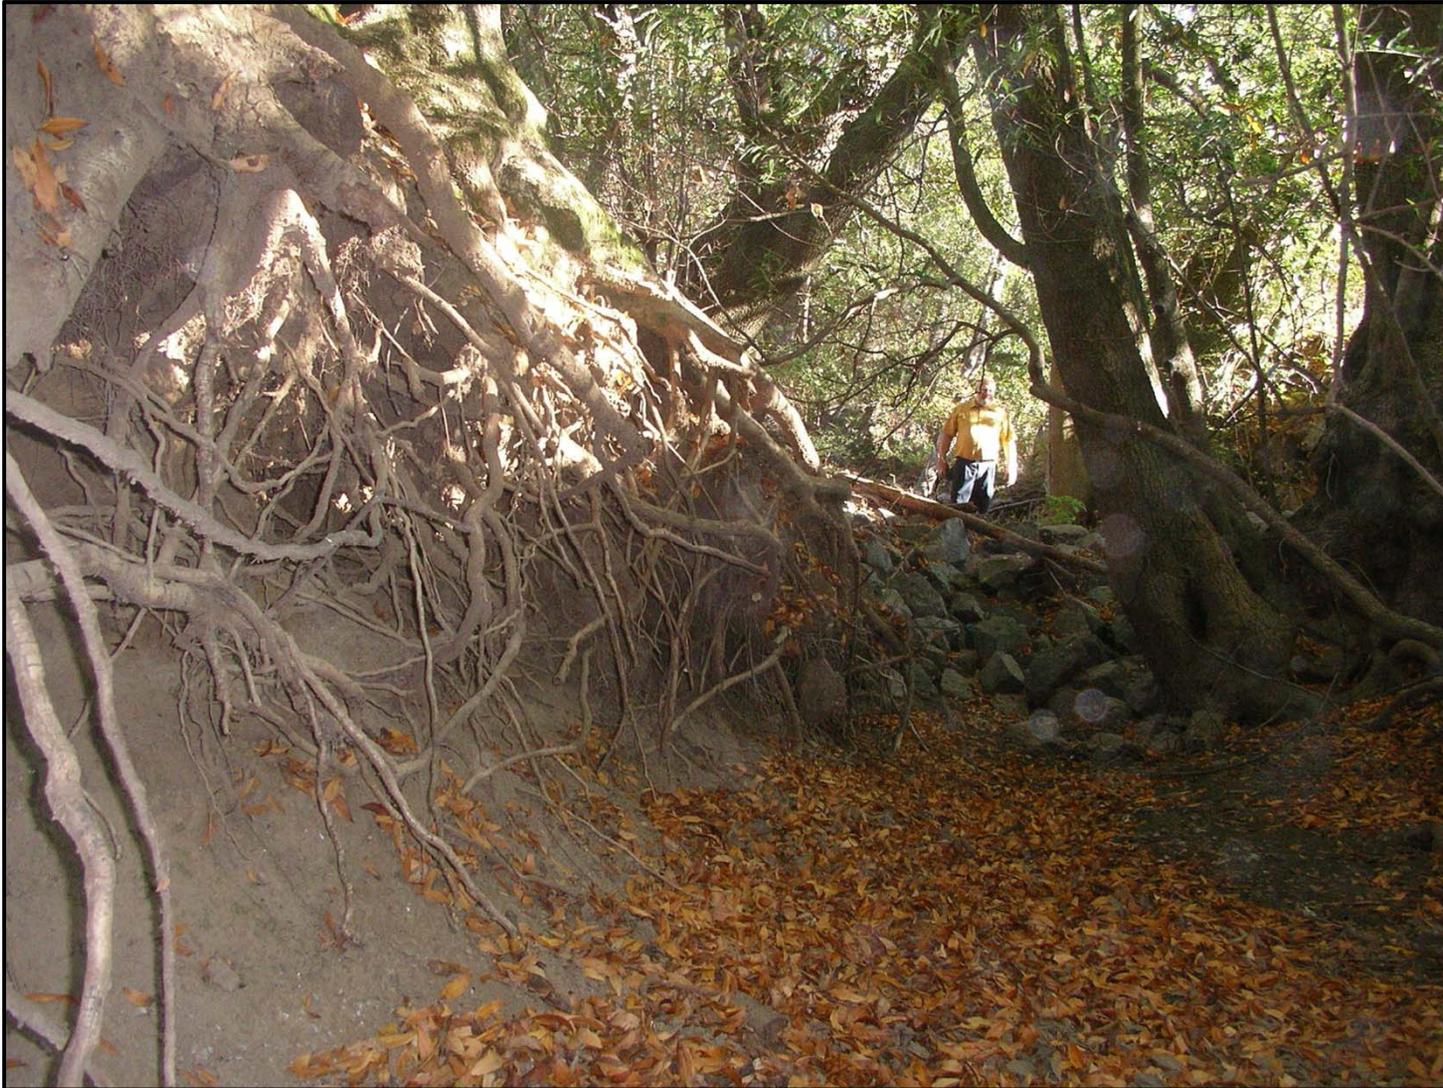
**Figure B2. Boulder weir at the Spirit Rock property, San Geronimo Creek watershed, Marin County, California.** The channel downstream of the downstream-most weir is incised, a relict of existing conditions before the weirs were installed. Note the undercutting of the roots of the stranded riparian vegetation at the top of the incised bank, similar to the existing conditions of upper Miller Creek ('Meander Reach'), in contrast to conditions upstream of the weir (Figure B3).

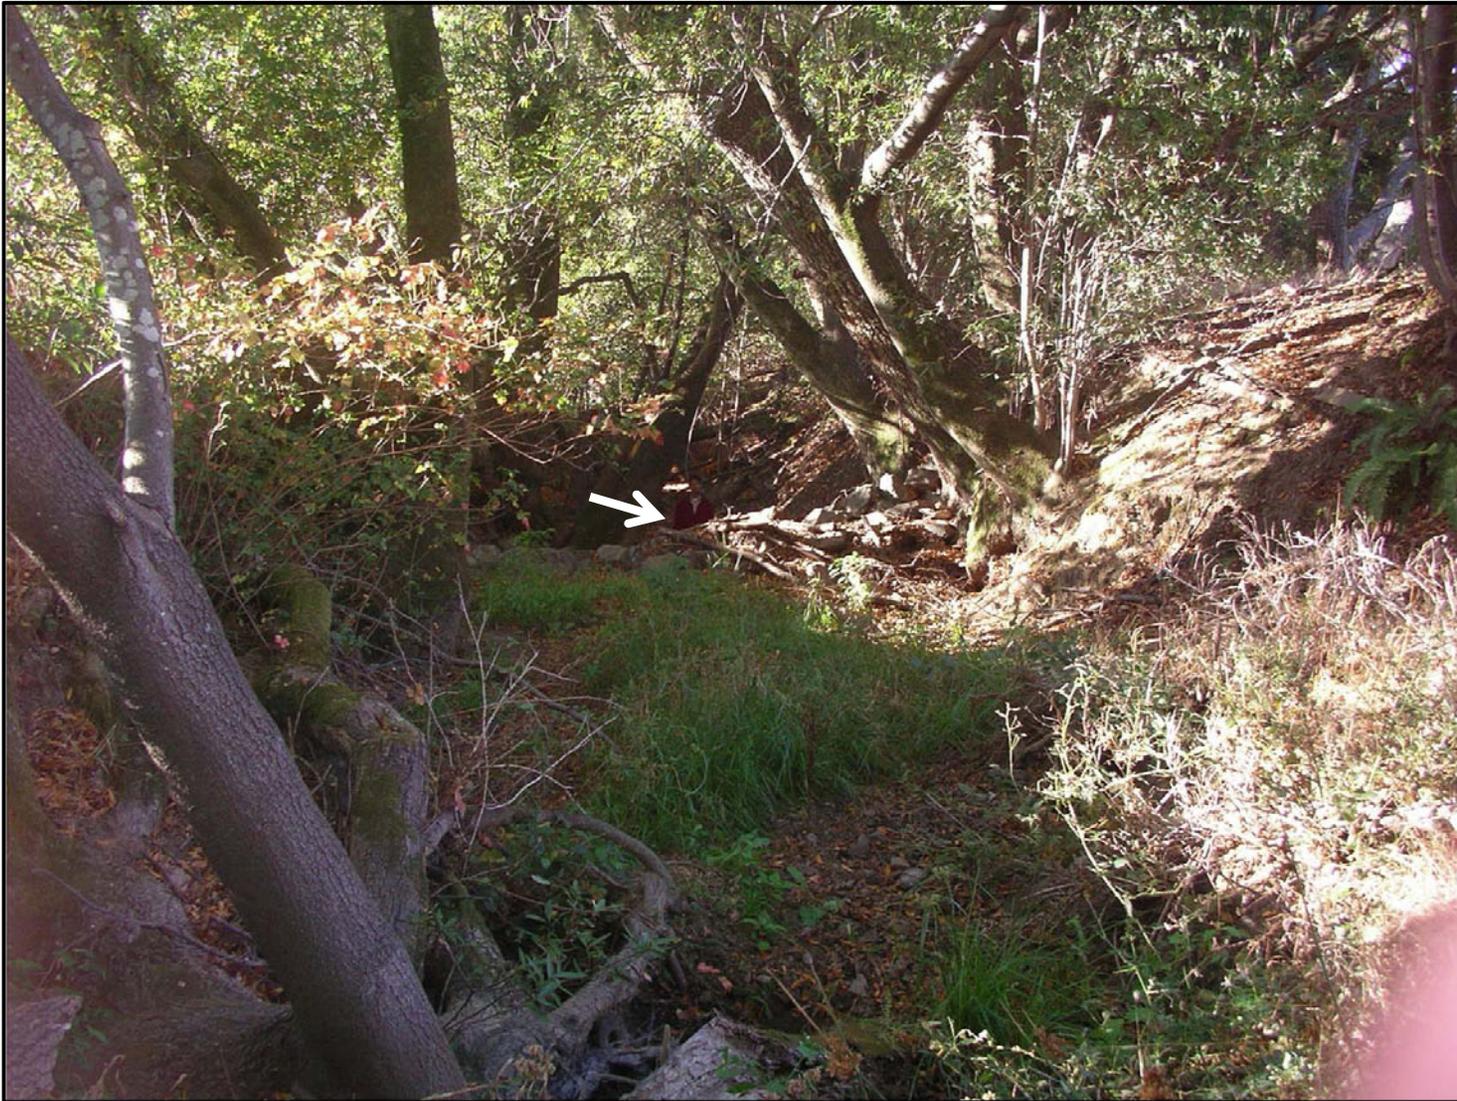
**Figure B3. Stream channel upstream of boulder weir at the Spirit Rock property, San Geronimo Creek watershed, Marin County, California.** Upstream of the weir, the channel shows no signs of significant erosion. (White arrow points to the crest of the weir. Note the person standing downstream, in the incised portion of the channel.)

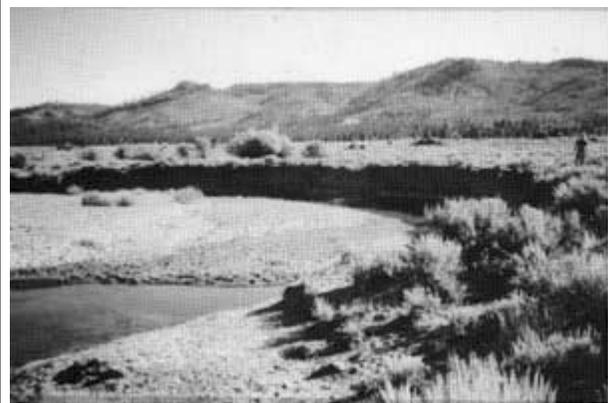
Red Clover Creek in September 1985, before the demonstration project. Stream banks are bare of vegetation, and sage brush dominates the landscape.

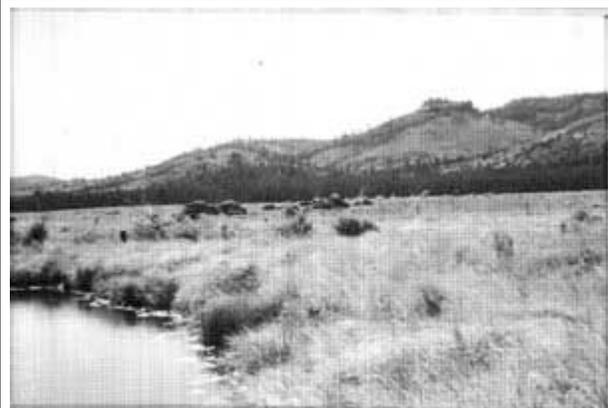
Red Clover Creek in August 1993 after the demonstration project. Stream banks are covered with moist site plant species.

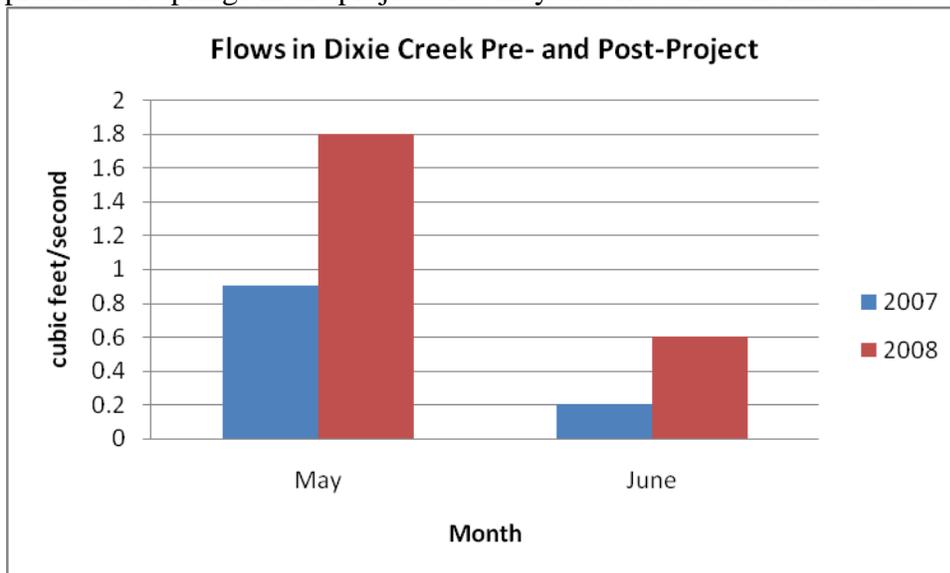
1) **Improve retention of water for augmented base flow in streams:** Pre- and post-project flows were measured approximately 500 feet downstream of the project area. This location was chosen because it was just below a valley facet, where project-induced subsurface flow improvement was thought to most likely become surface flow. Later season flows were not measured because Dixie Creek was known to dry up. However casual observations indicated that, at least post-project, the channel did not dry up at this location. In May and June, flows more than doubled at this location, even though precipitation was nearly equal between the two years (8.45” in Jun-Jul 2007 Water Year and 8.96” for WY2008 at Frenchman Dam). It should be noted however, that snow was on the ground later into the year in 2008 than 2007, and the presence of springs in the project area may also have had an influence.

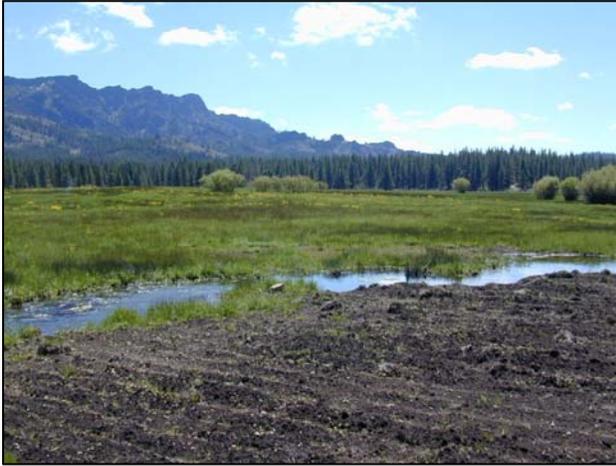
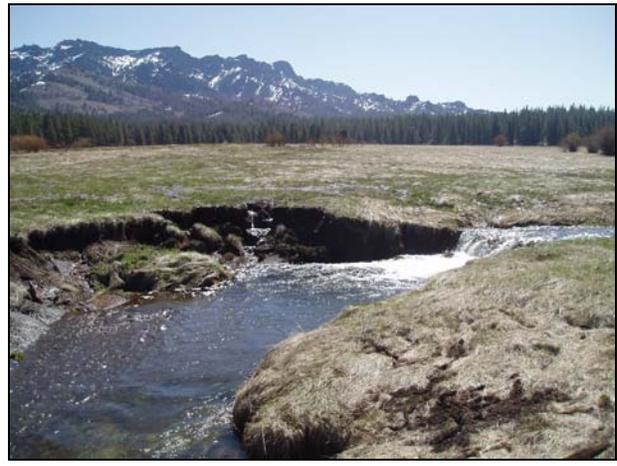
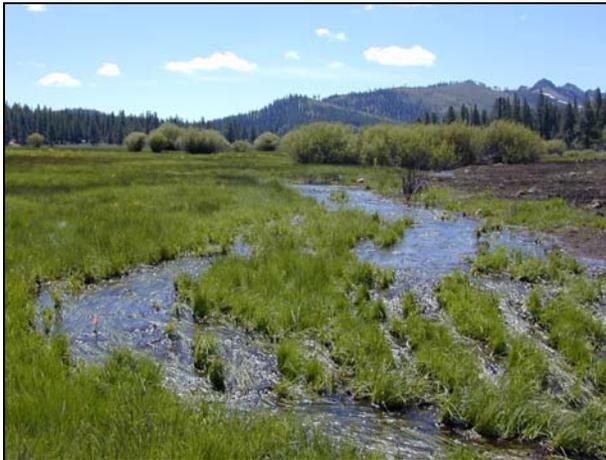
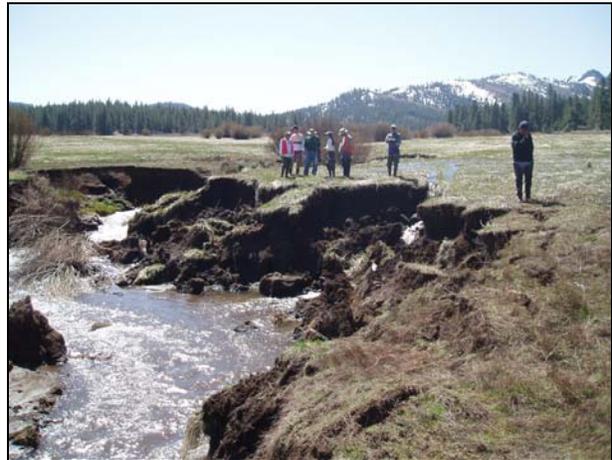
2) **Improve water quality and streambank protection:** No water quality data were collected, however, sedimentation was reduced due to elimination of headcuts. Sedimentation from widening vertical raw banks was also eliminated. These outcomes are visible in the following

sets photos. Post-project photos on the left were taken in spring 2008, before the first growing season. Pre-project photos on the right were taken in spring 2006.

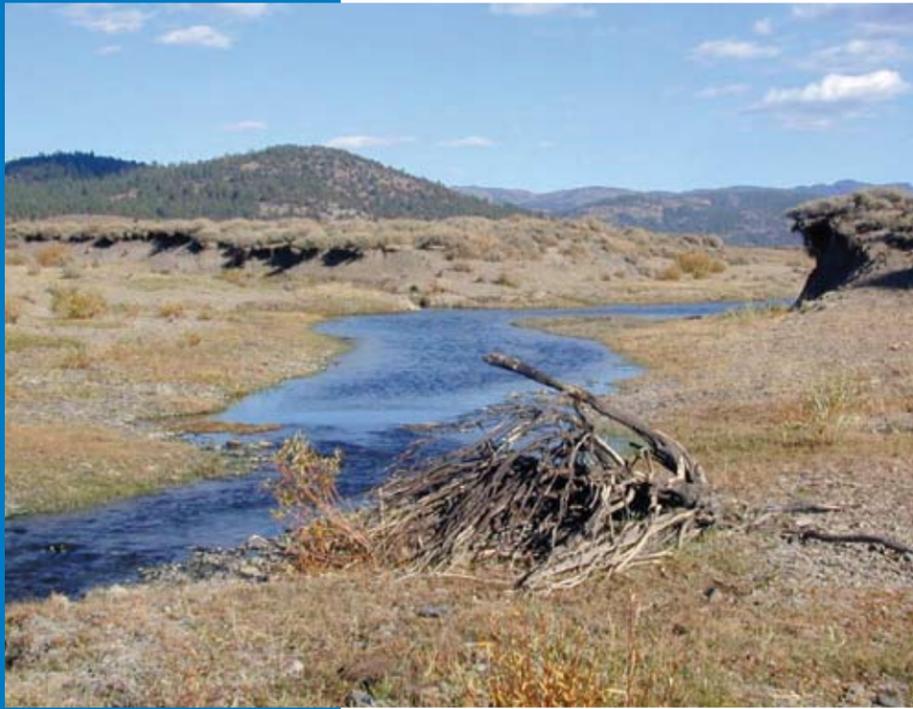
Red Clover channel, pre-project 2004

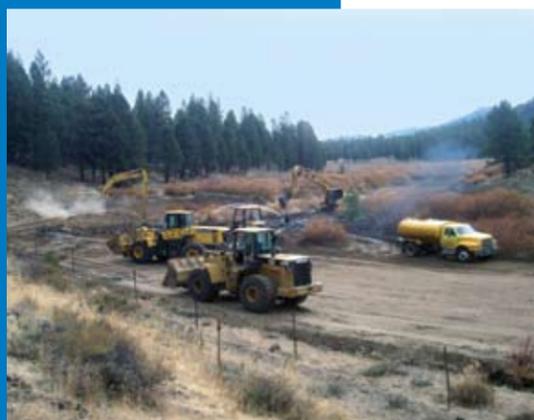
Project construction work

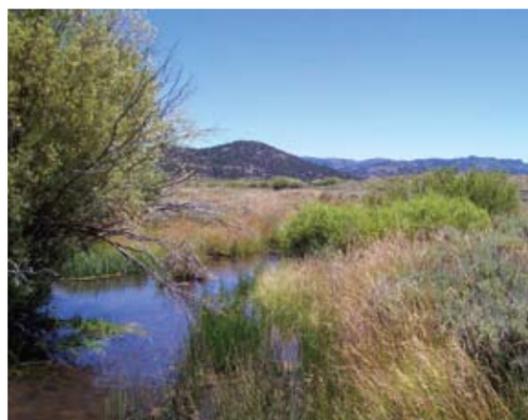
Red Clover channel, post-project 2007

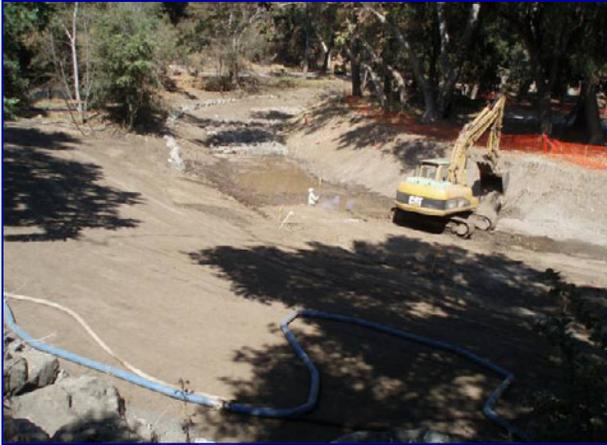
Construction of new stream

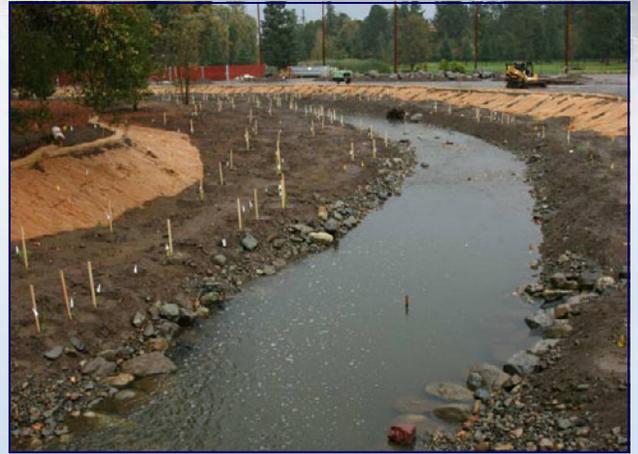
November, 2008—newly constructed

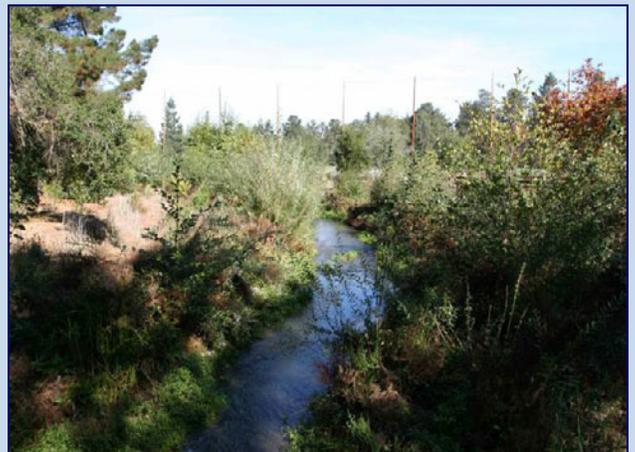
November 2010—two years after construction
