COMMUNITY DEVELOPMENT AGENCY PLANNING DIVISION

SUBJECT: Appeal of the Tarigo Design Review and Second Unit Draft Initial Study Assessor's Parcel: 168-034-14 21 Barranca Road, Lagunitas

Tarigo/Terrass Residence Planning Commission Presentation October 22, 2018

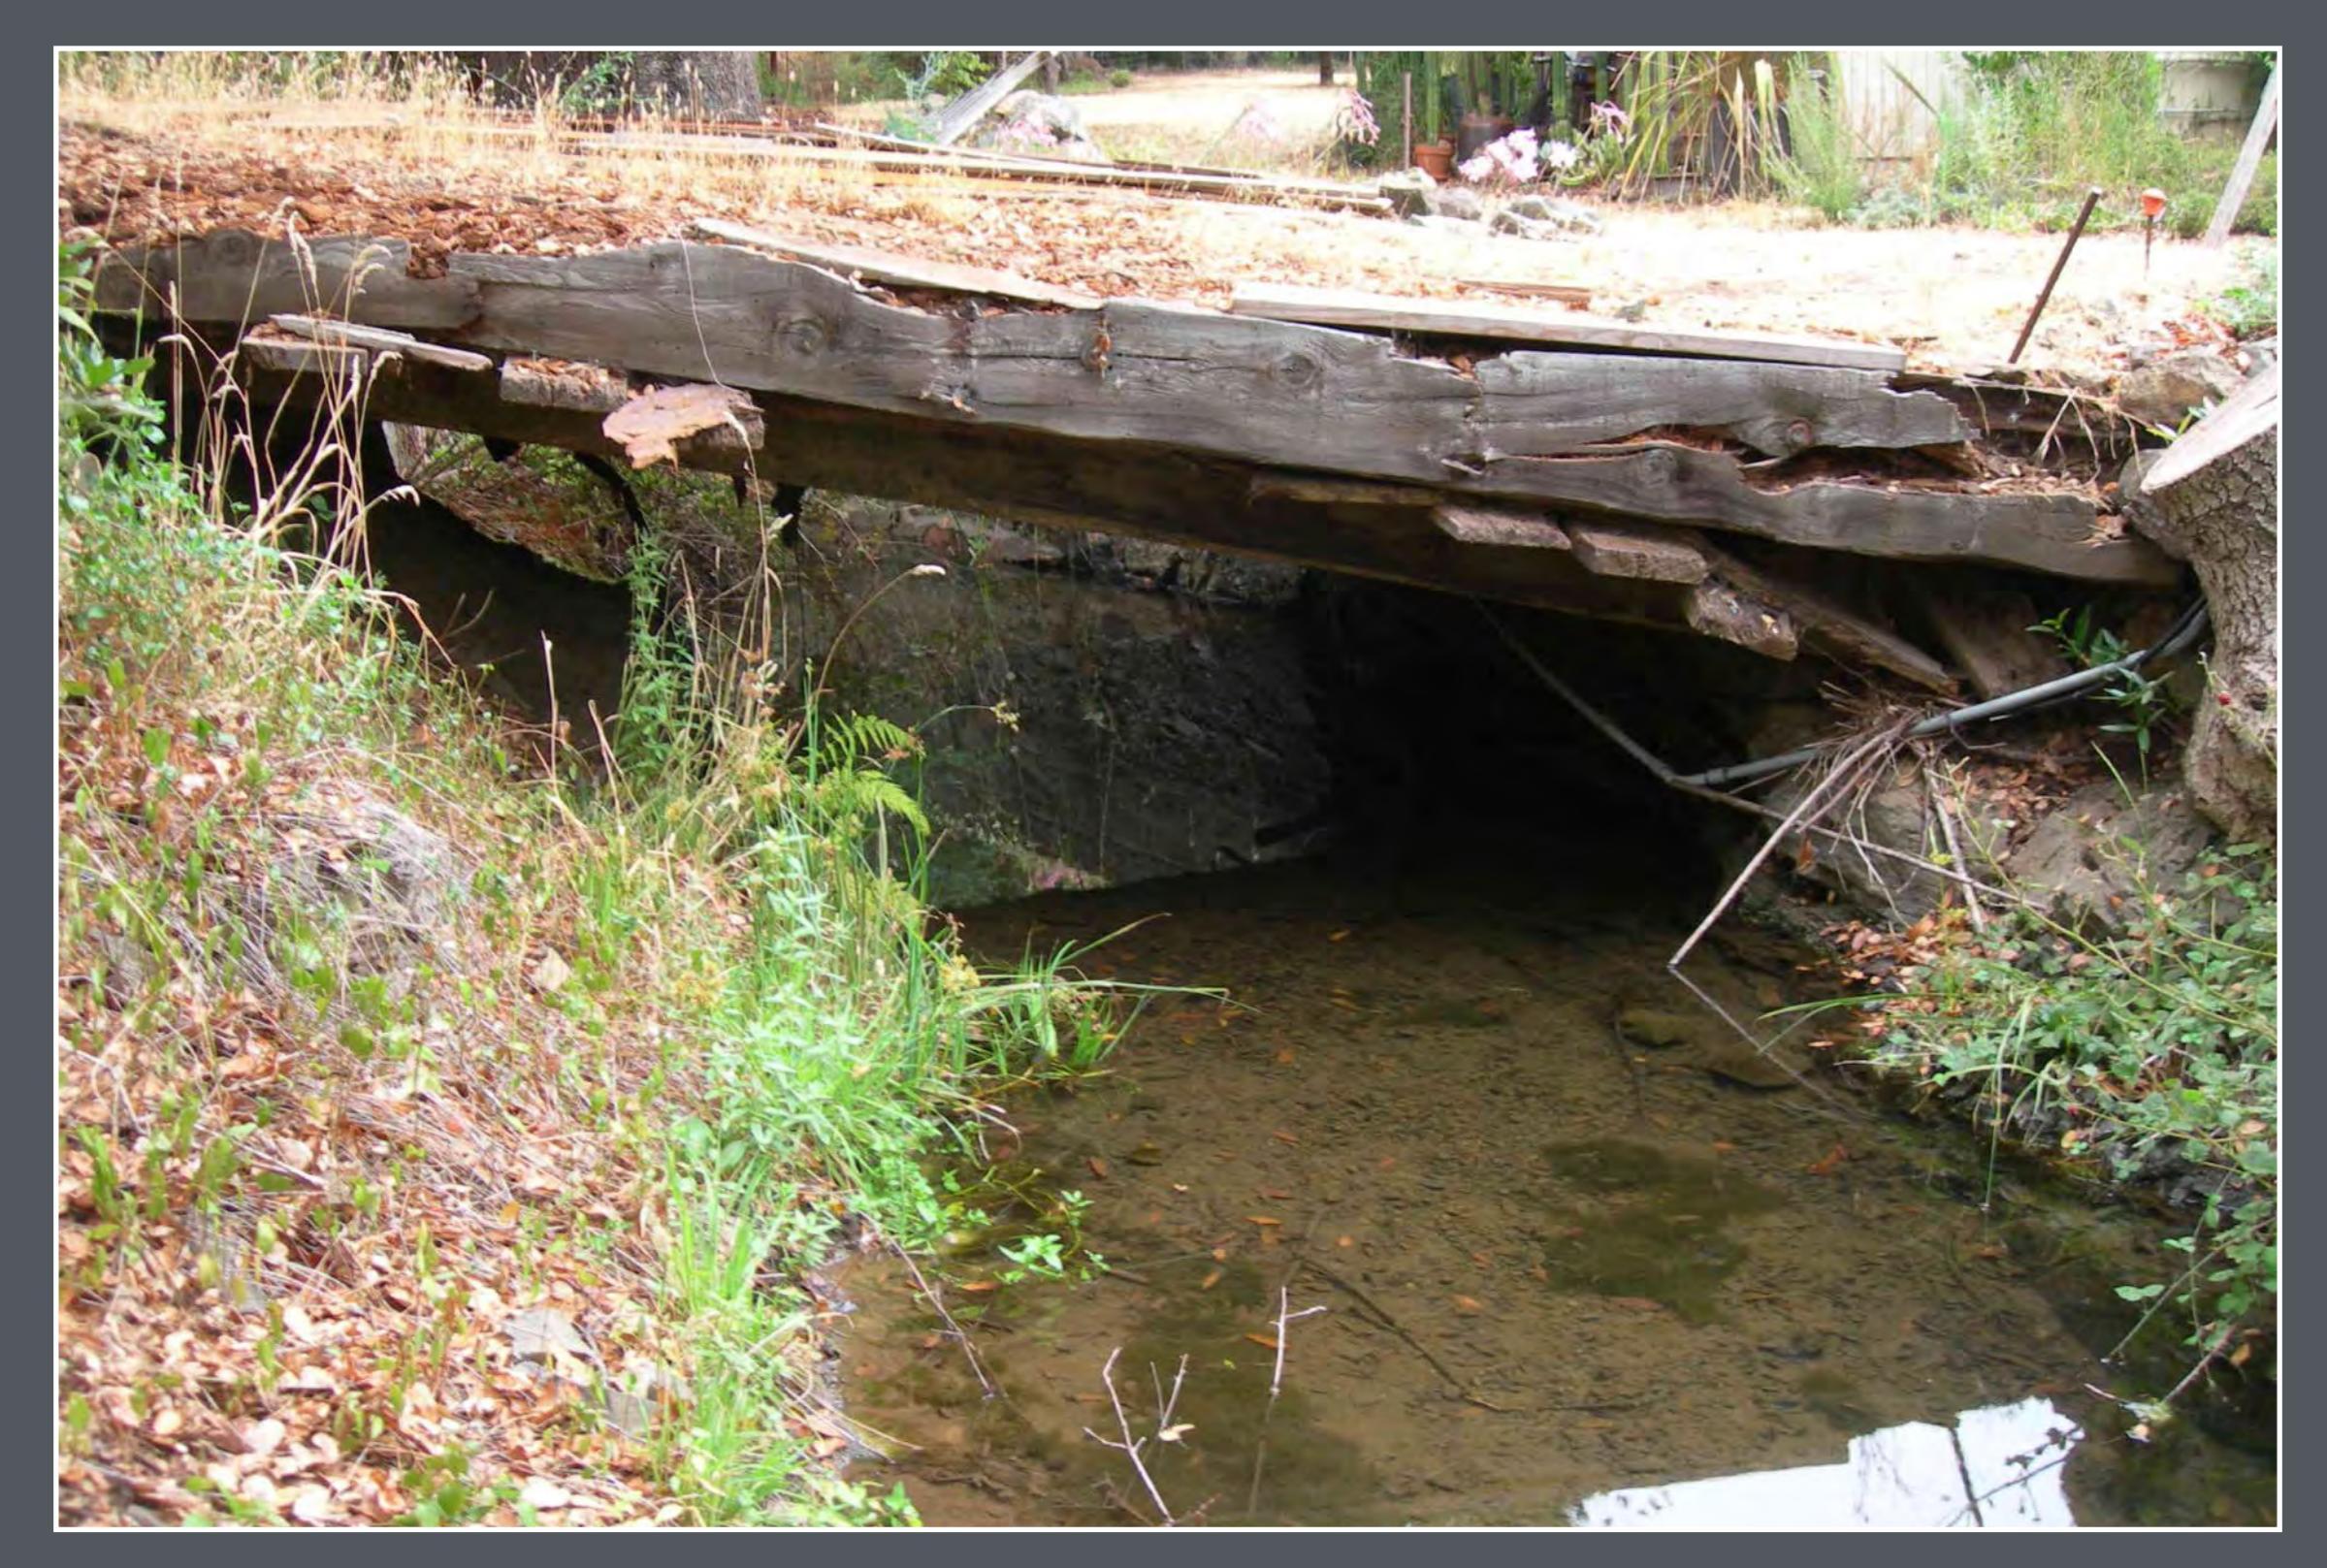
Old Wood Bridge at Barranca Creek Condition of bridge in 2006 showing deterioration just before the collapse of one of the principle support logs.

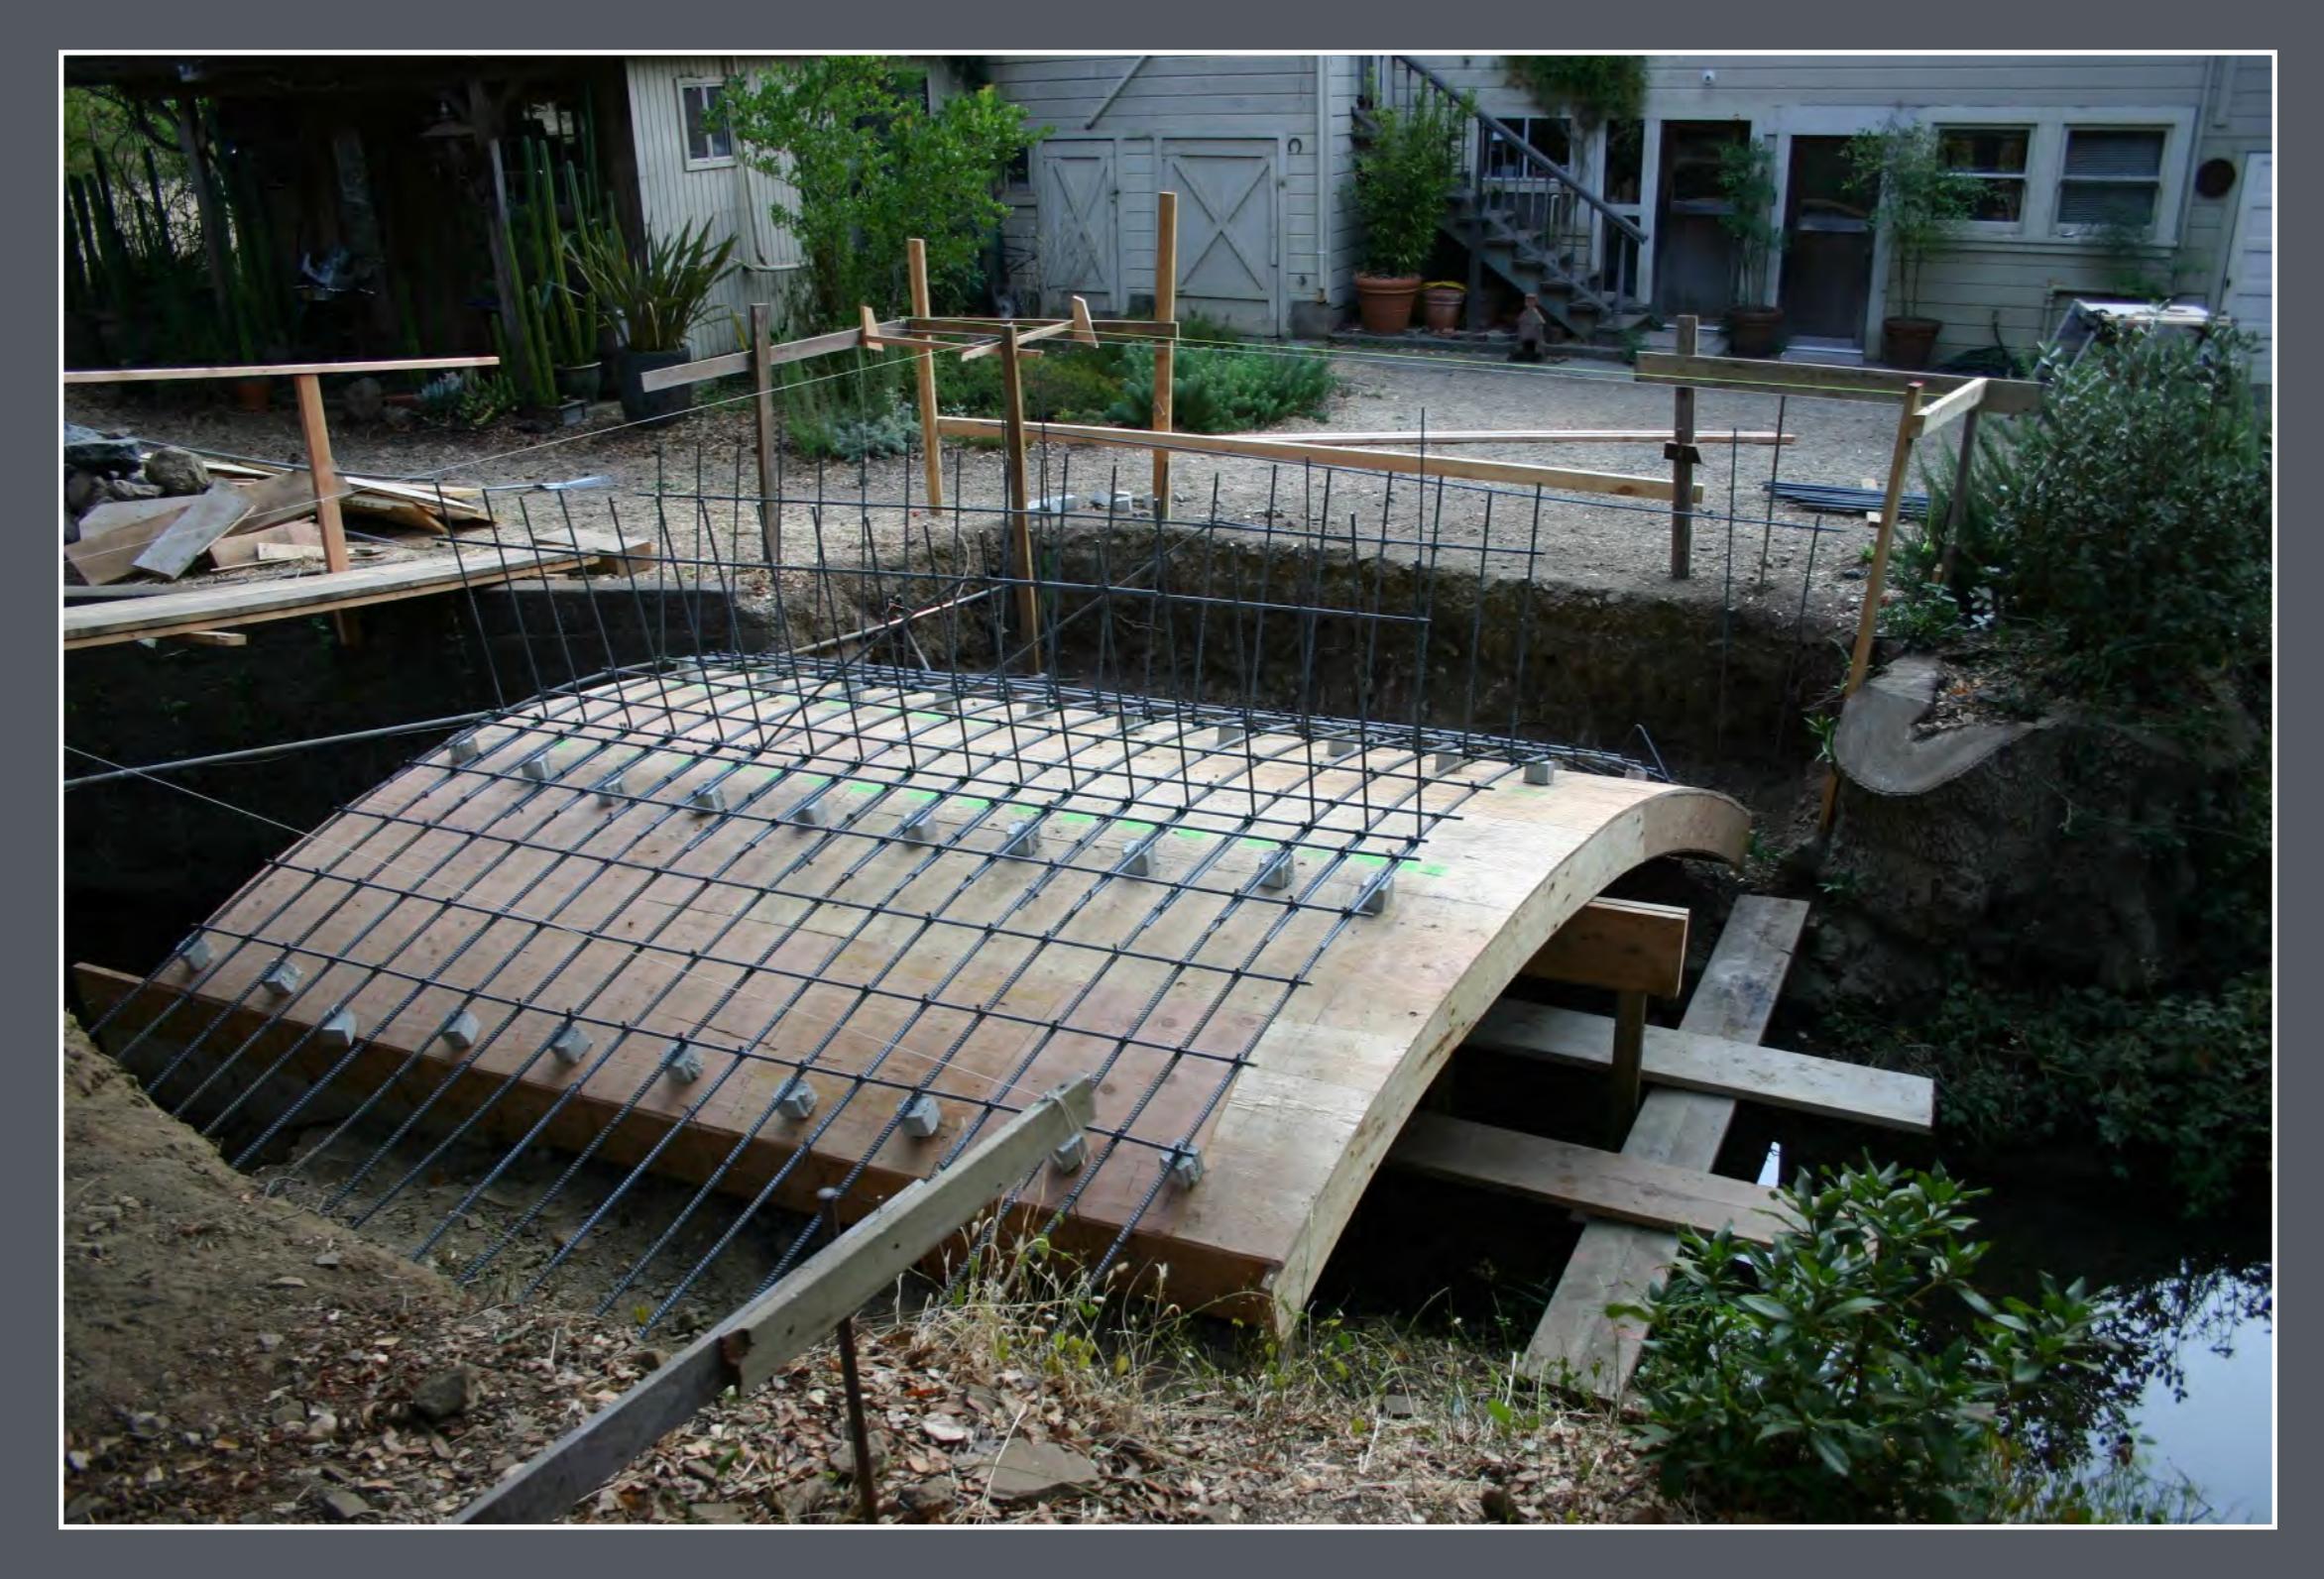
New Concrete Bridge Construction, October 2006

Scaffolding and lower slab reinforcing per plan: #6 span bars at 8", #4 cross bars at 12", and #4 bars at center to tie the slabs together.

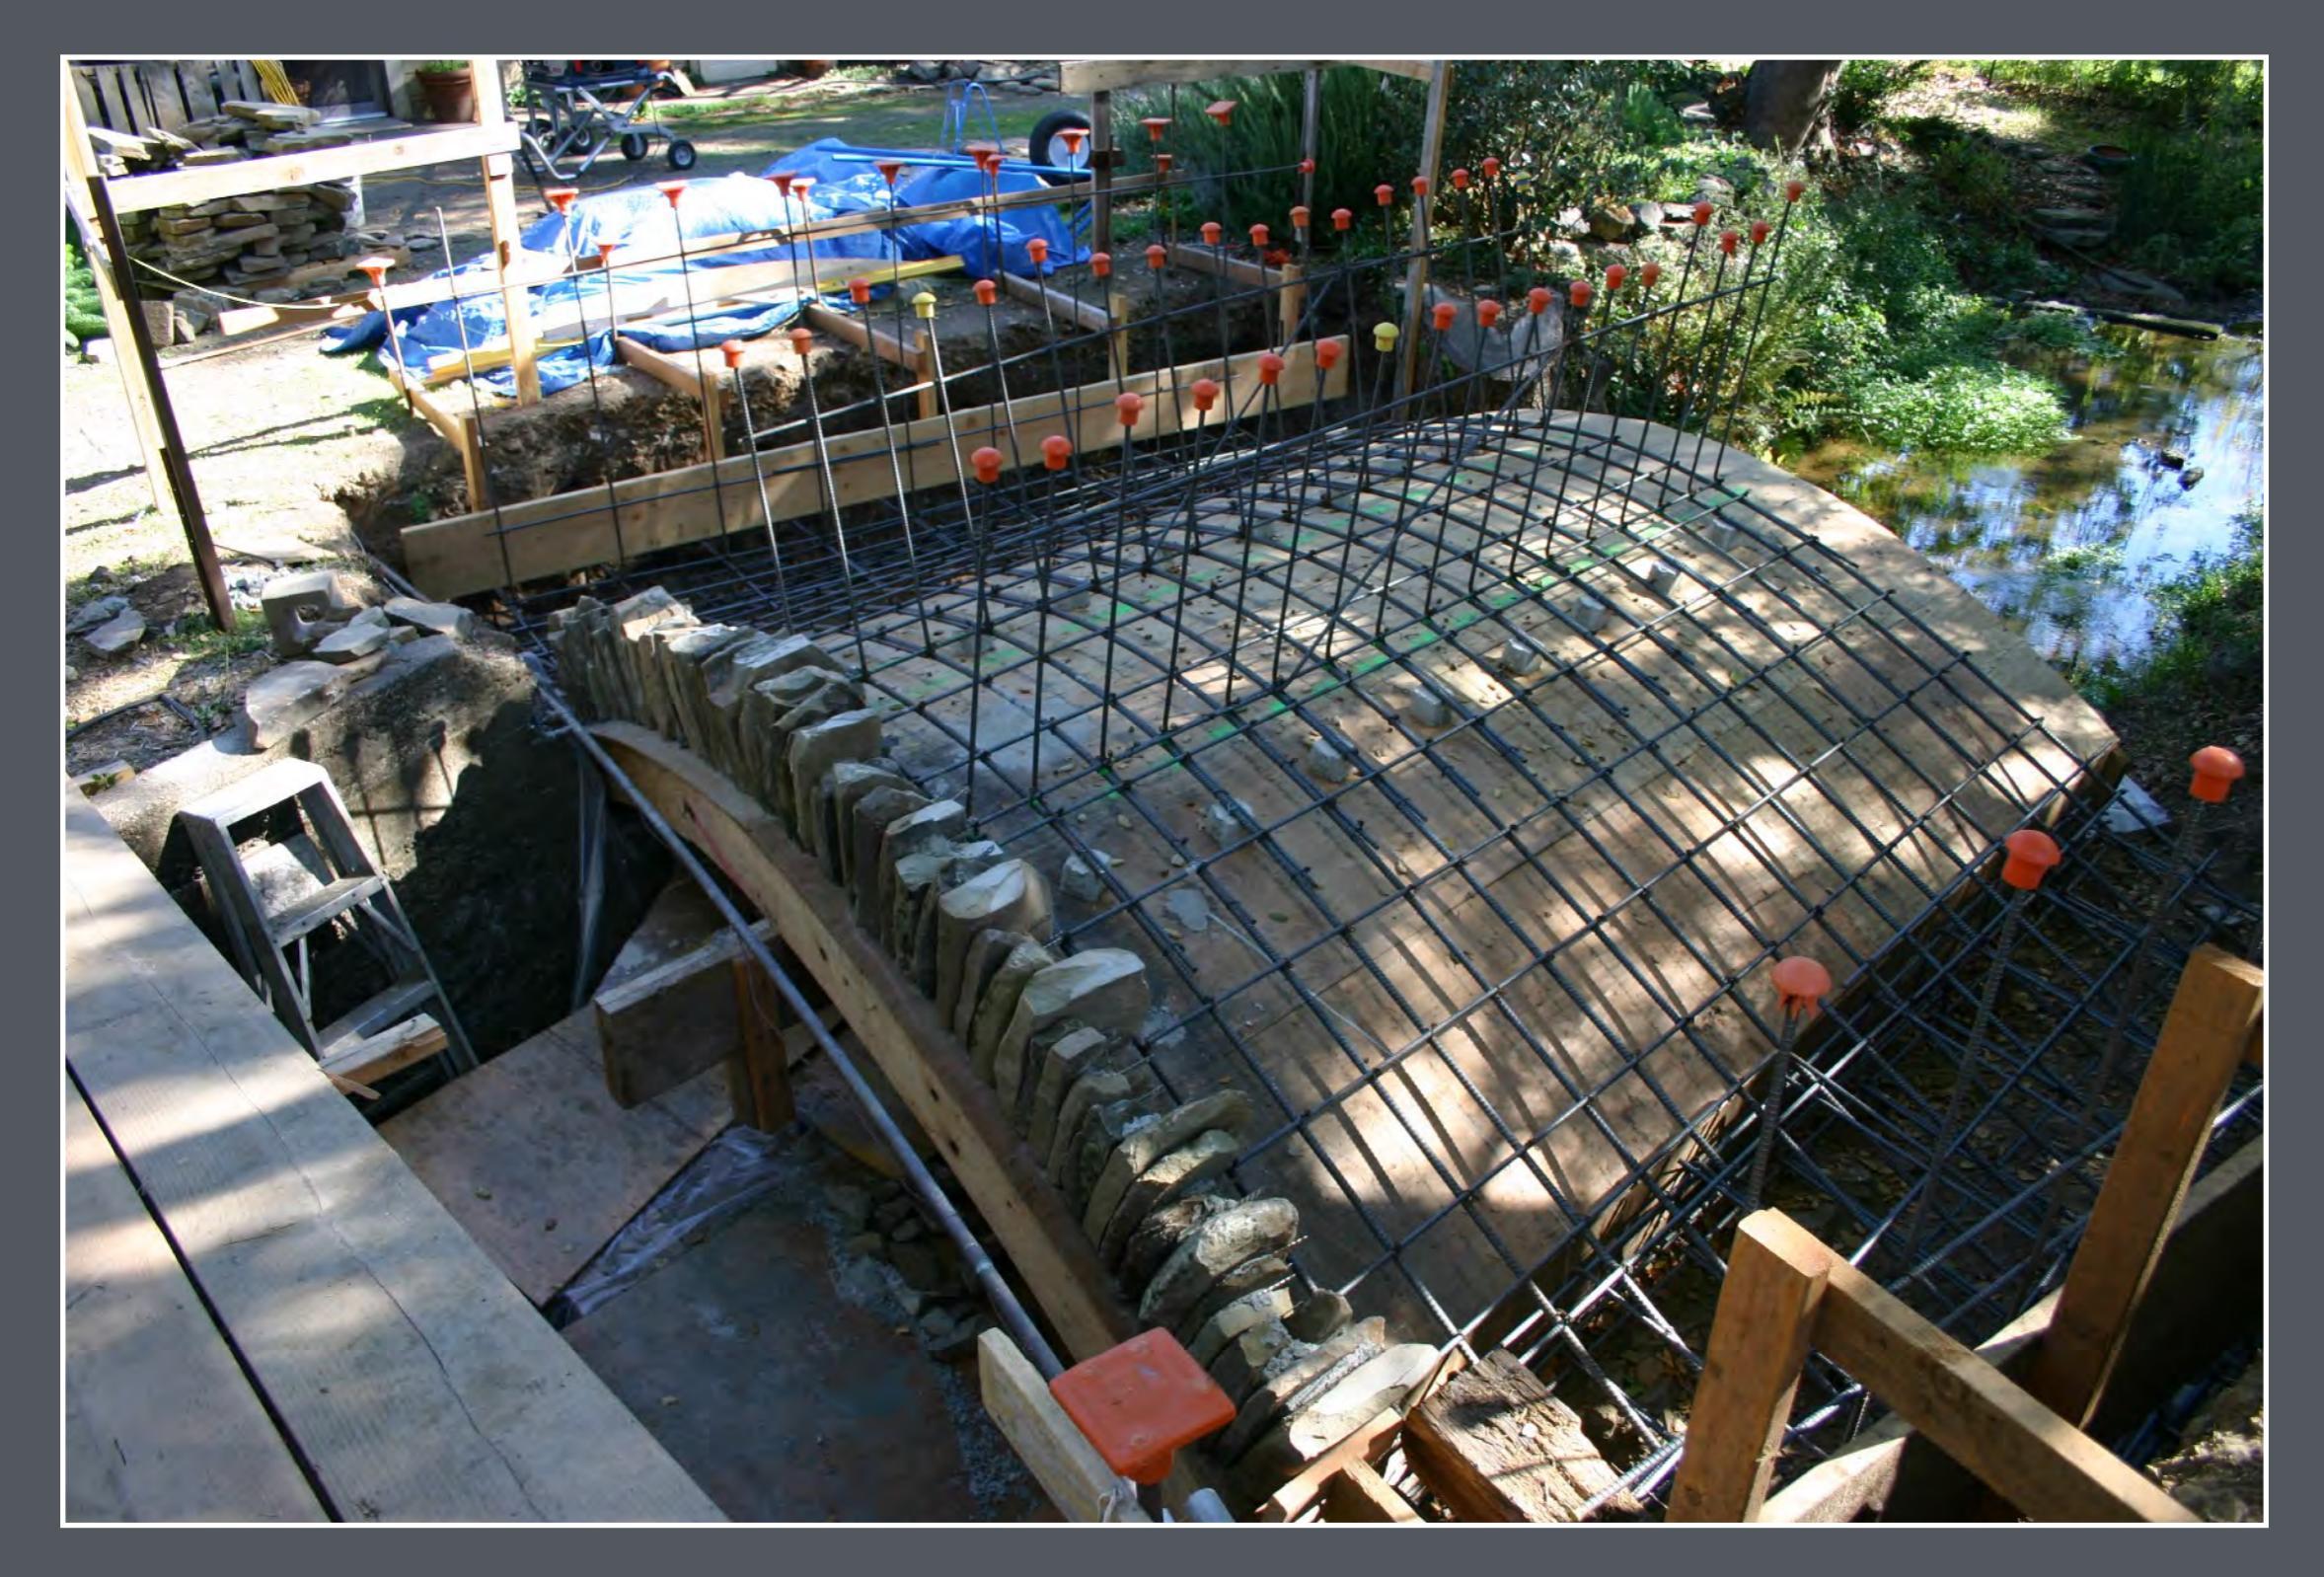
New Concrete Bridge Construction, October 2006 Placement of key stones tied to reinforcing. Note double layer of footing reinforcing in lower right.

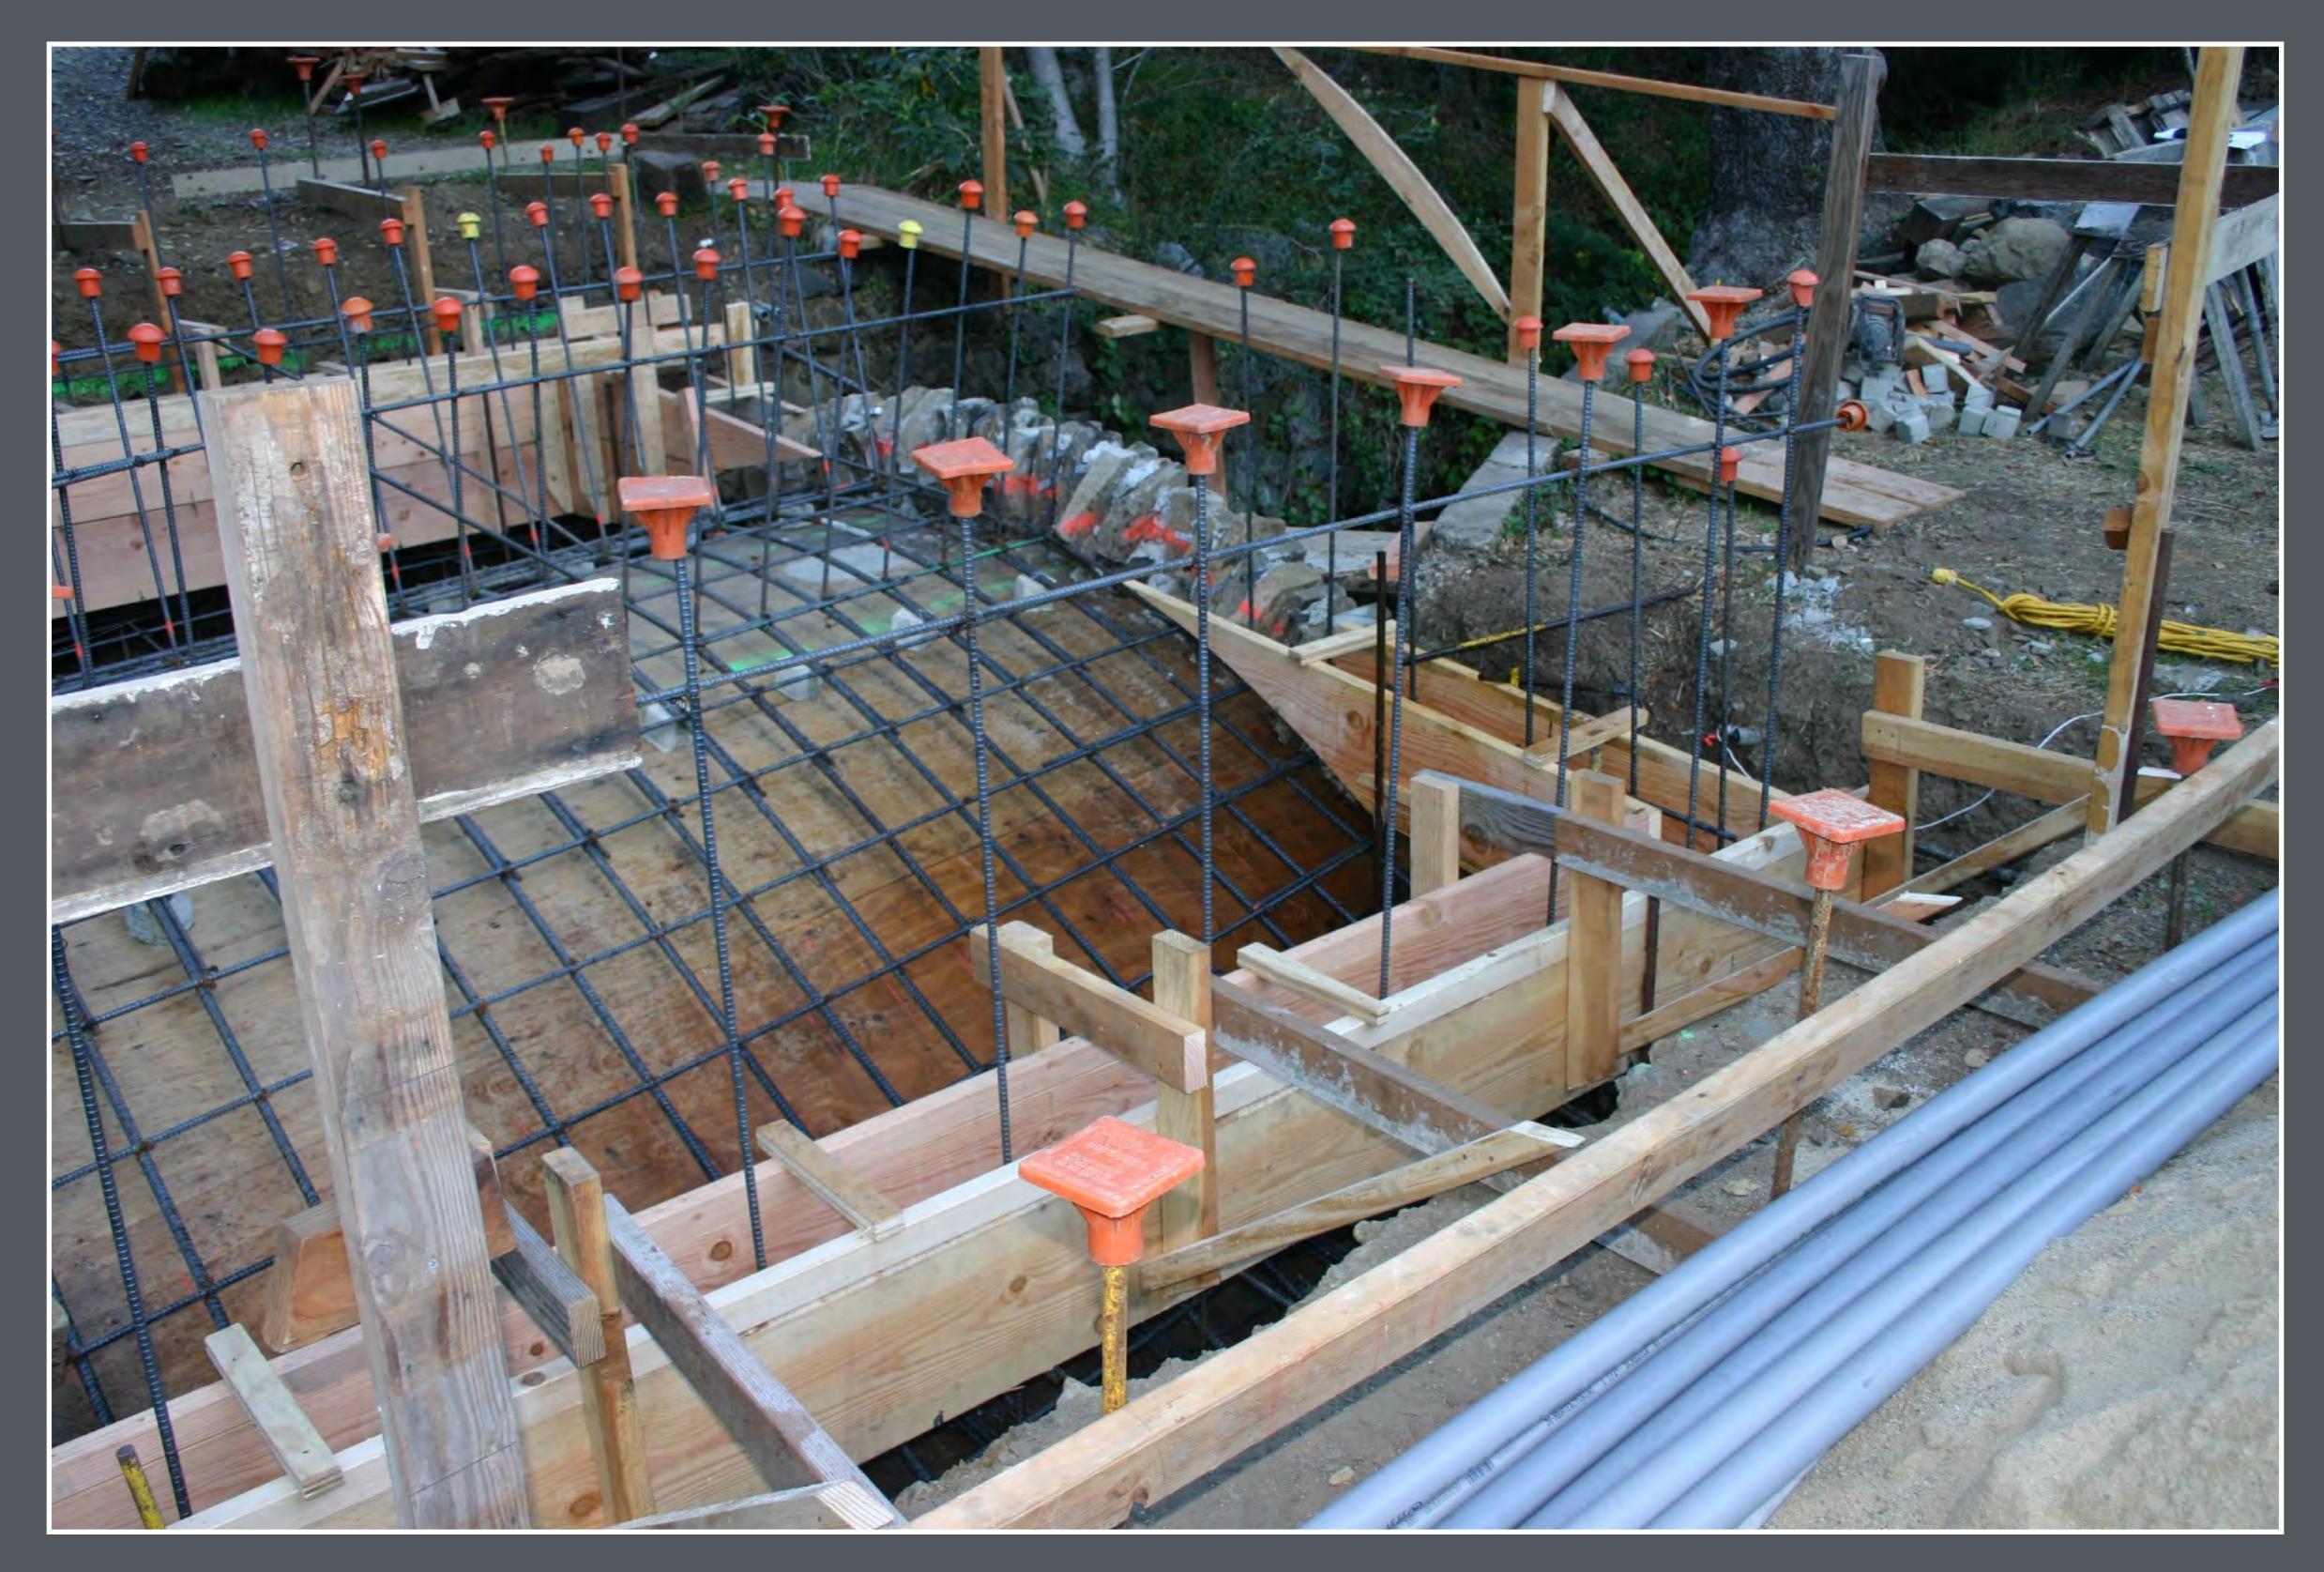
New Concrete Bridge Construction, October 2006 Addition of form work for 8" perimeter stem wall.

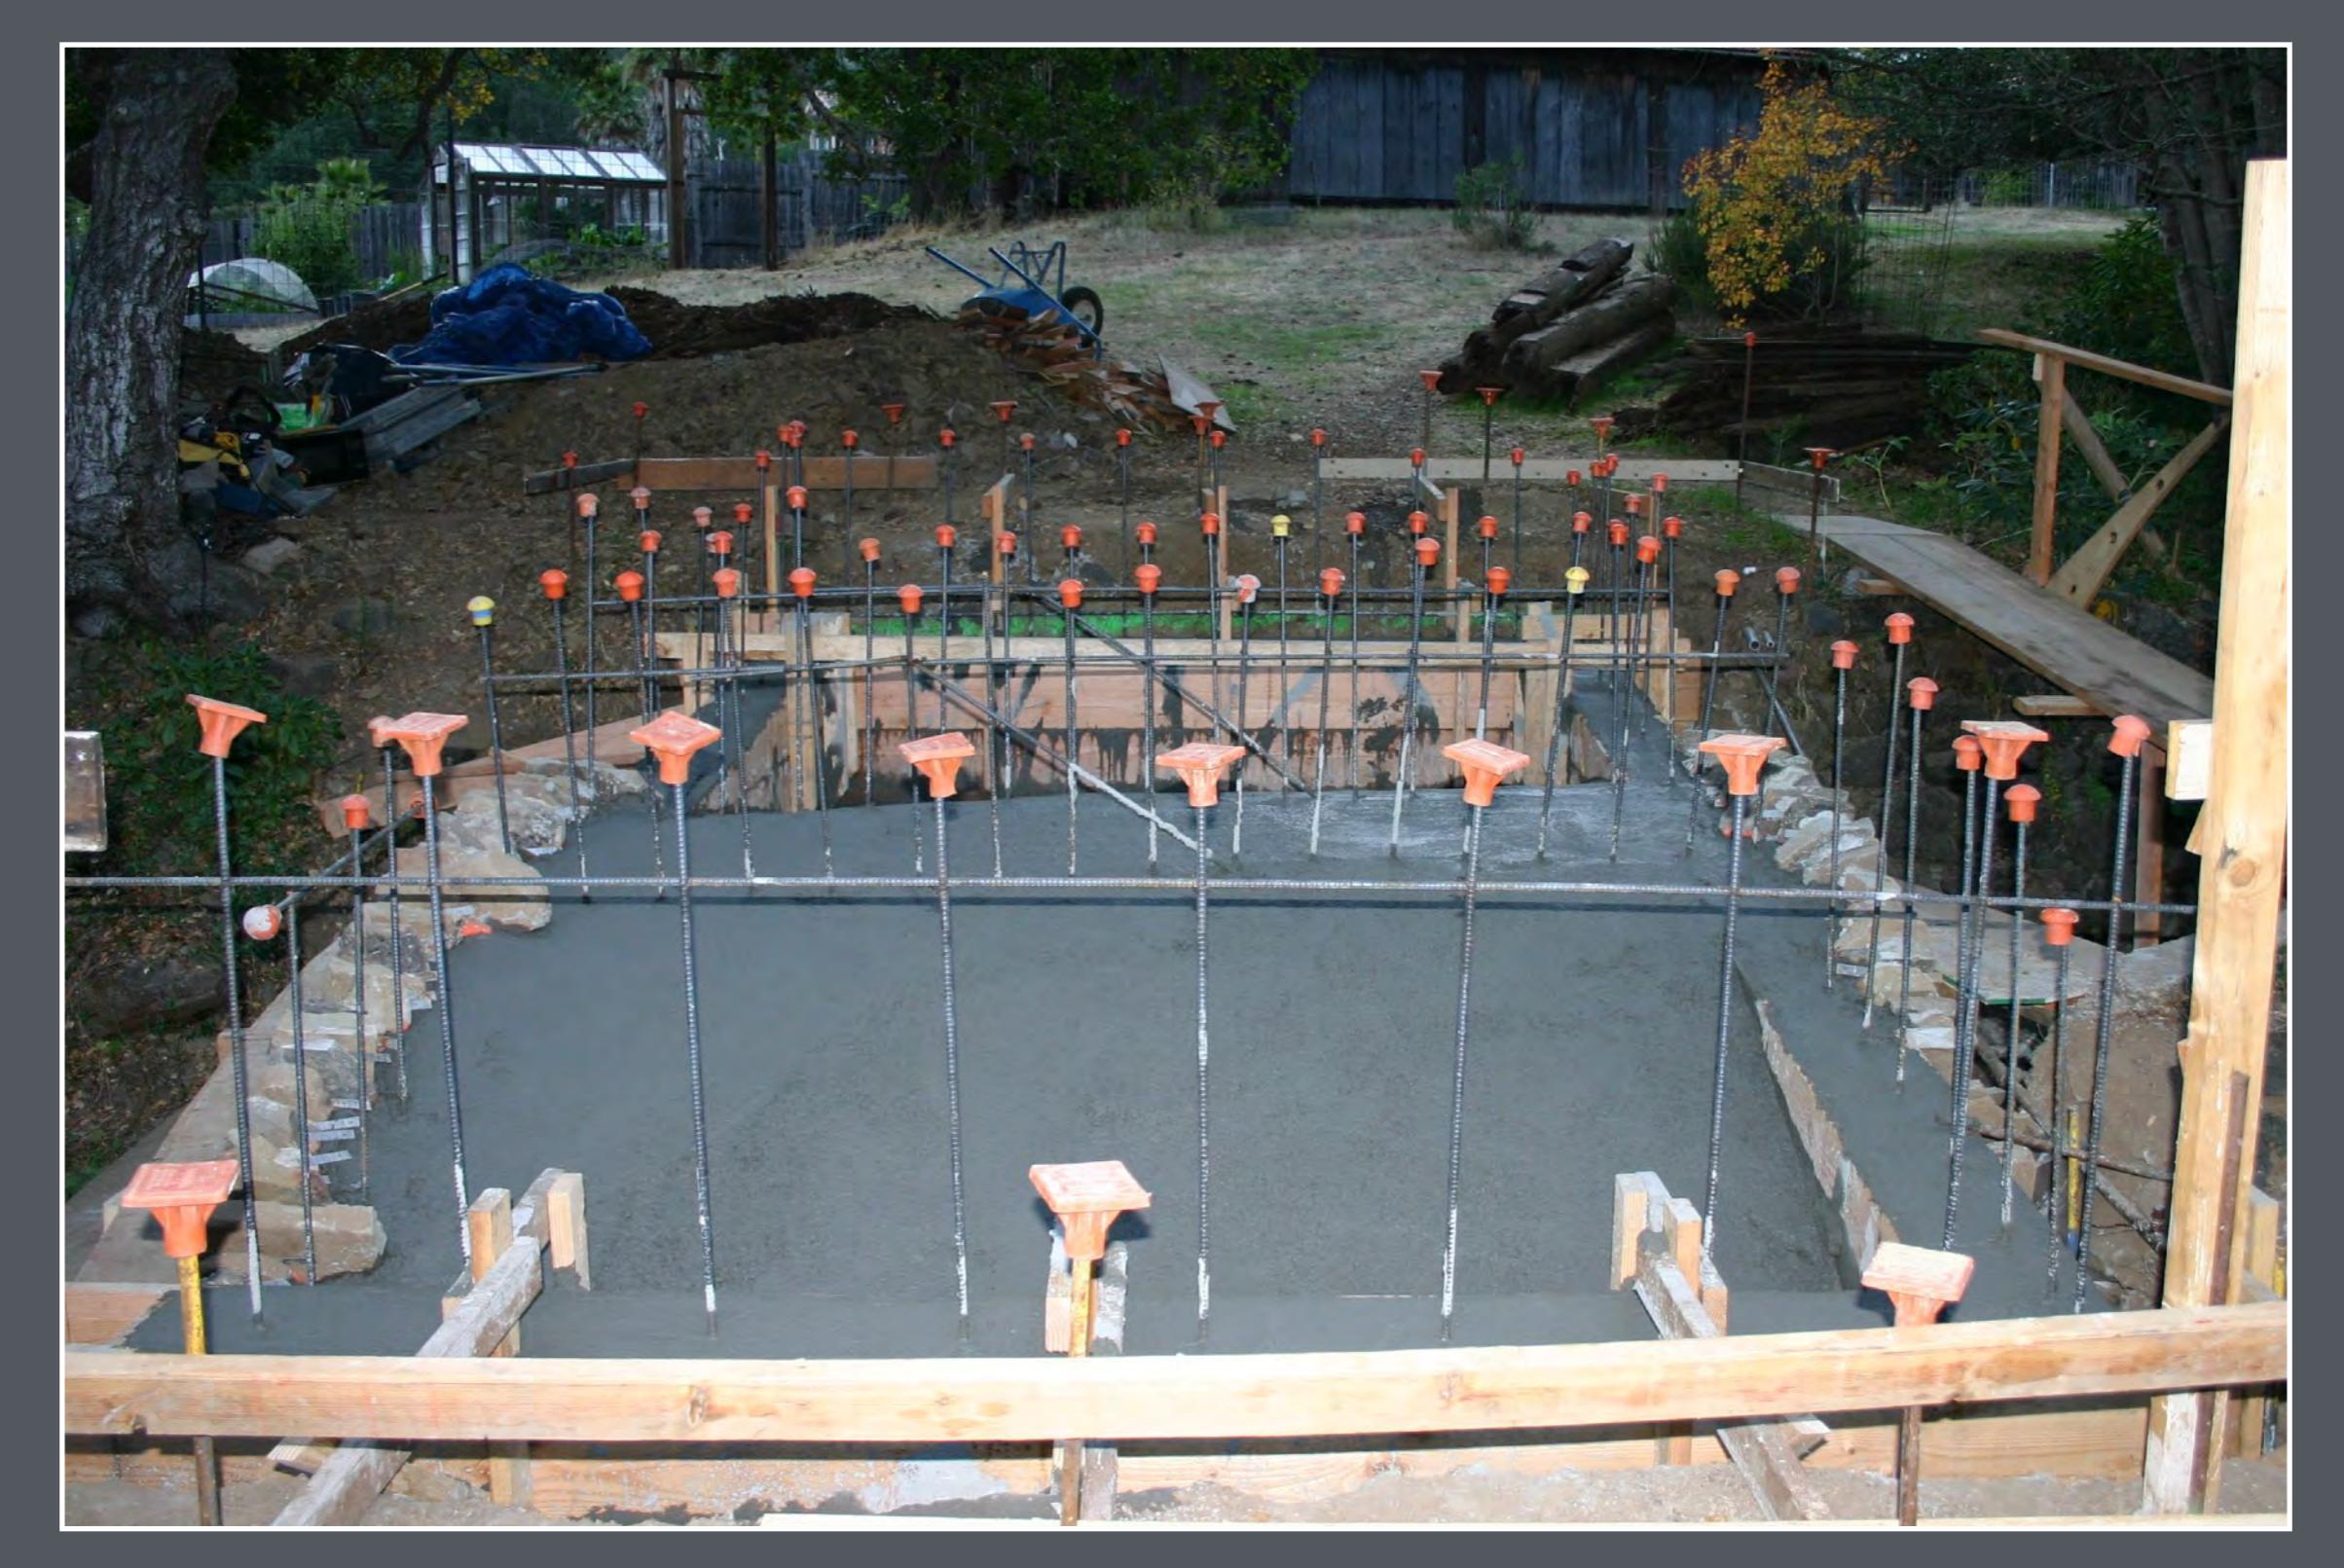
New Concrete Bridge Construction, October 2006 Completed first pour showing #4 tying bars to be bent over and connected to upper slab reinforcing

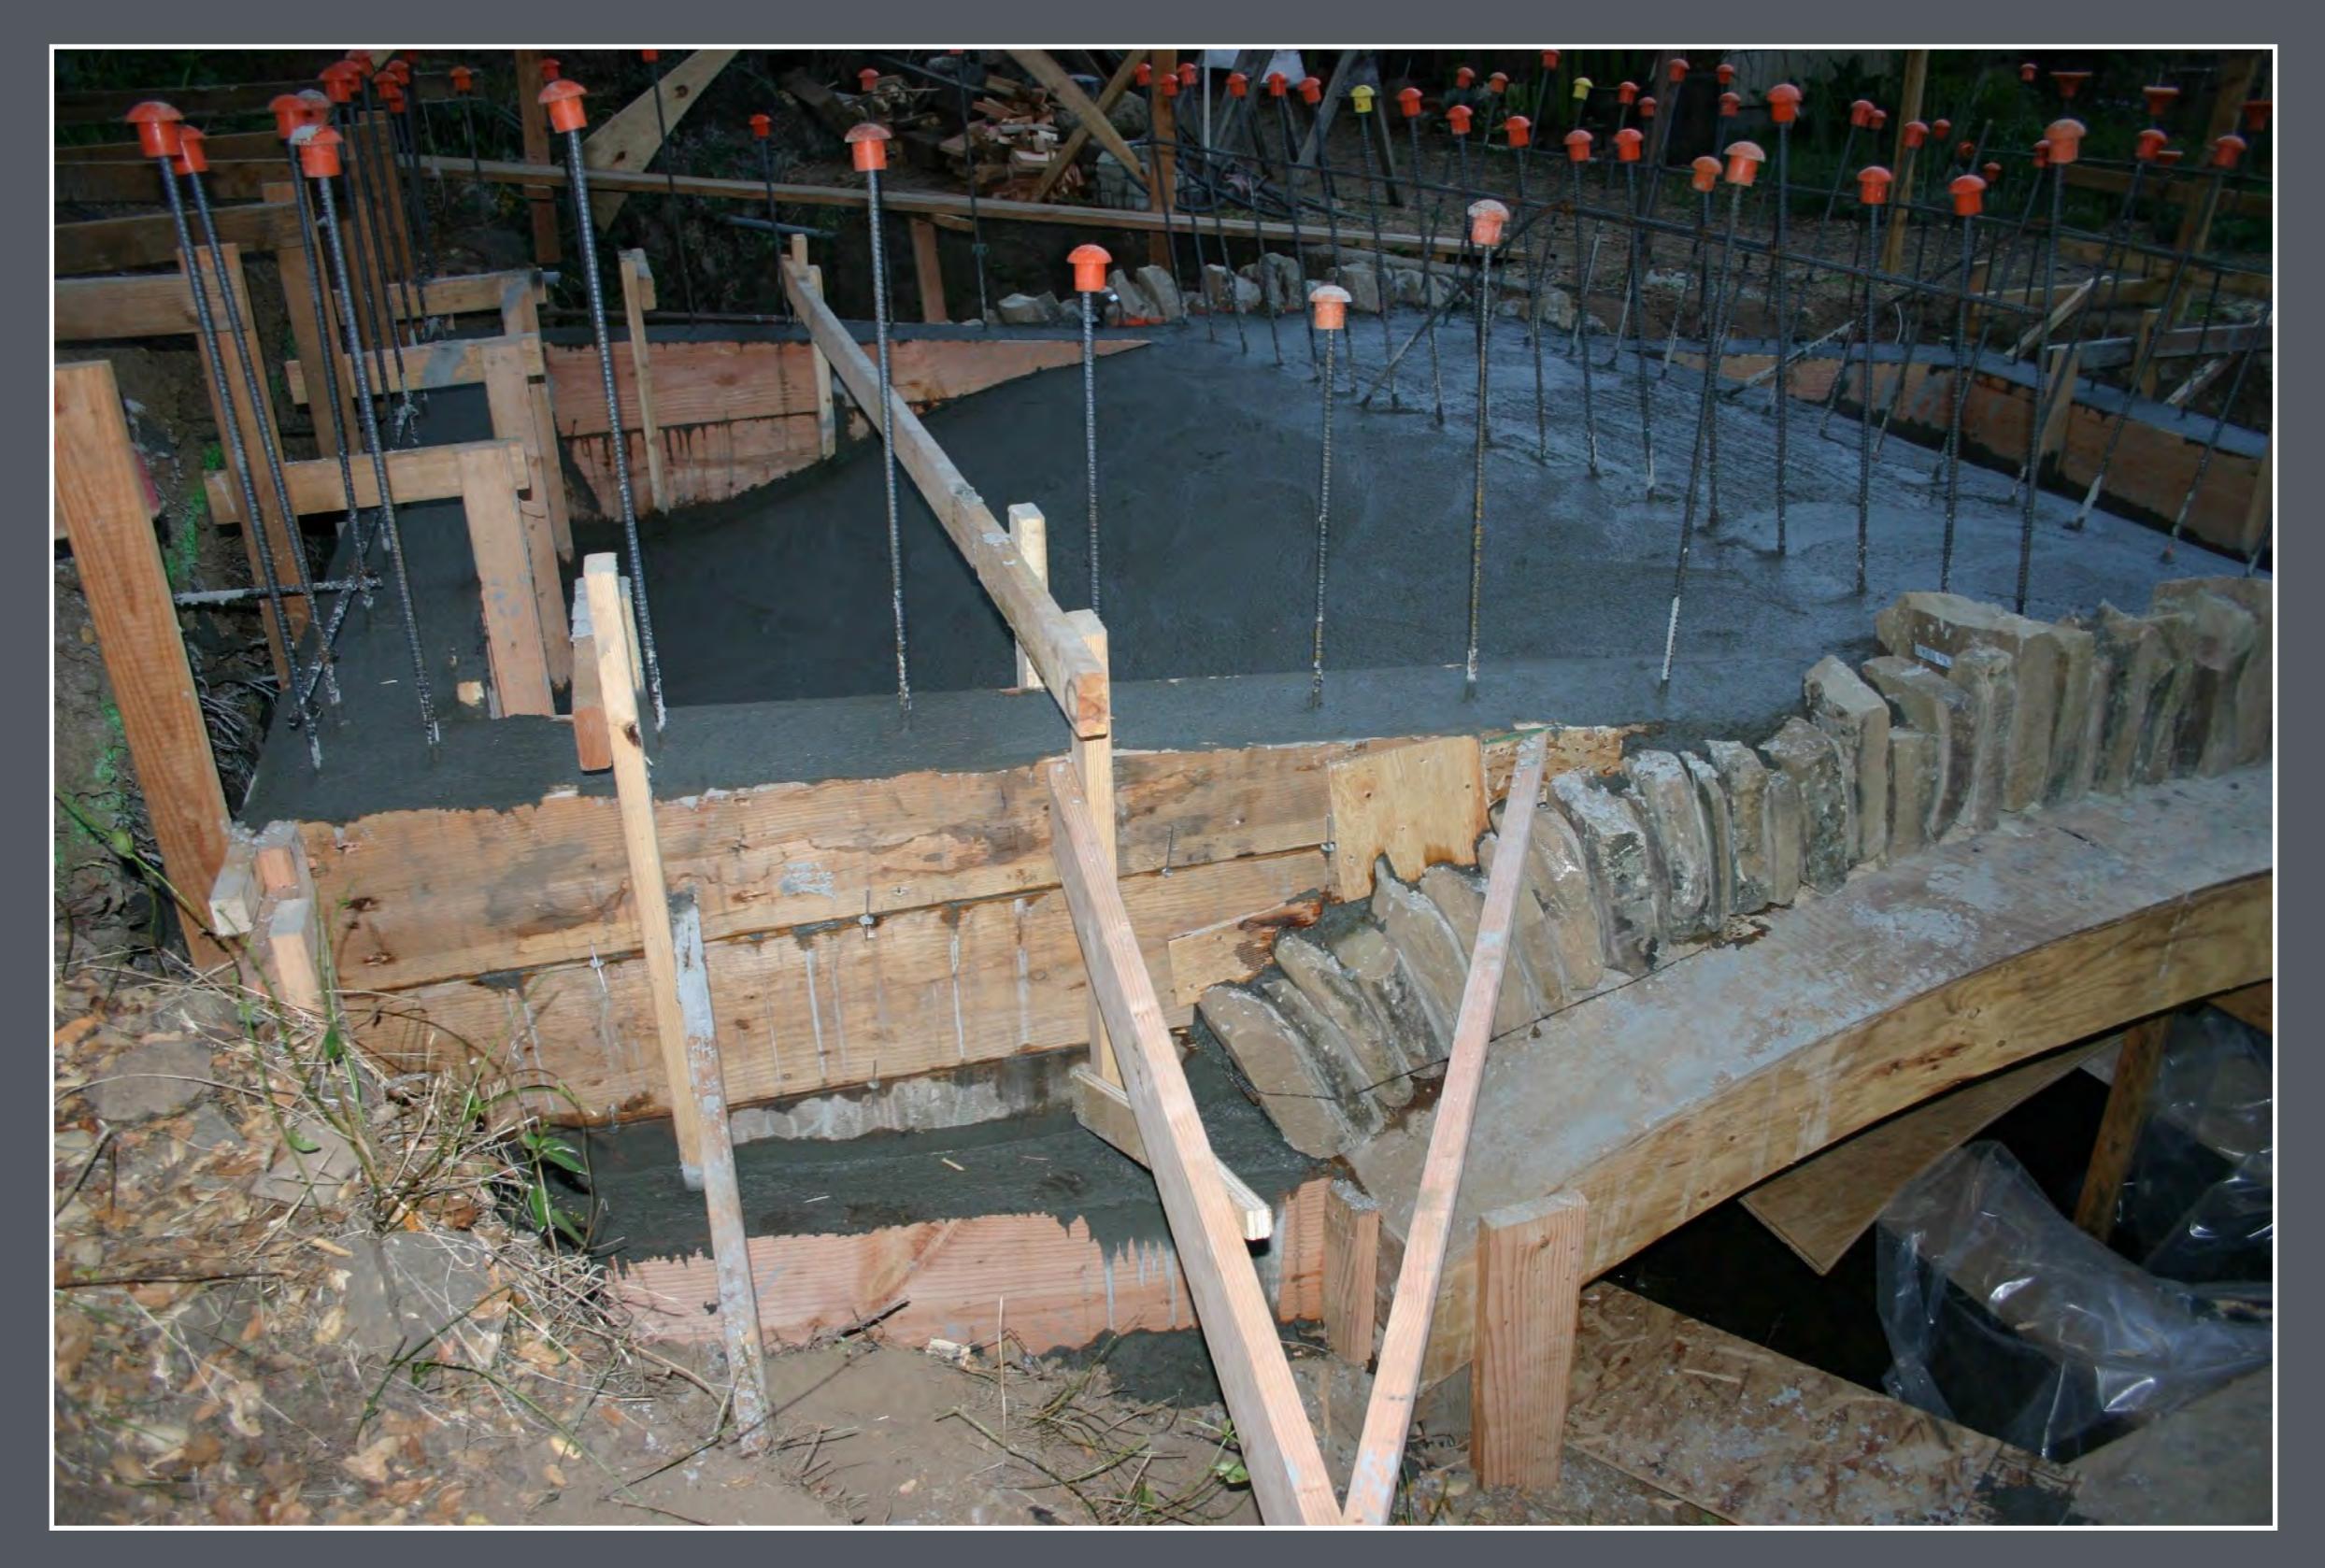
New Concrete Bridge Construction, October 2006 Completed first pour showing cavity to receive gravel fill.
