COMMUNITY DEVELOPMENT AGENCY PLANNING DIVISION

SUBJECT: Appeal of the Tarigo Design Review and Second Unit Draft Initial Study Assessor's Parcel: 168-034-14 21 Barranca Road, Lagunitas

Tarigo/Terrass Residence Planning Commission Presentation October 22, 2018

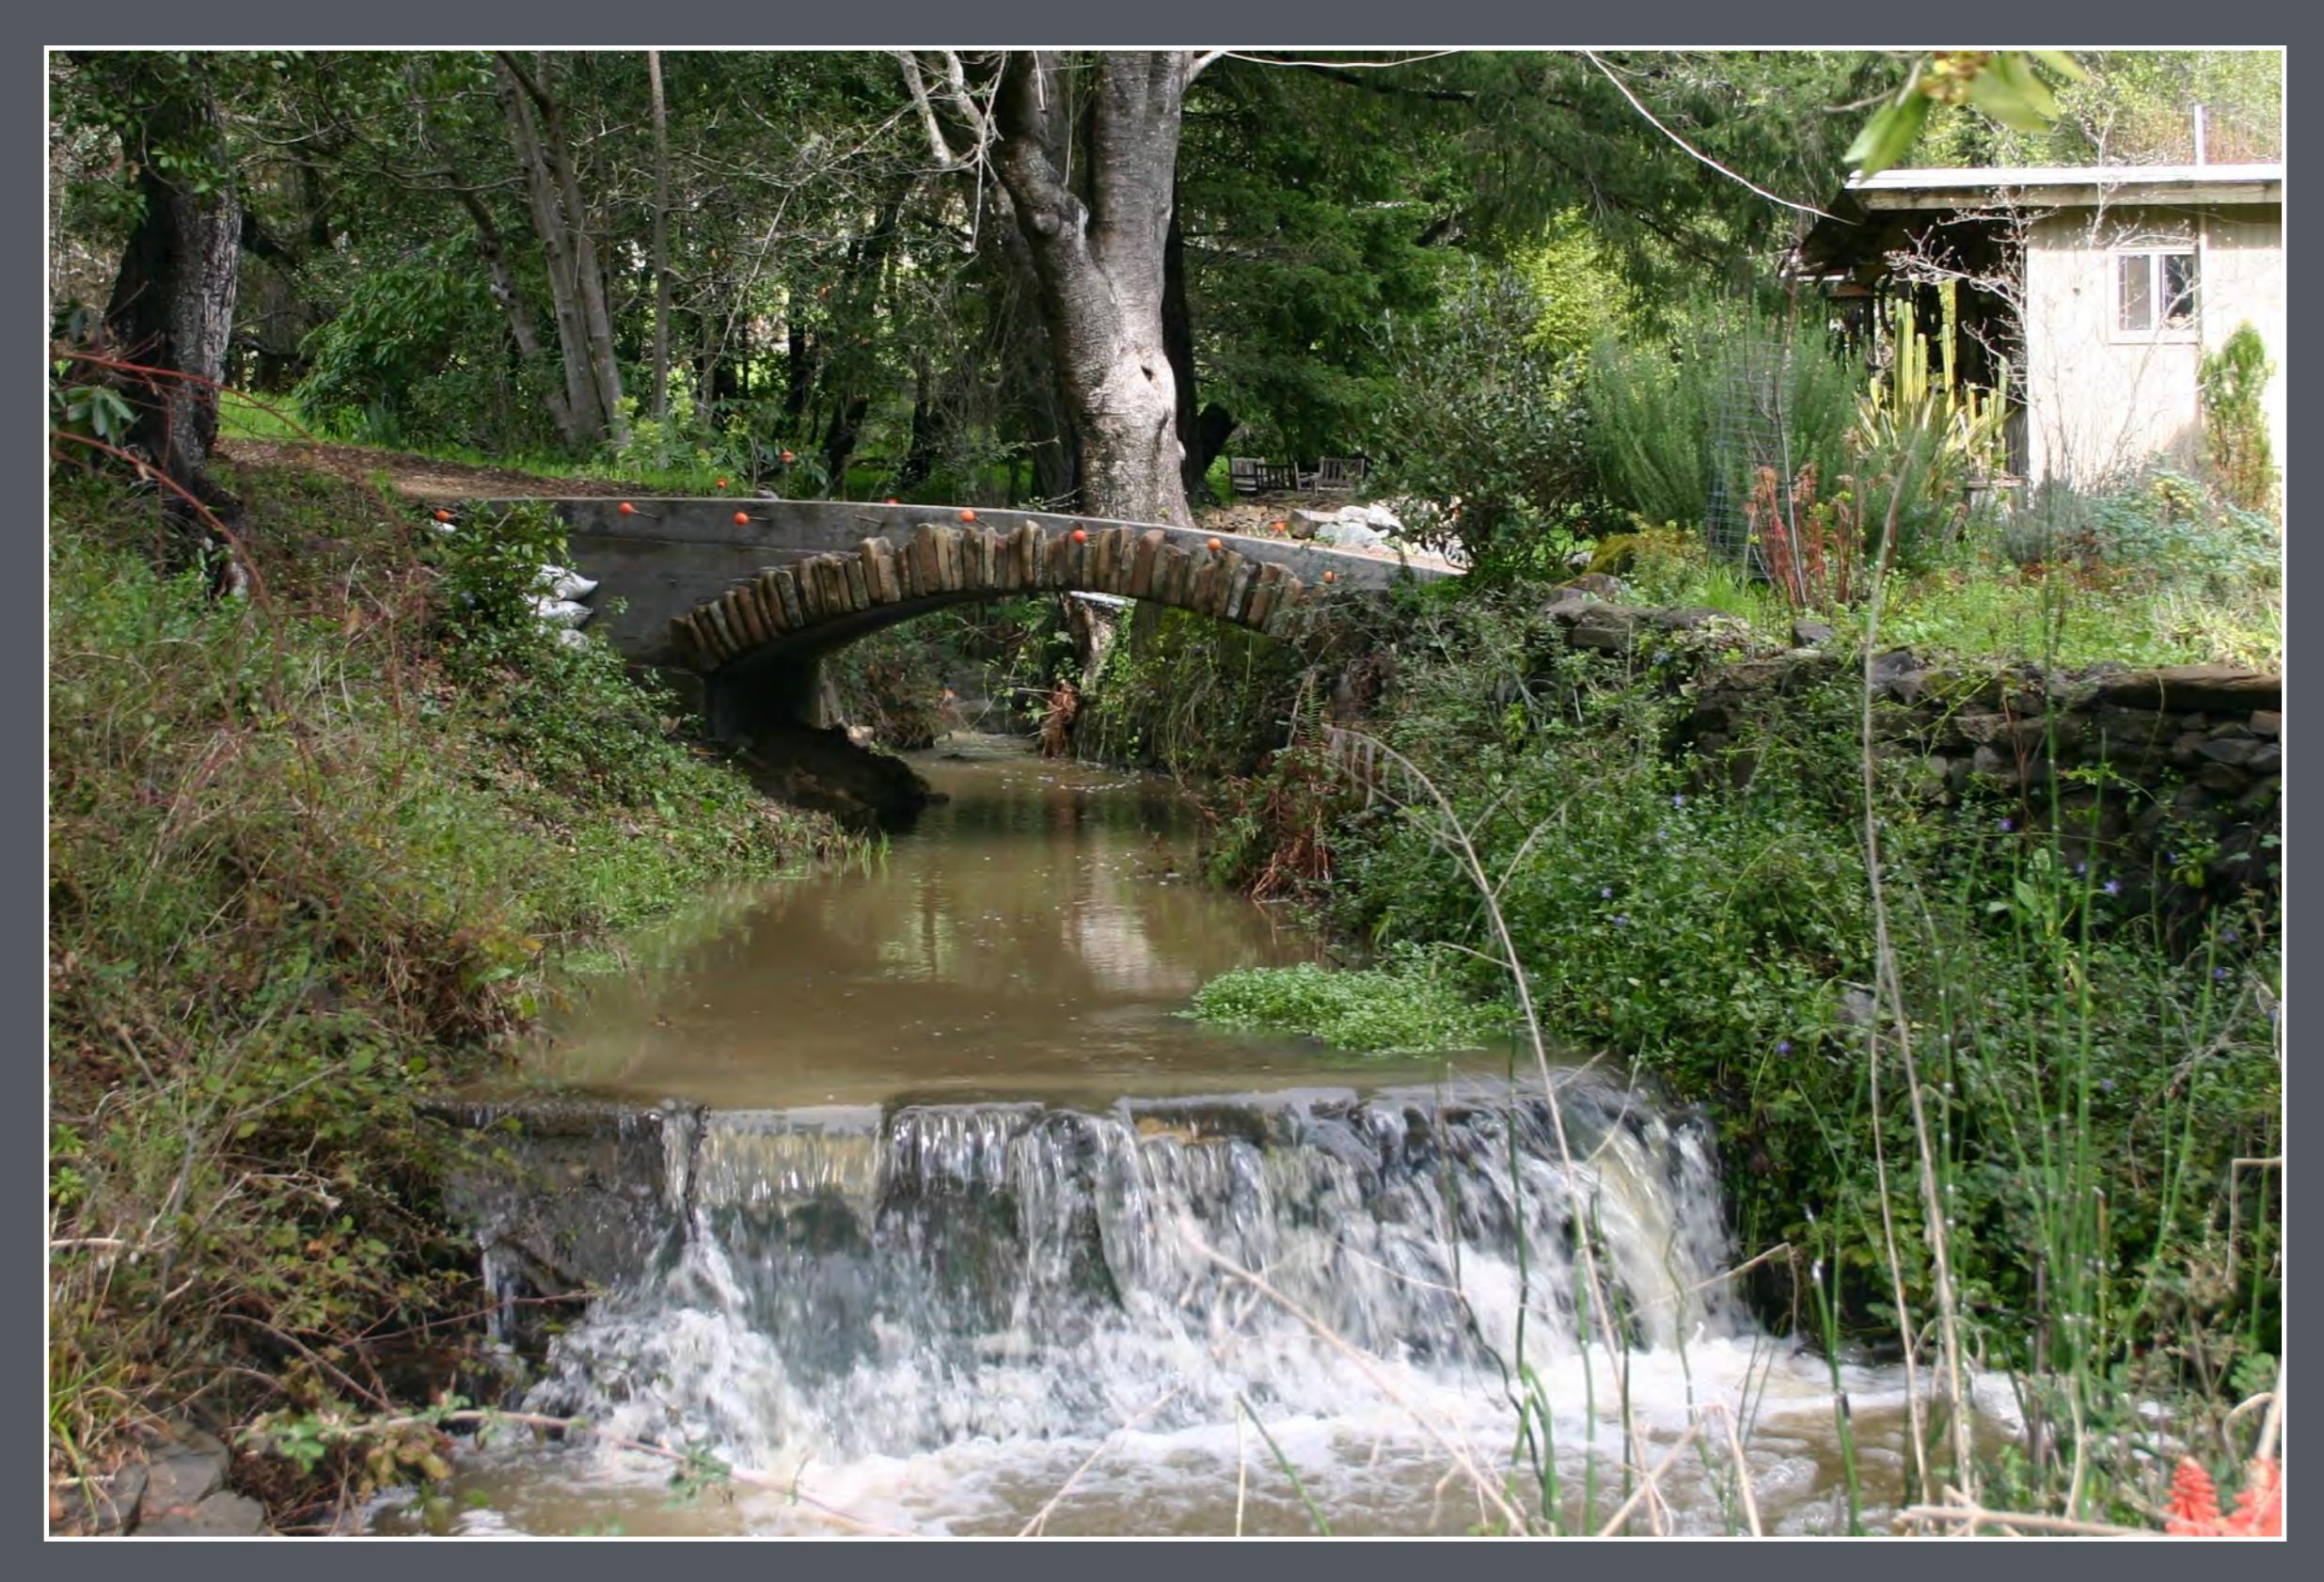
Dam and Completed Structural Bridge, February 2007 Note generous height and span. Bridge is 12" thick at mid span and weighs 43 tons.

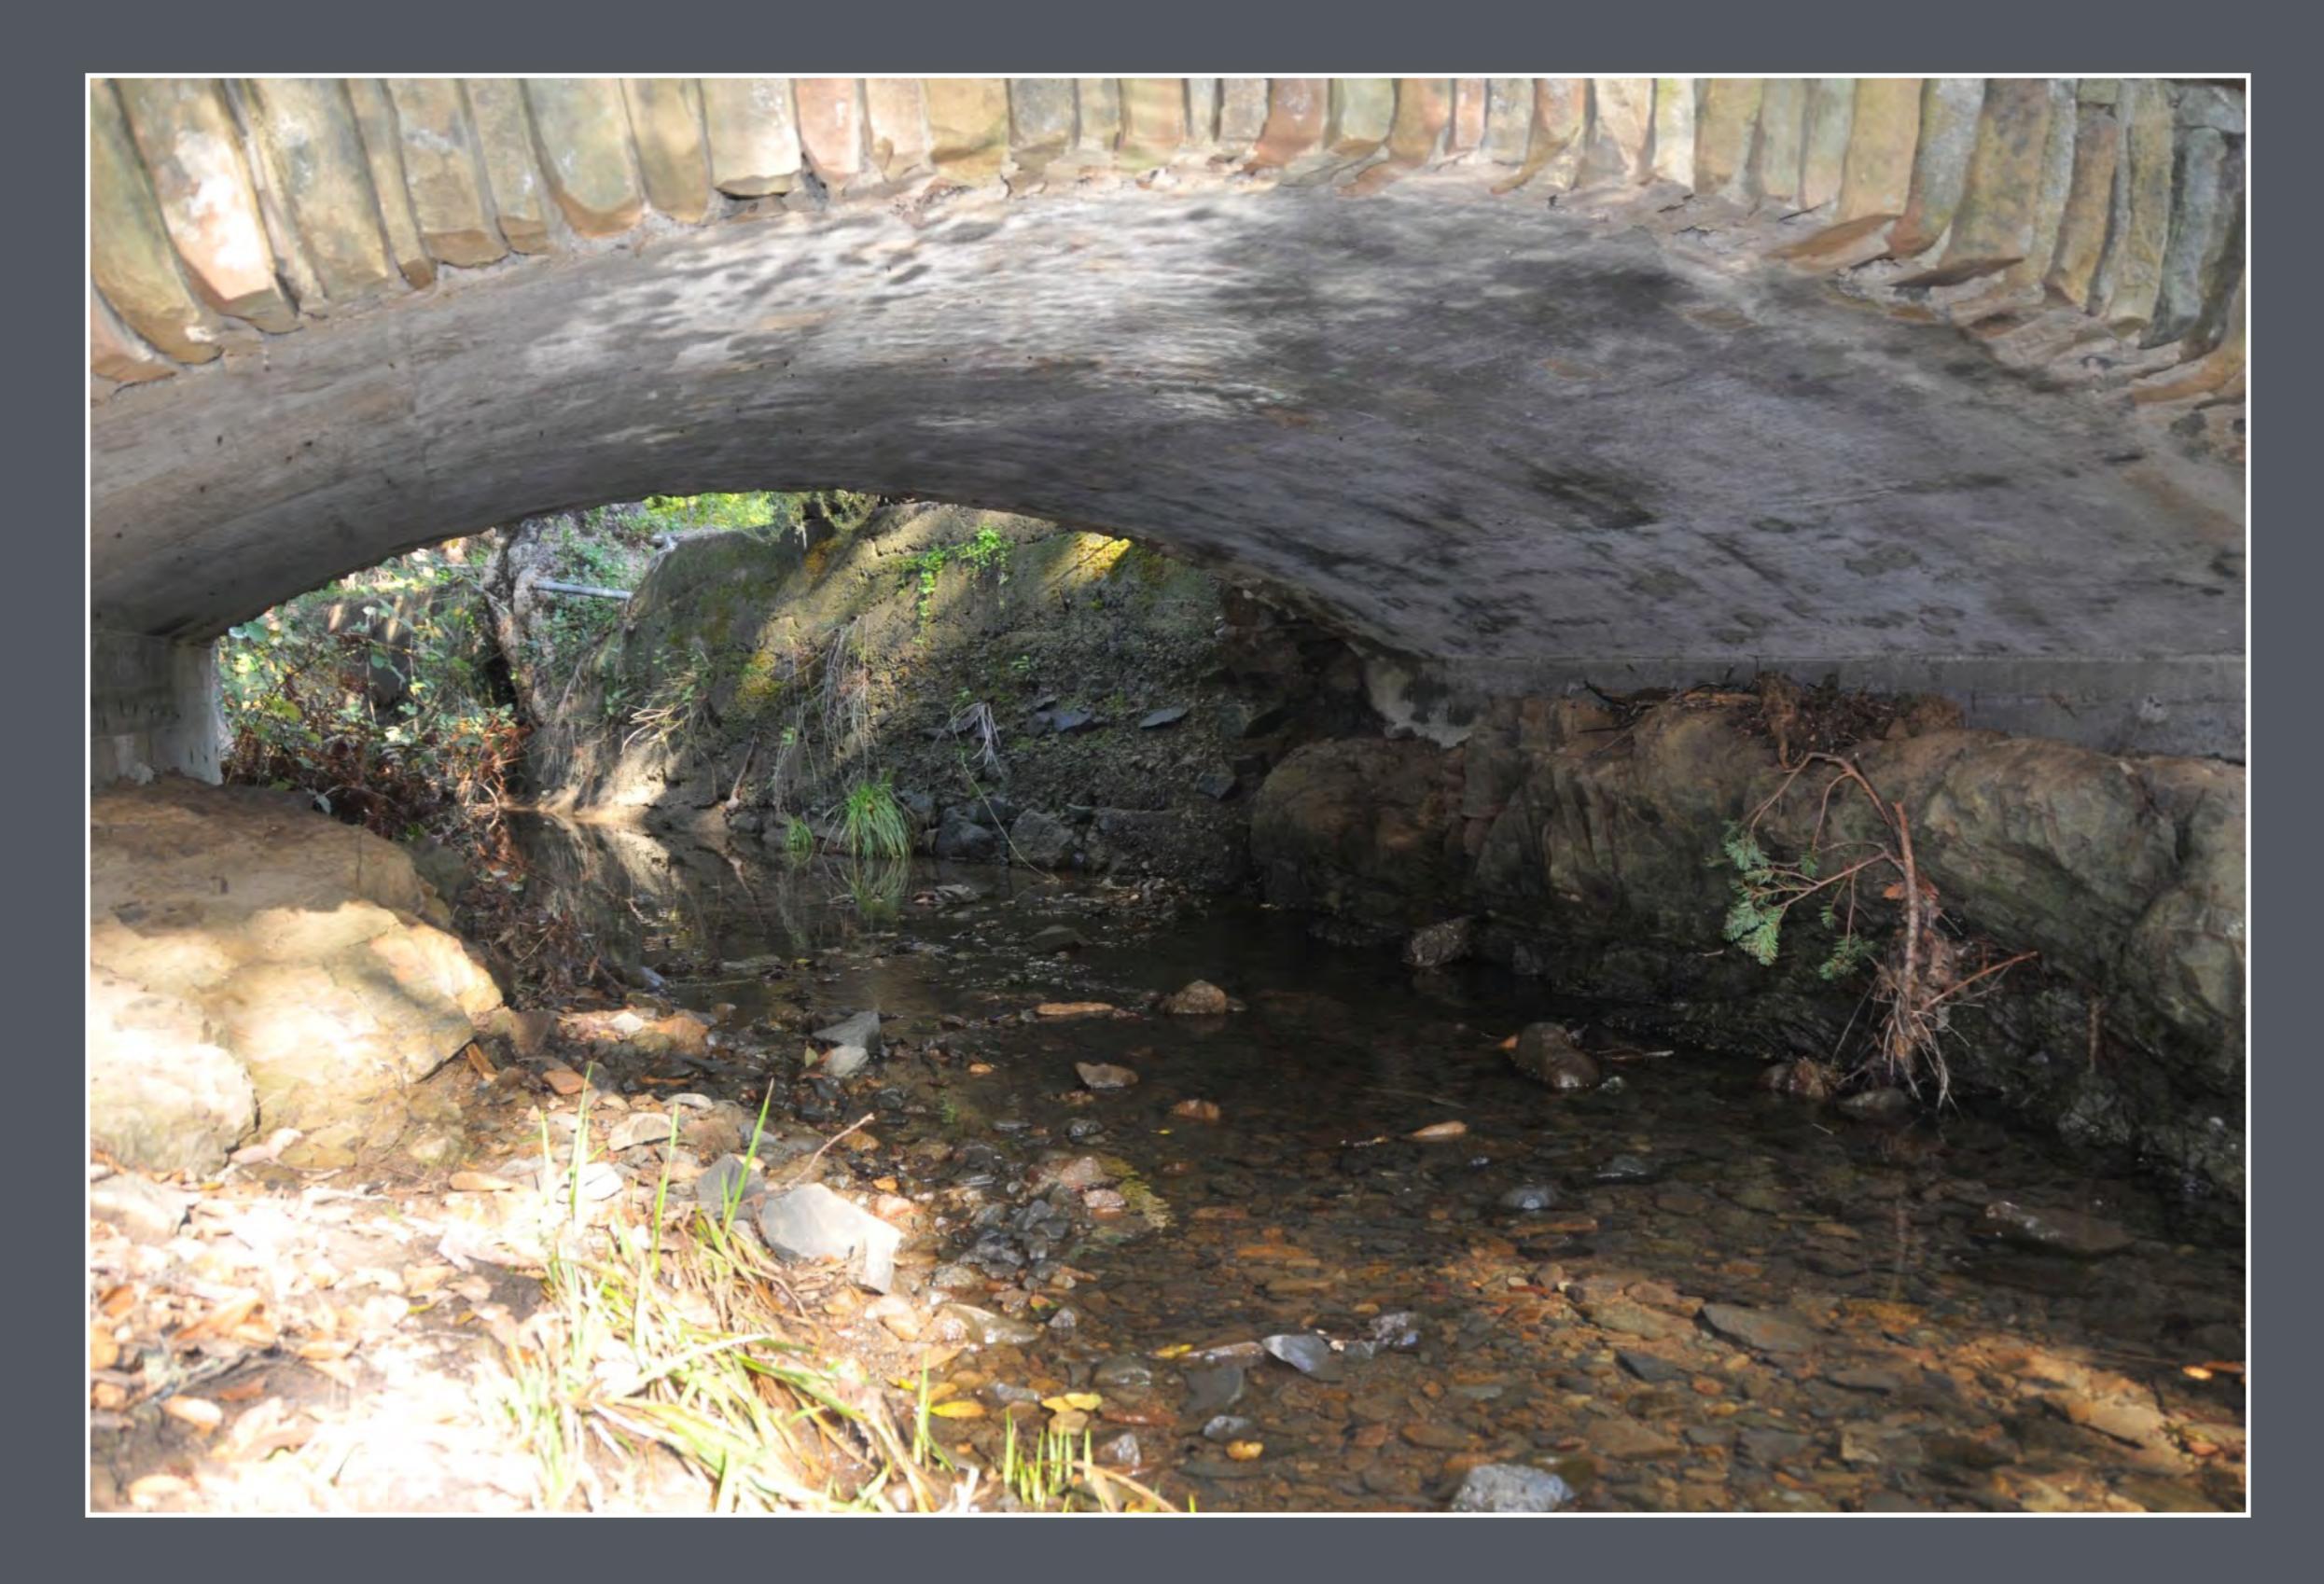
Bridge Span Over Barranca Creek Bridge abutments sit on exposed bedrock, 30" above creek bottom.

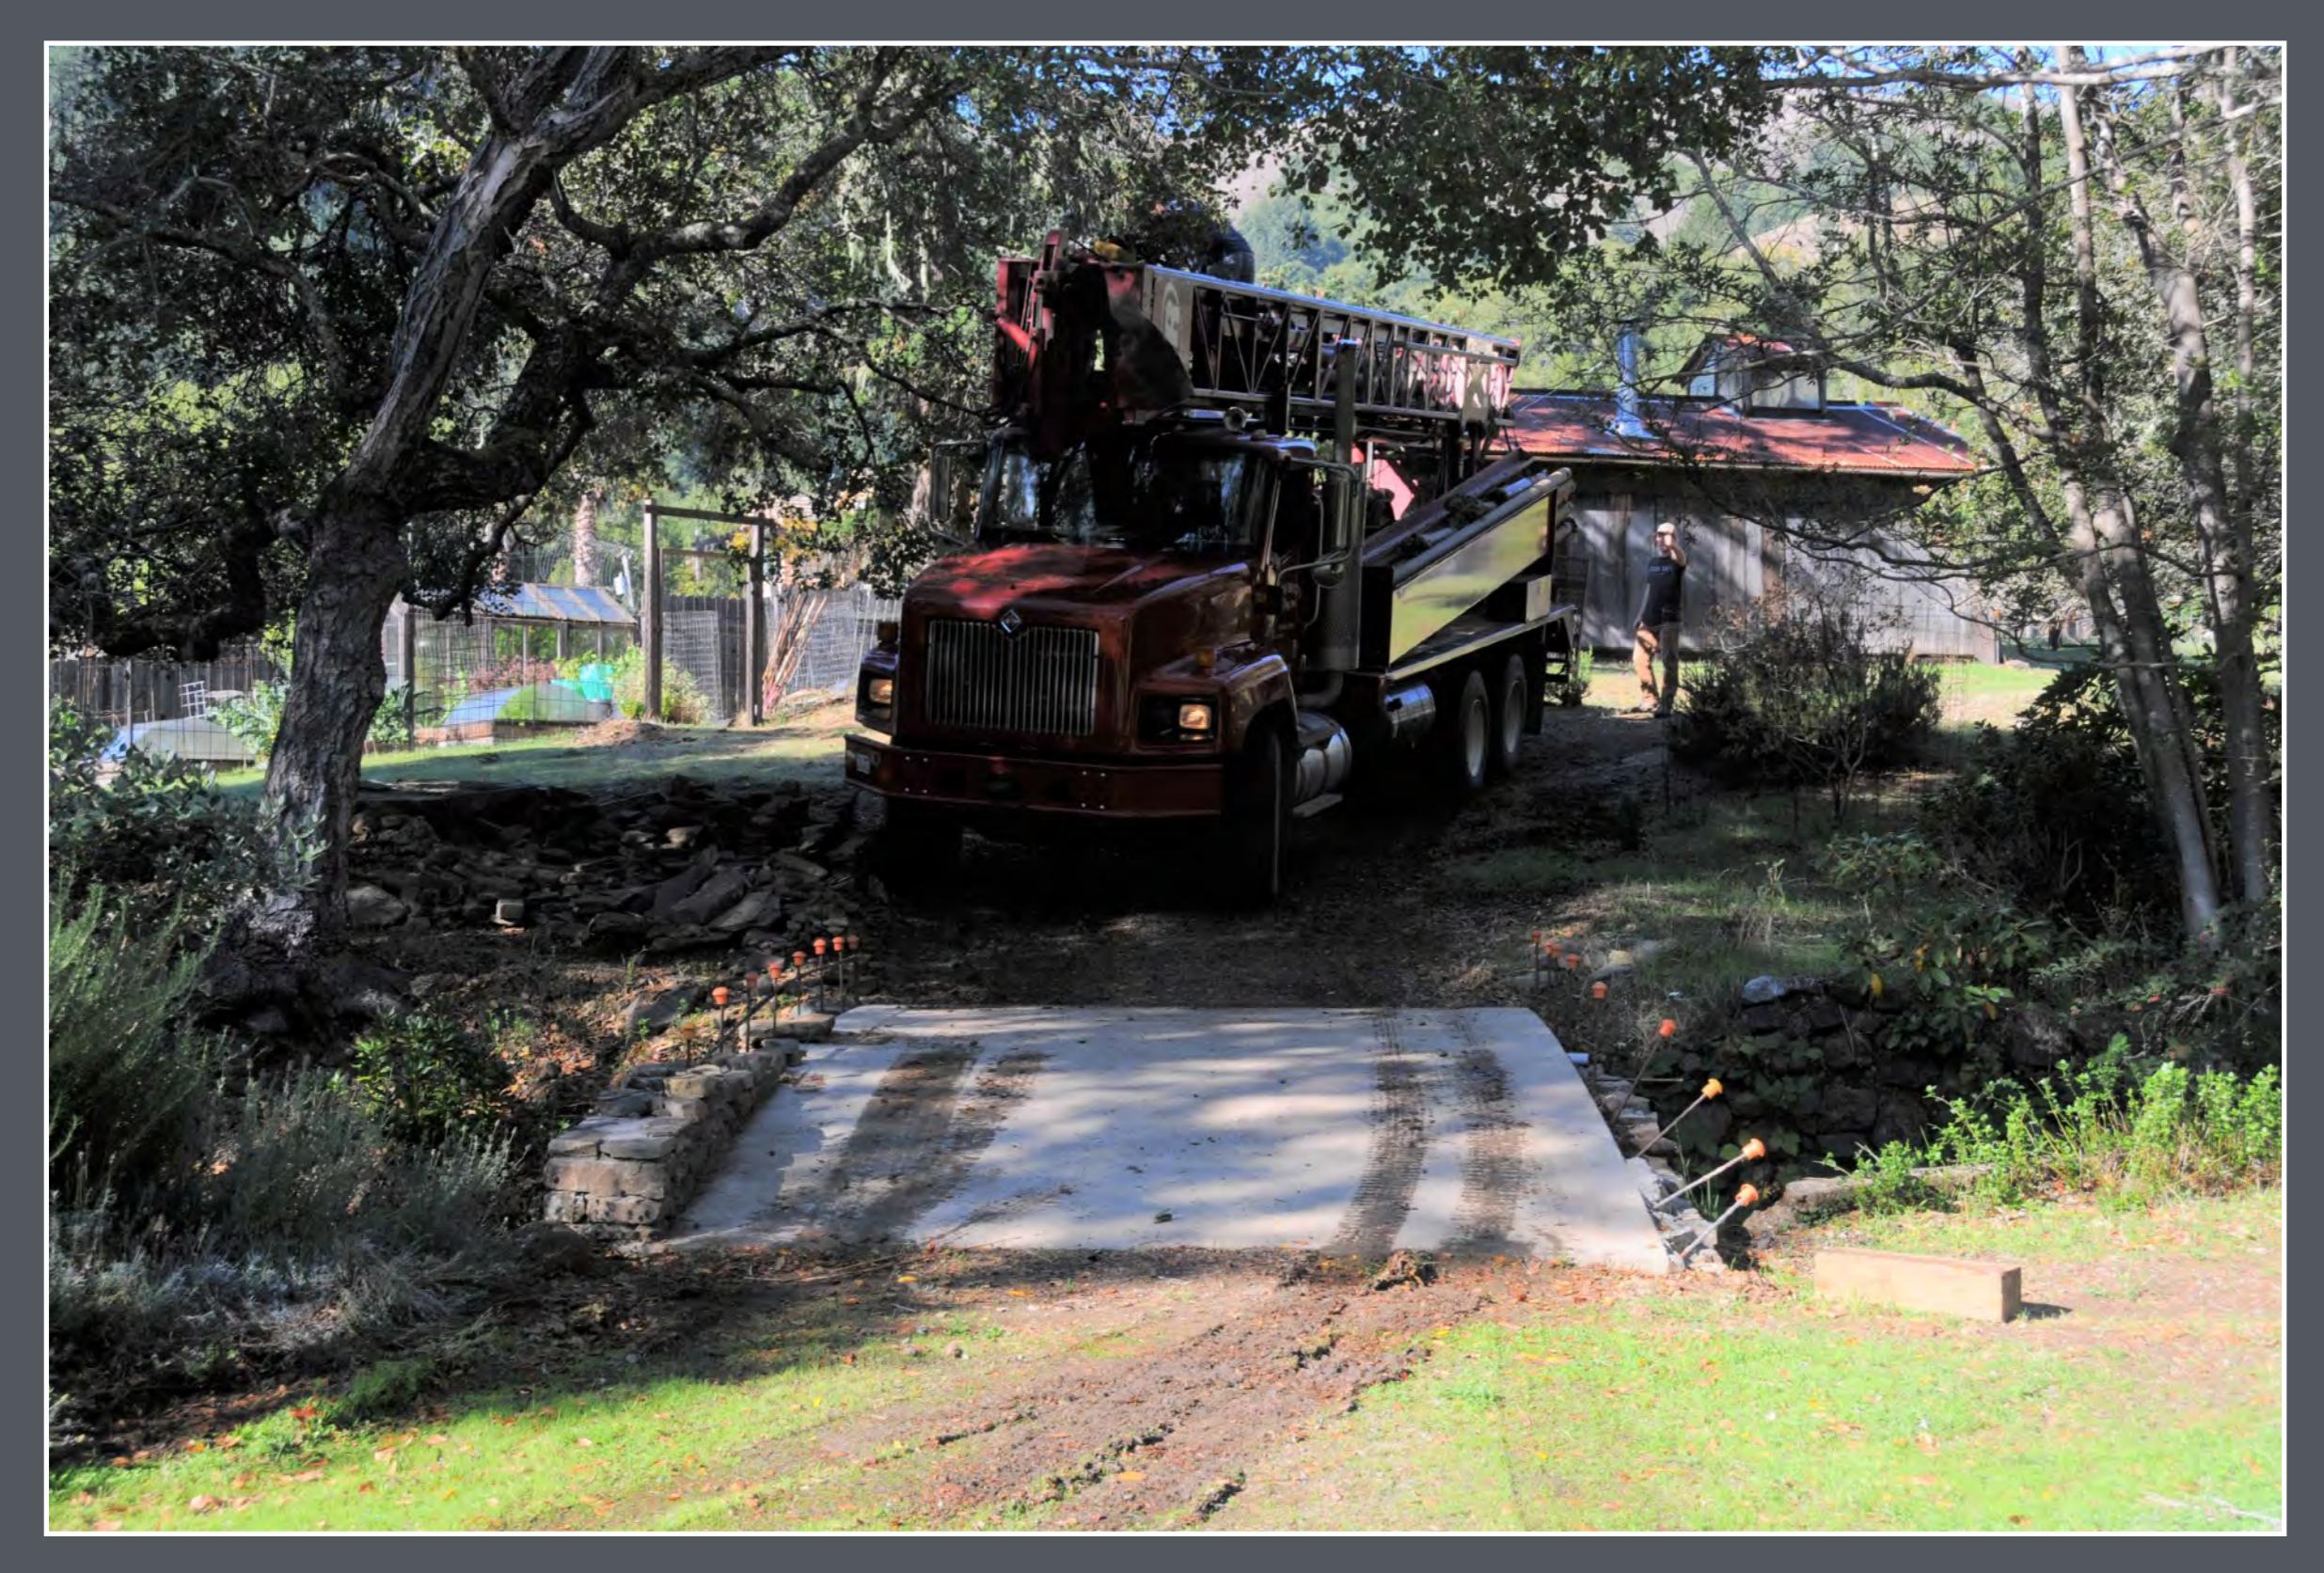
Drill Rig Crossing Bridge, November 2008 Drill rig weighs about 60,000 lbs.

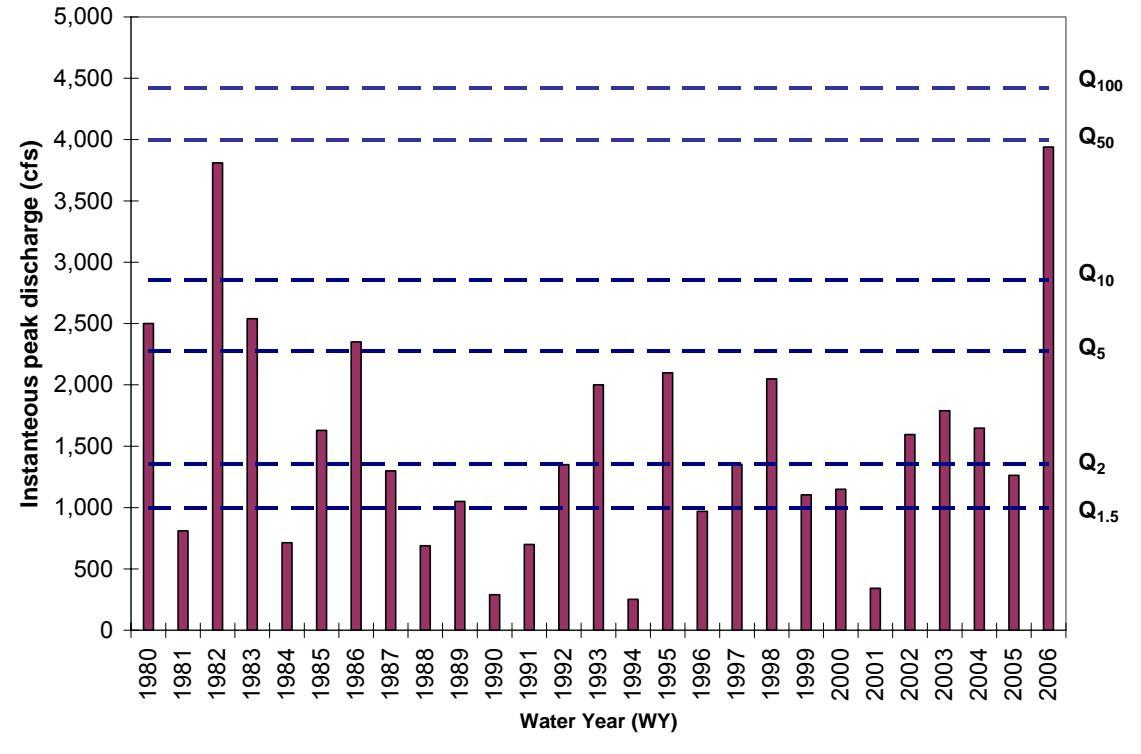
Figure 3-6. Annual peak discharges for San Geronimo Creek at the Lagunitas Road bridge.

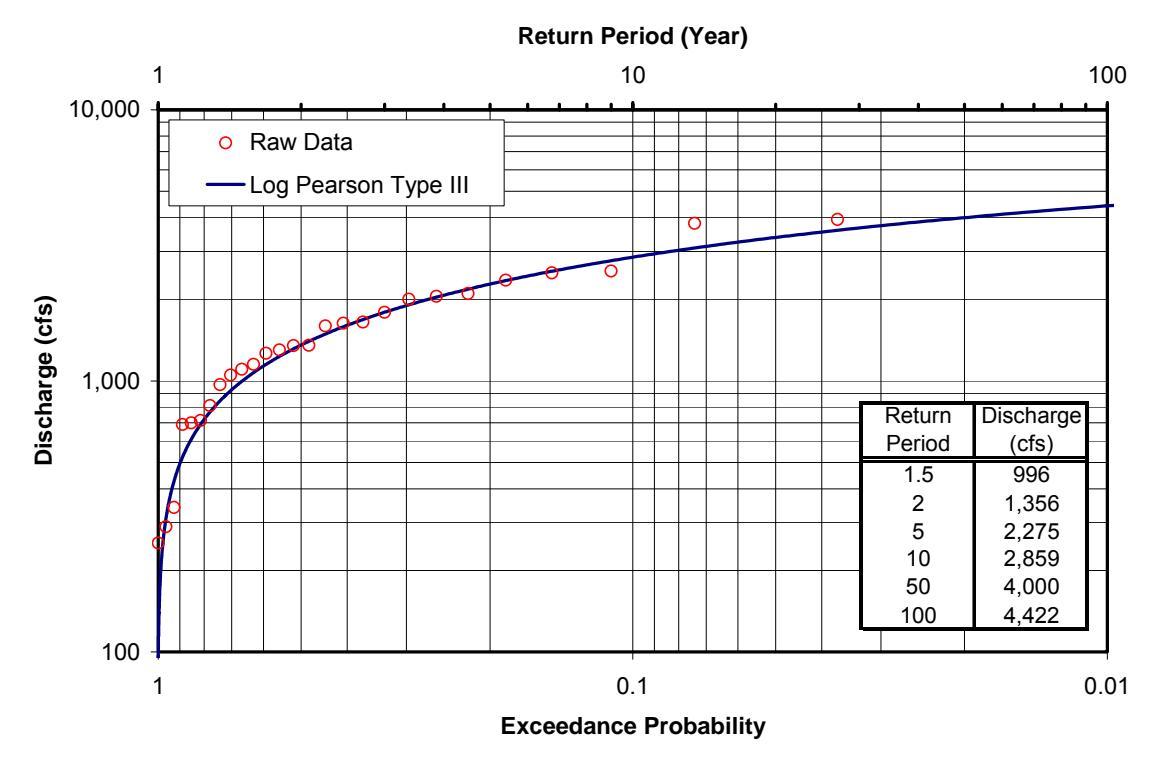
Figure 3-7. Flood frequency curve for the San Geronimo Creek at Lagunitas Road bridge (WY 1980-2006).

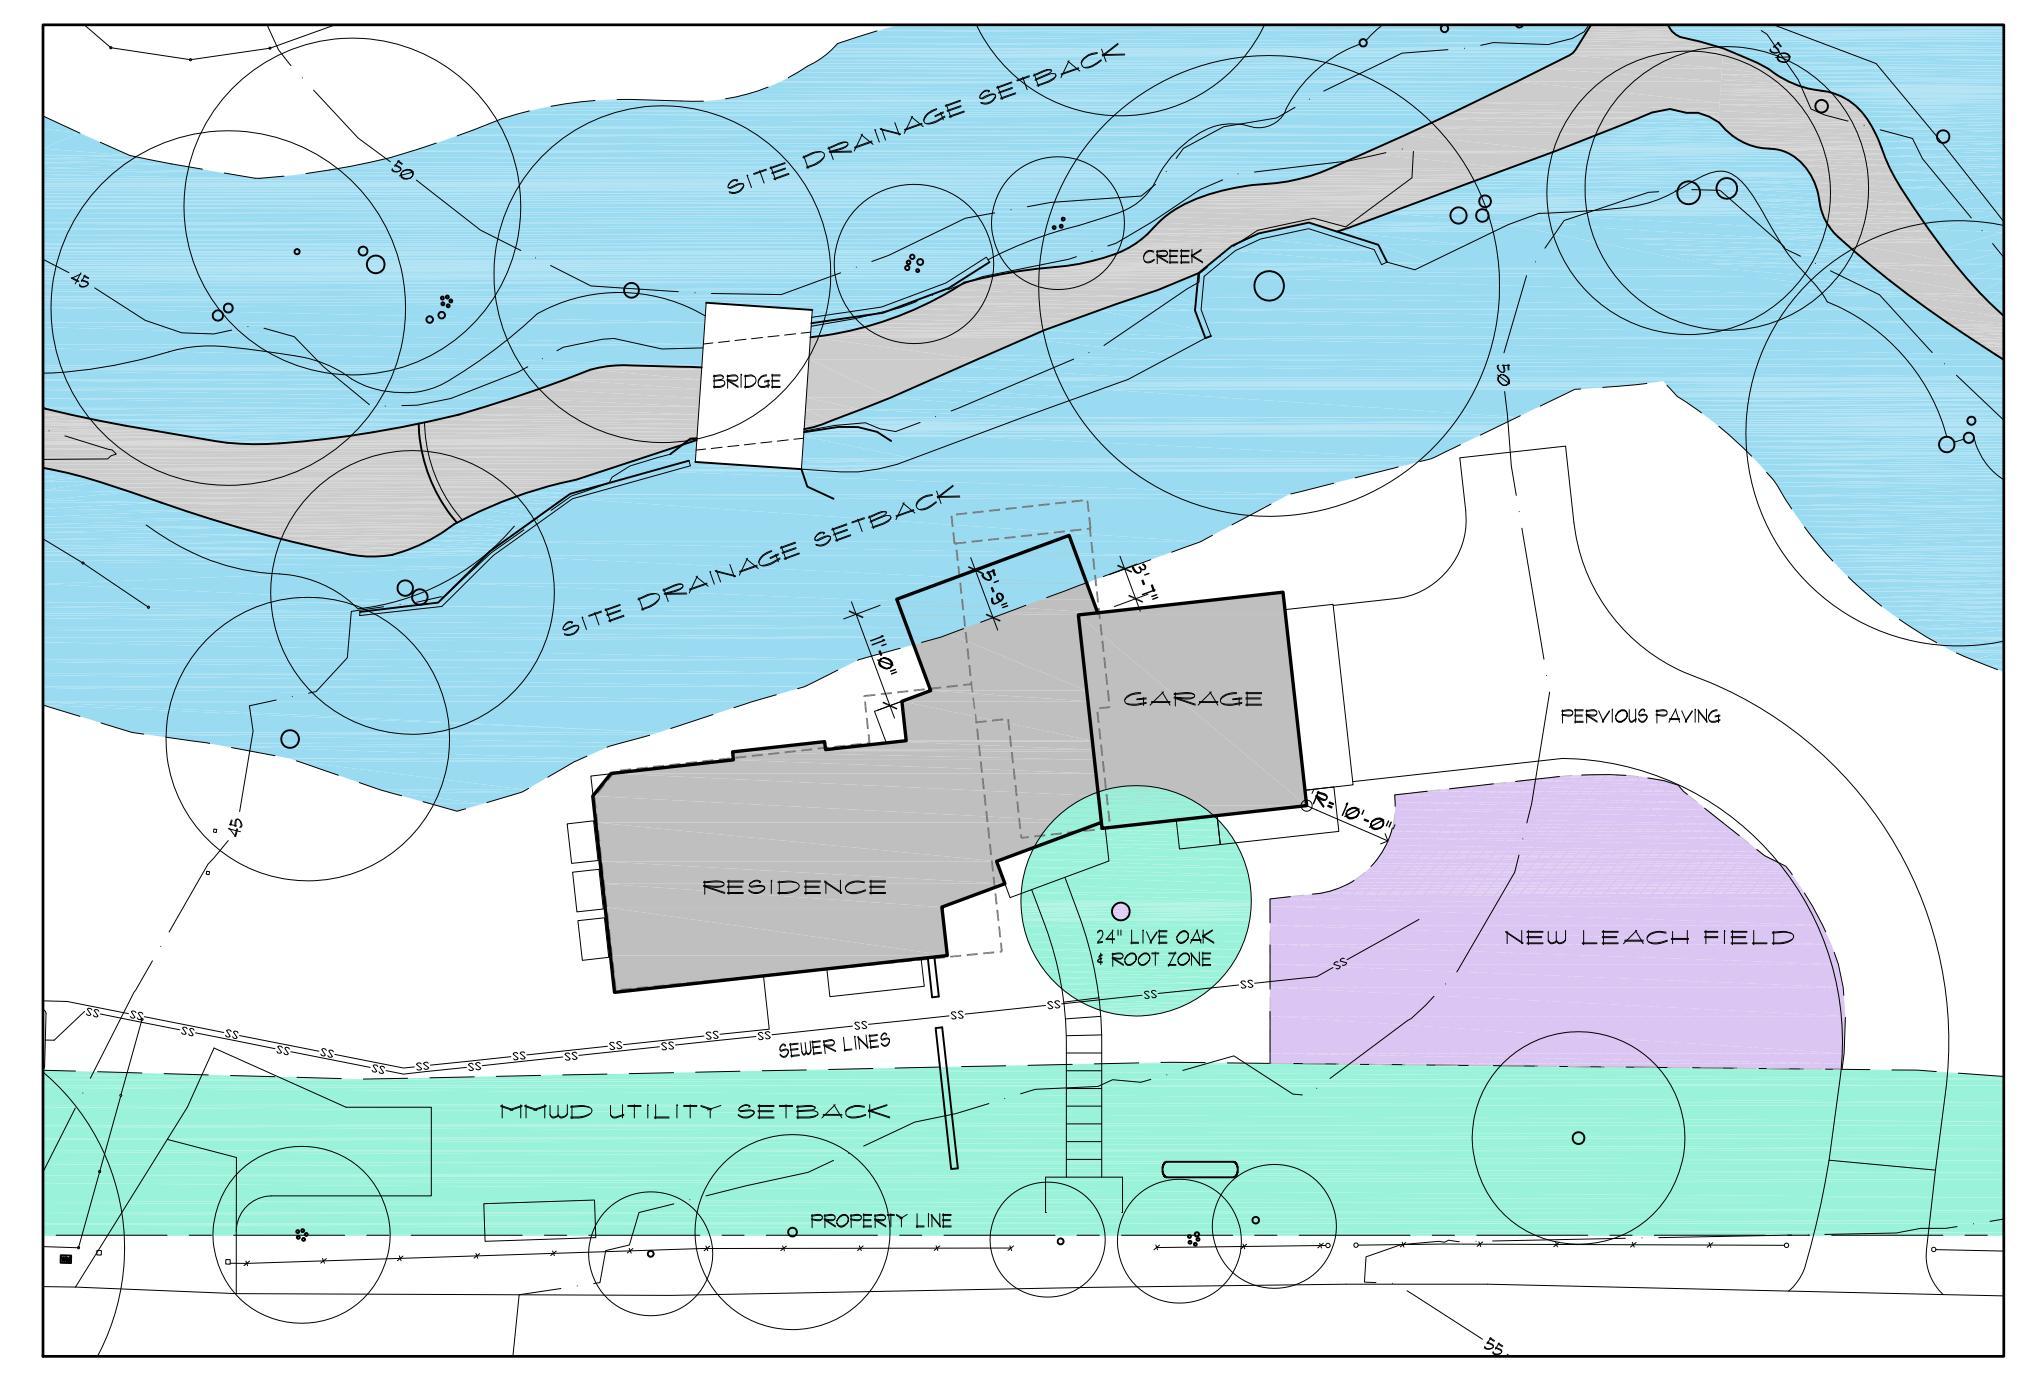
LOCAL SITE CONSTRAINTS

SITE DRAINAGE, UTILITY AND SEPTIC SETBACKS, AS WELL AS PRESERVATION OF HERITAGE LIVE OAK, HIGHLY CONSTRAIN BUILDABLE AREA.

EXISTING AND PROPOSED SETBACK ENCROACHMENT SETBACK IS 20' FROM TOP OF BANK, OR EFFECTIVELY ABOUT 30' FROM EDGE OF CREEK

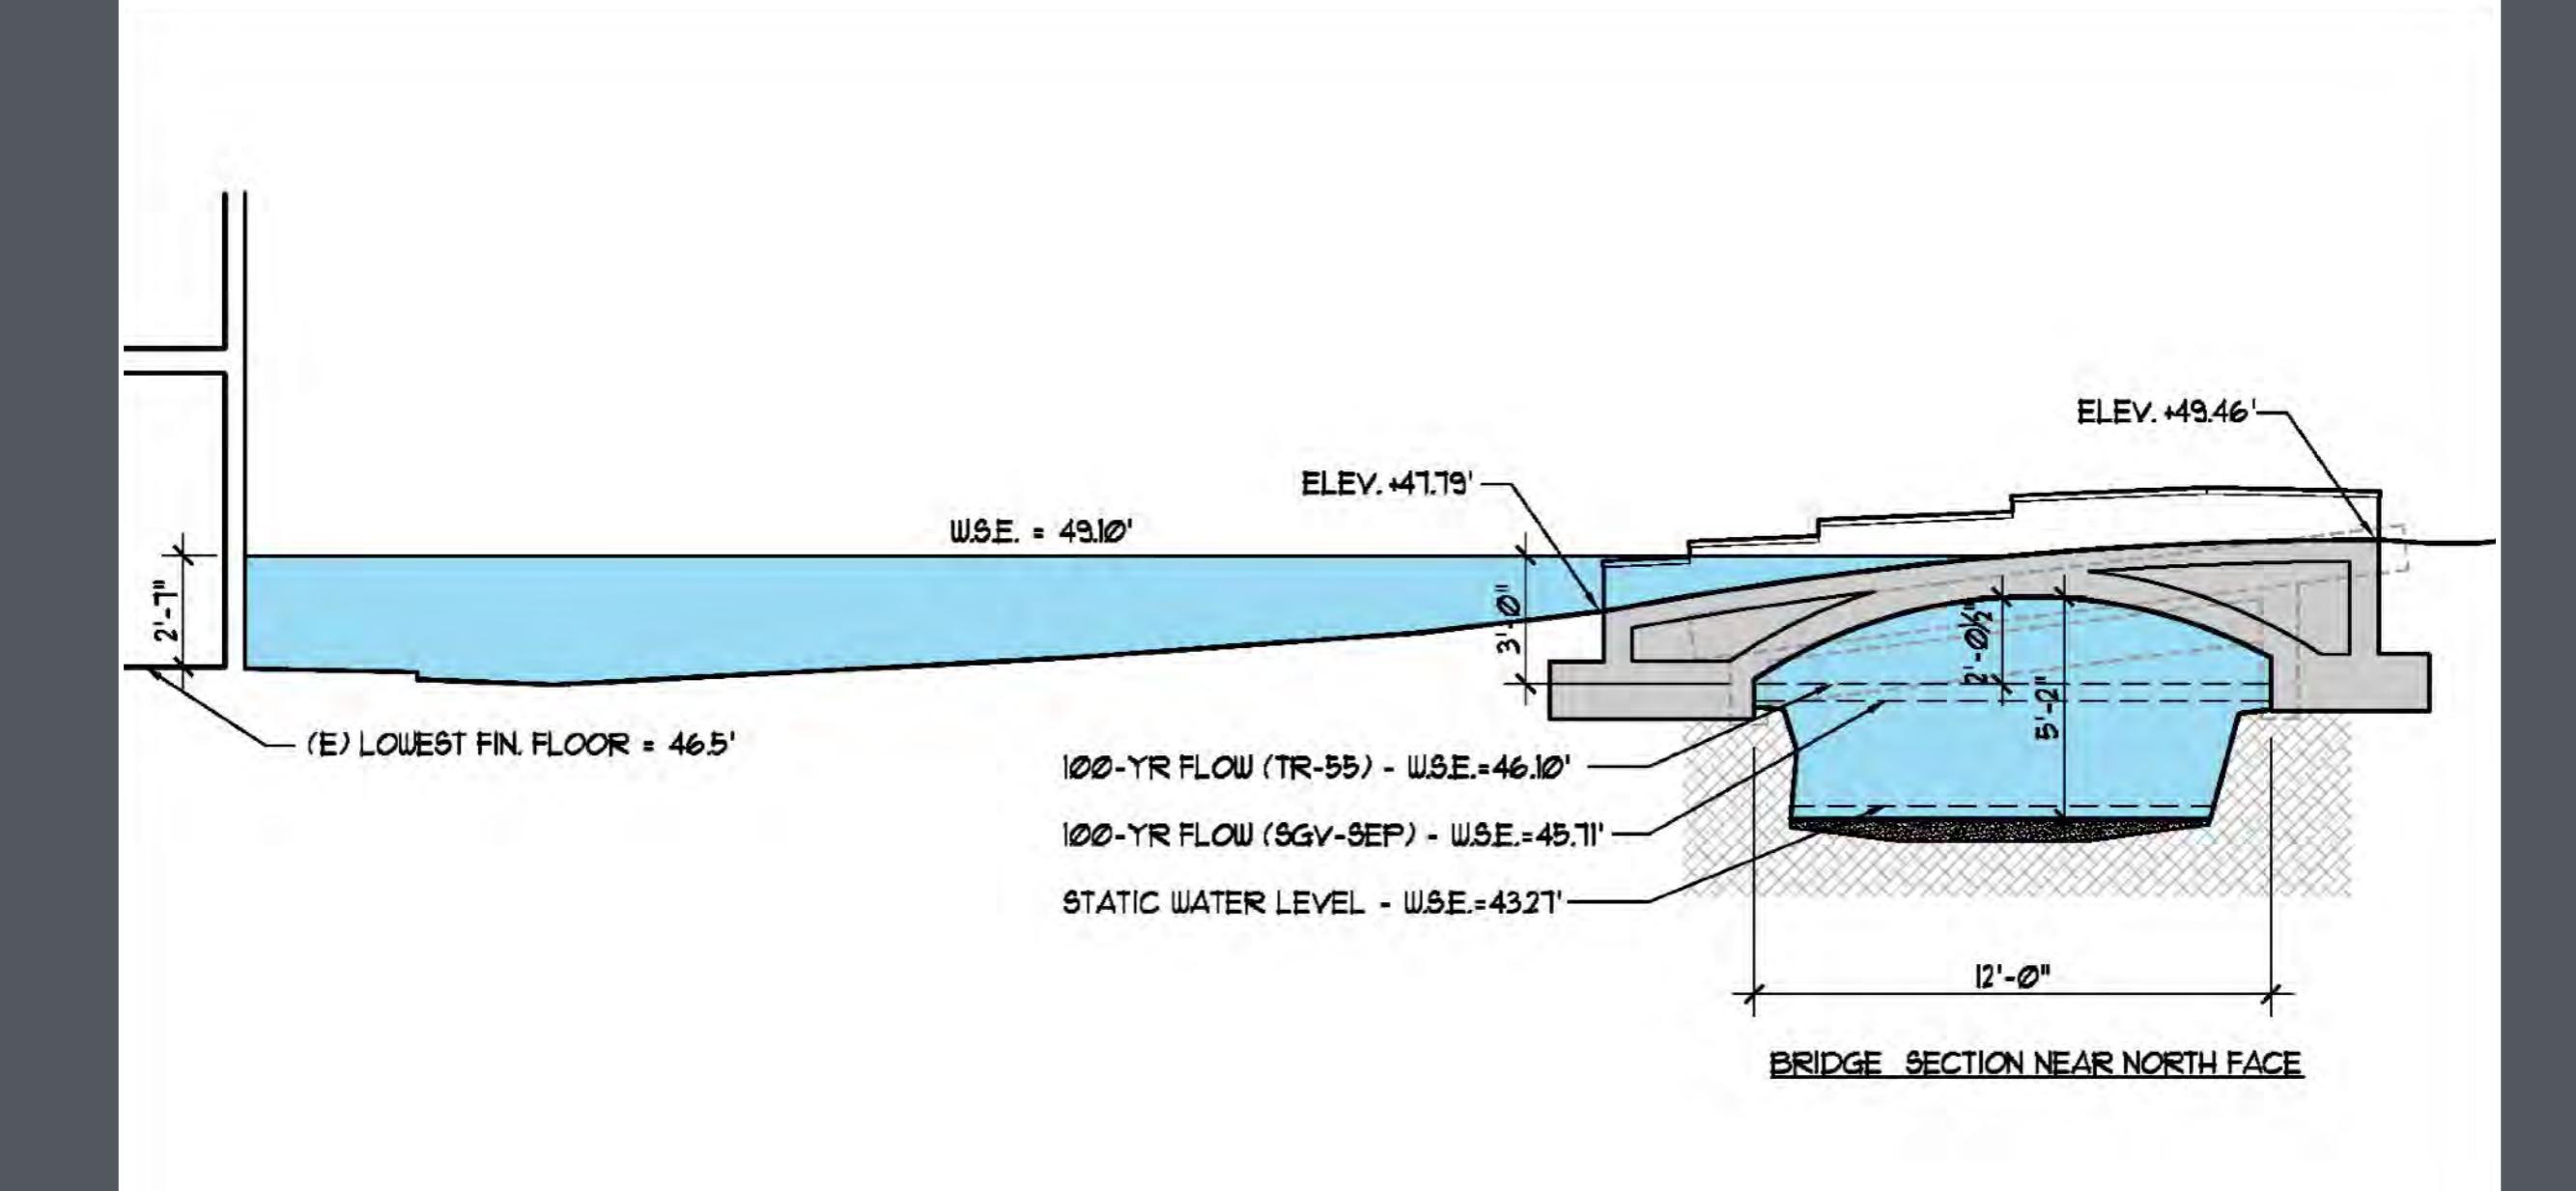
Flood Water Overtopping Bridge

Water surface elevation if flood water were to reach surface at center of bridge span. The entire yard would be under 24" to 30" of water.

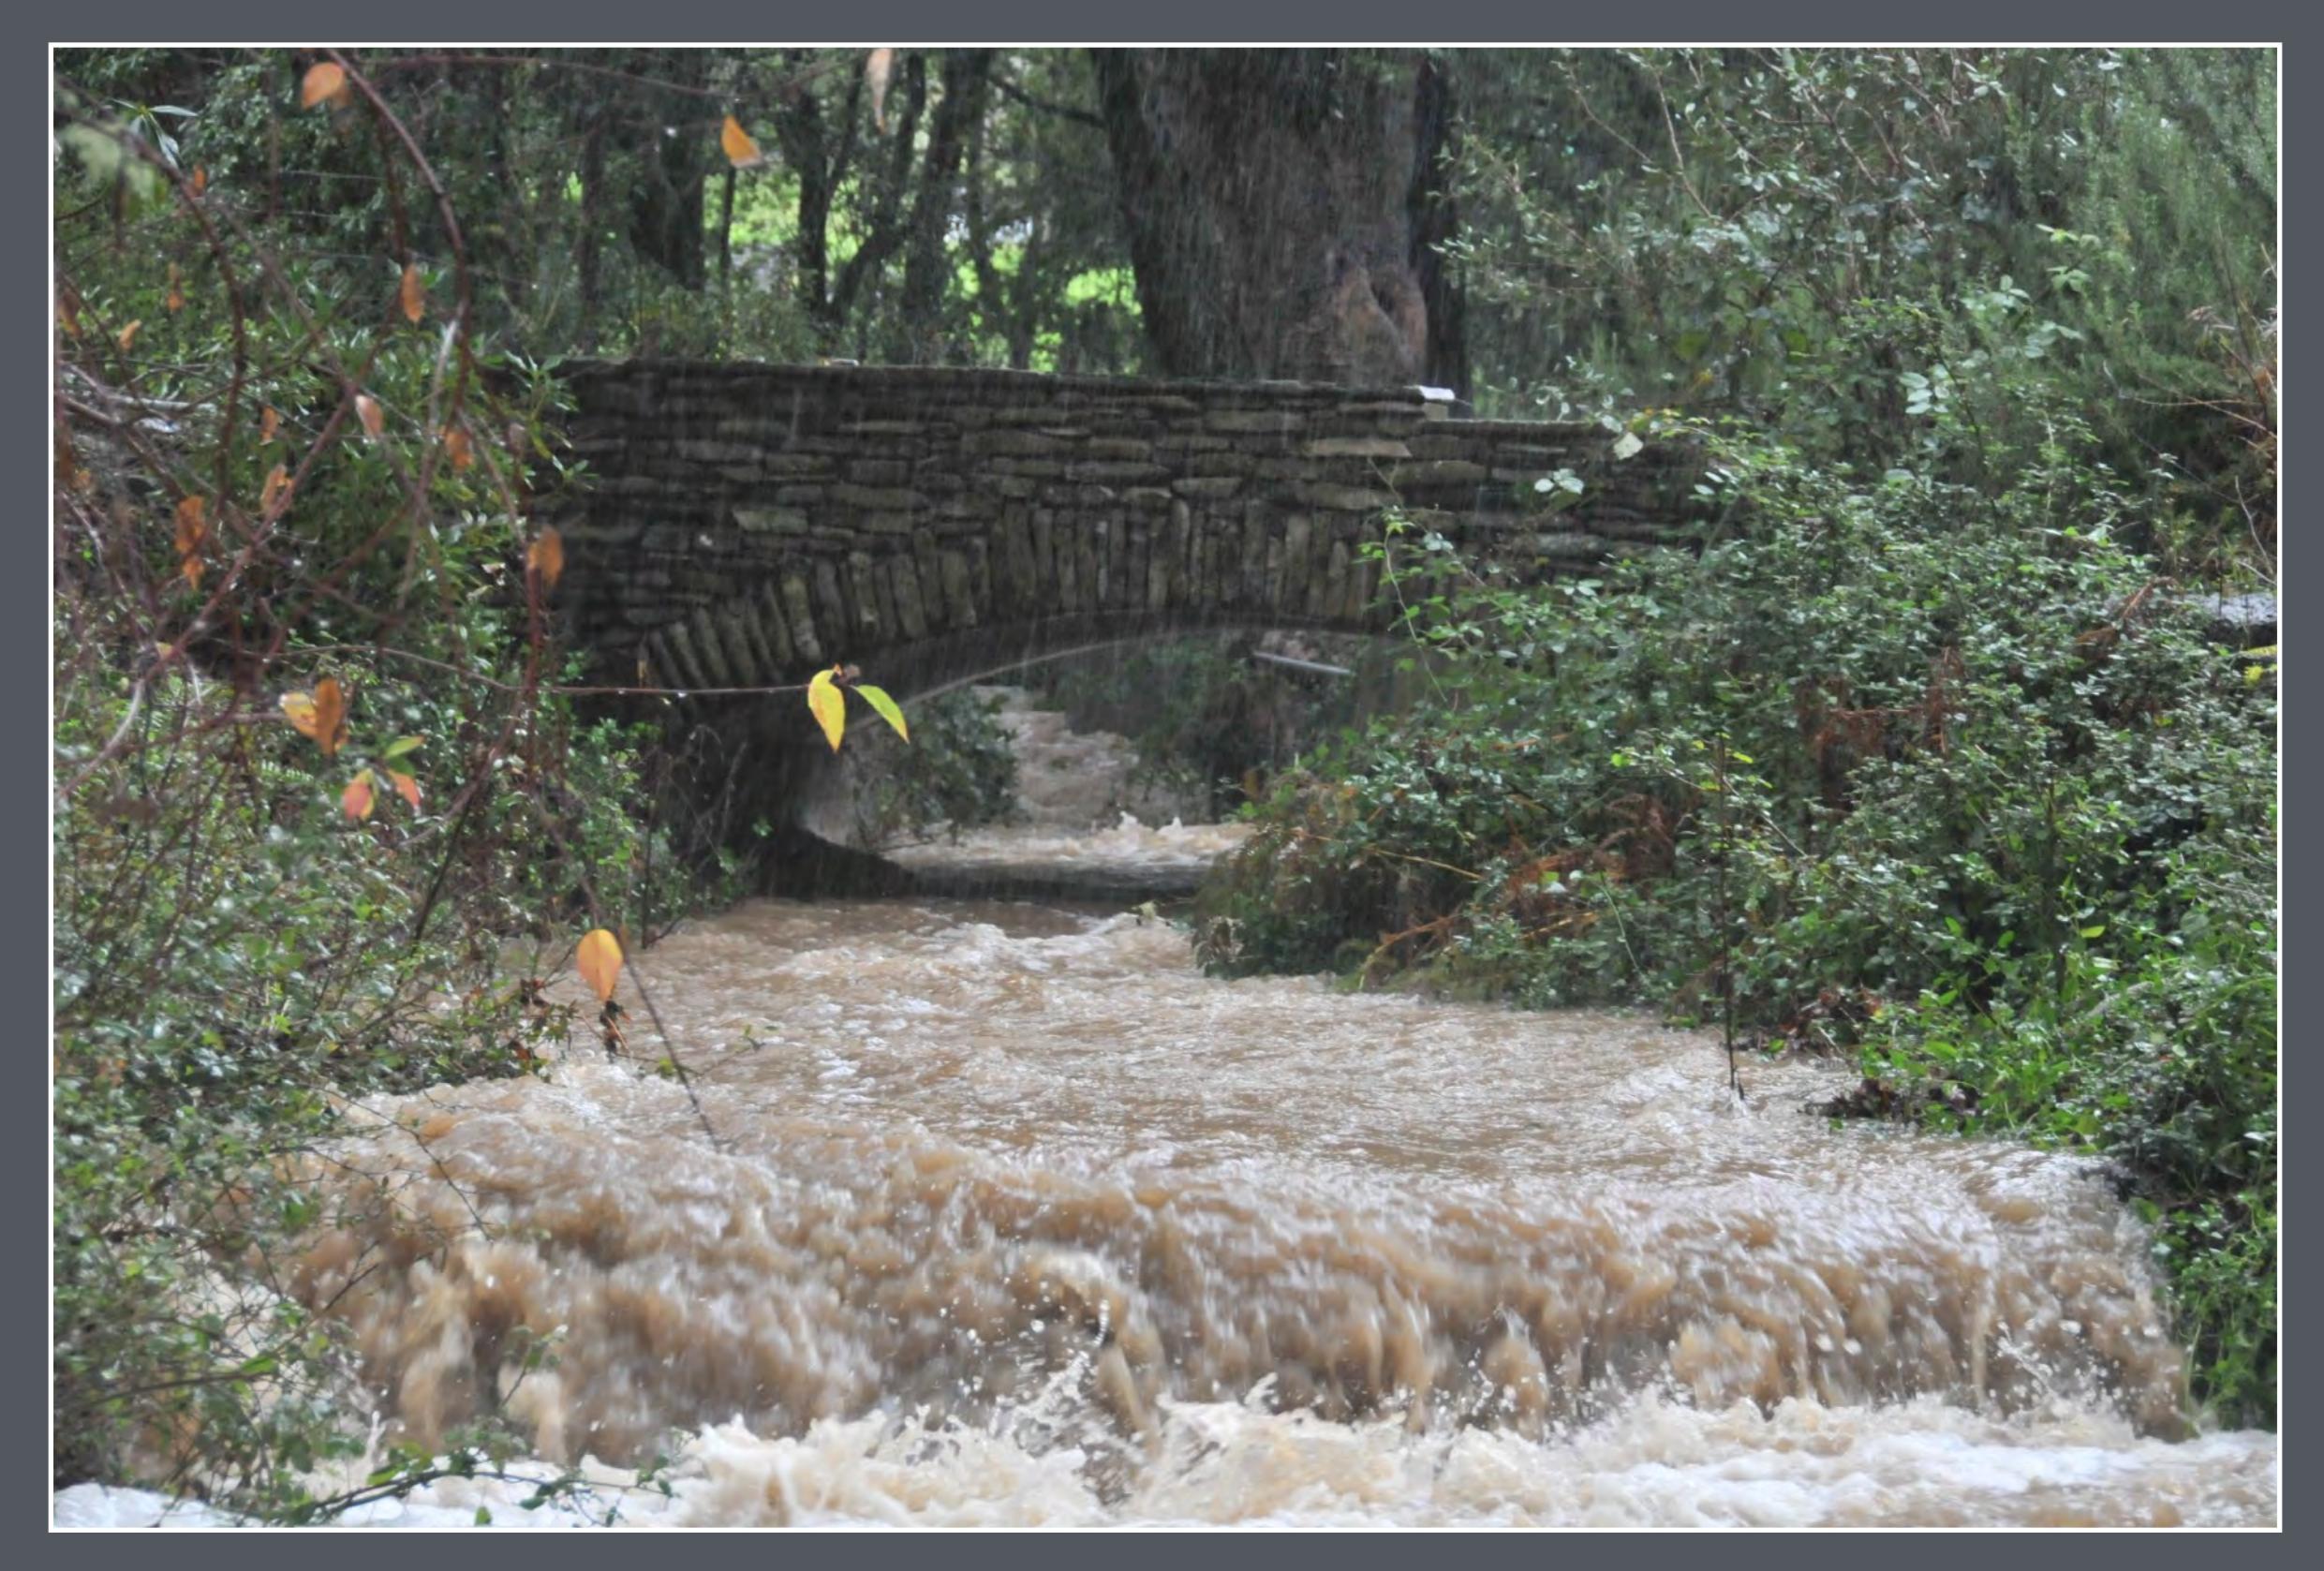
High Water Event in 2012 Typical annual peak event. Overlaid on bridge drawing, freeboard measures 42". State of California California Natural Resources Agency Department of Forestry and Fire Protection
