COMMUNITY DEVELOPMENT AGENCY PLANNING DIVISION

SUBJECT: Appeal of the Tarigo Design Review and Second Unit Draft Initial Study Assessor's Parcel: 168-034-14 21 Barranca Road, Lagunitas

Tarigo/Terrass Residence Planning Commission Presentation October 22, 2018

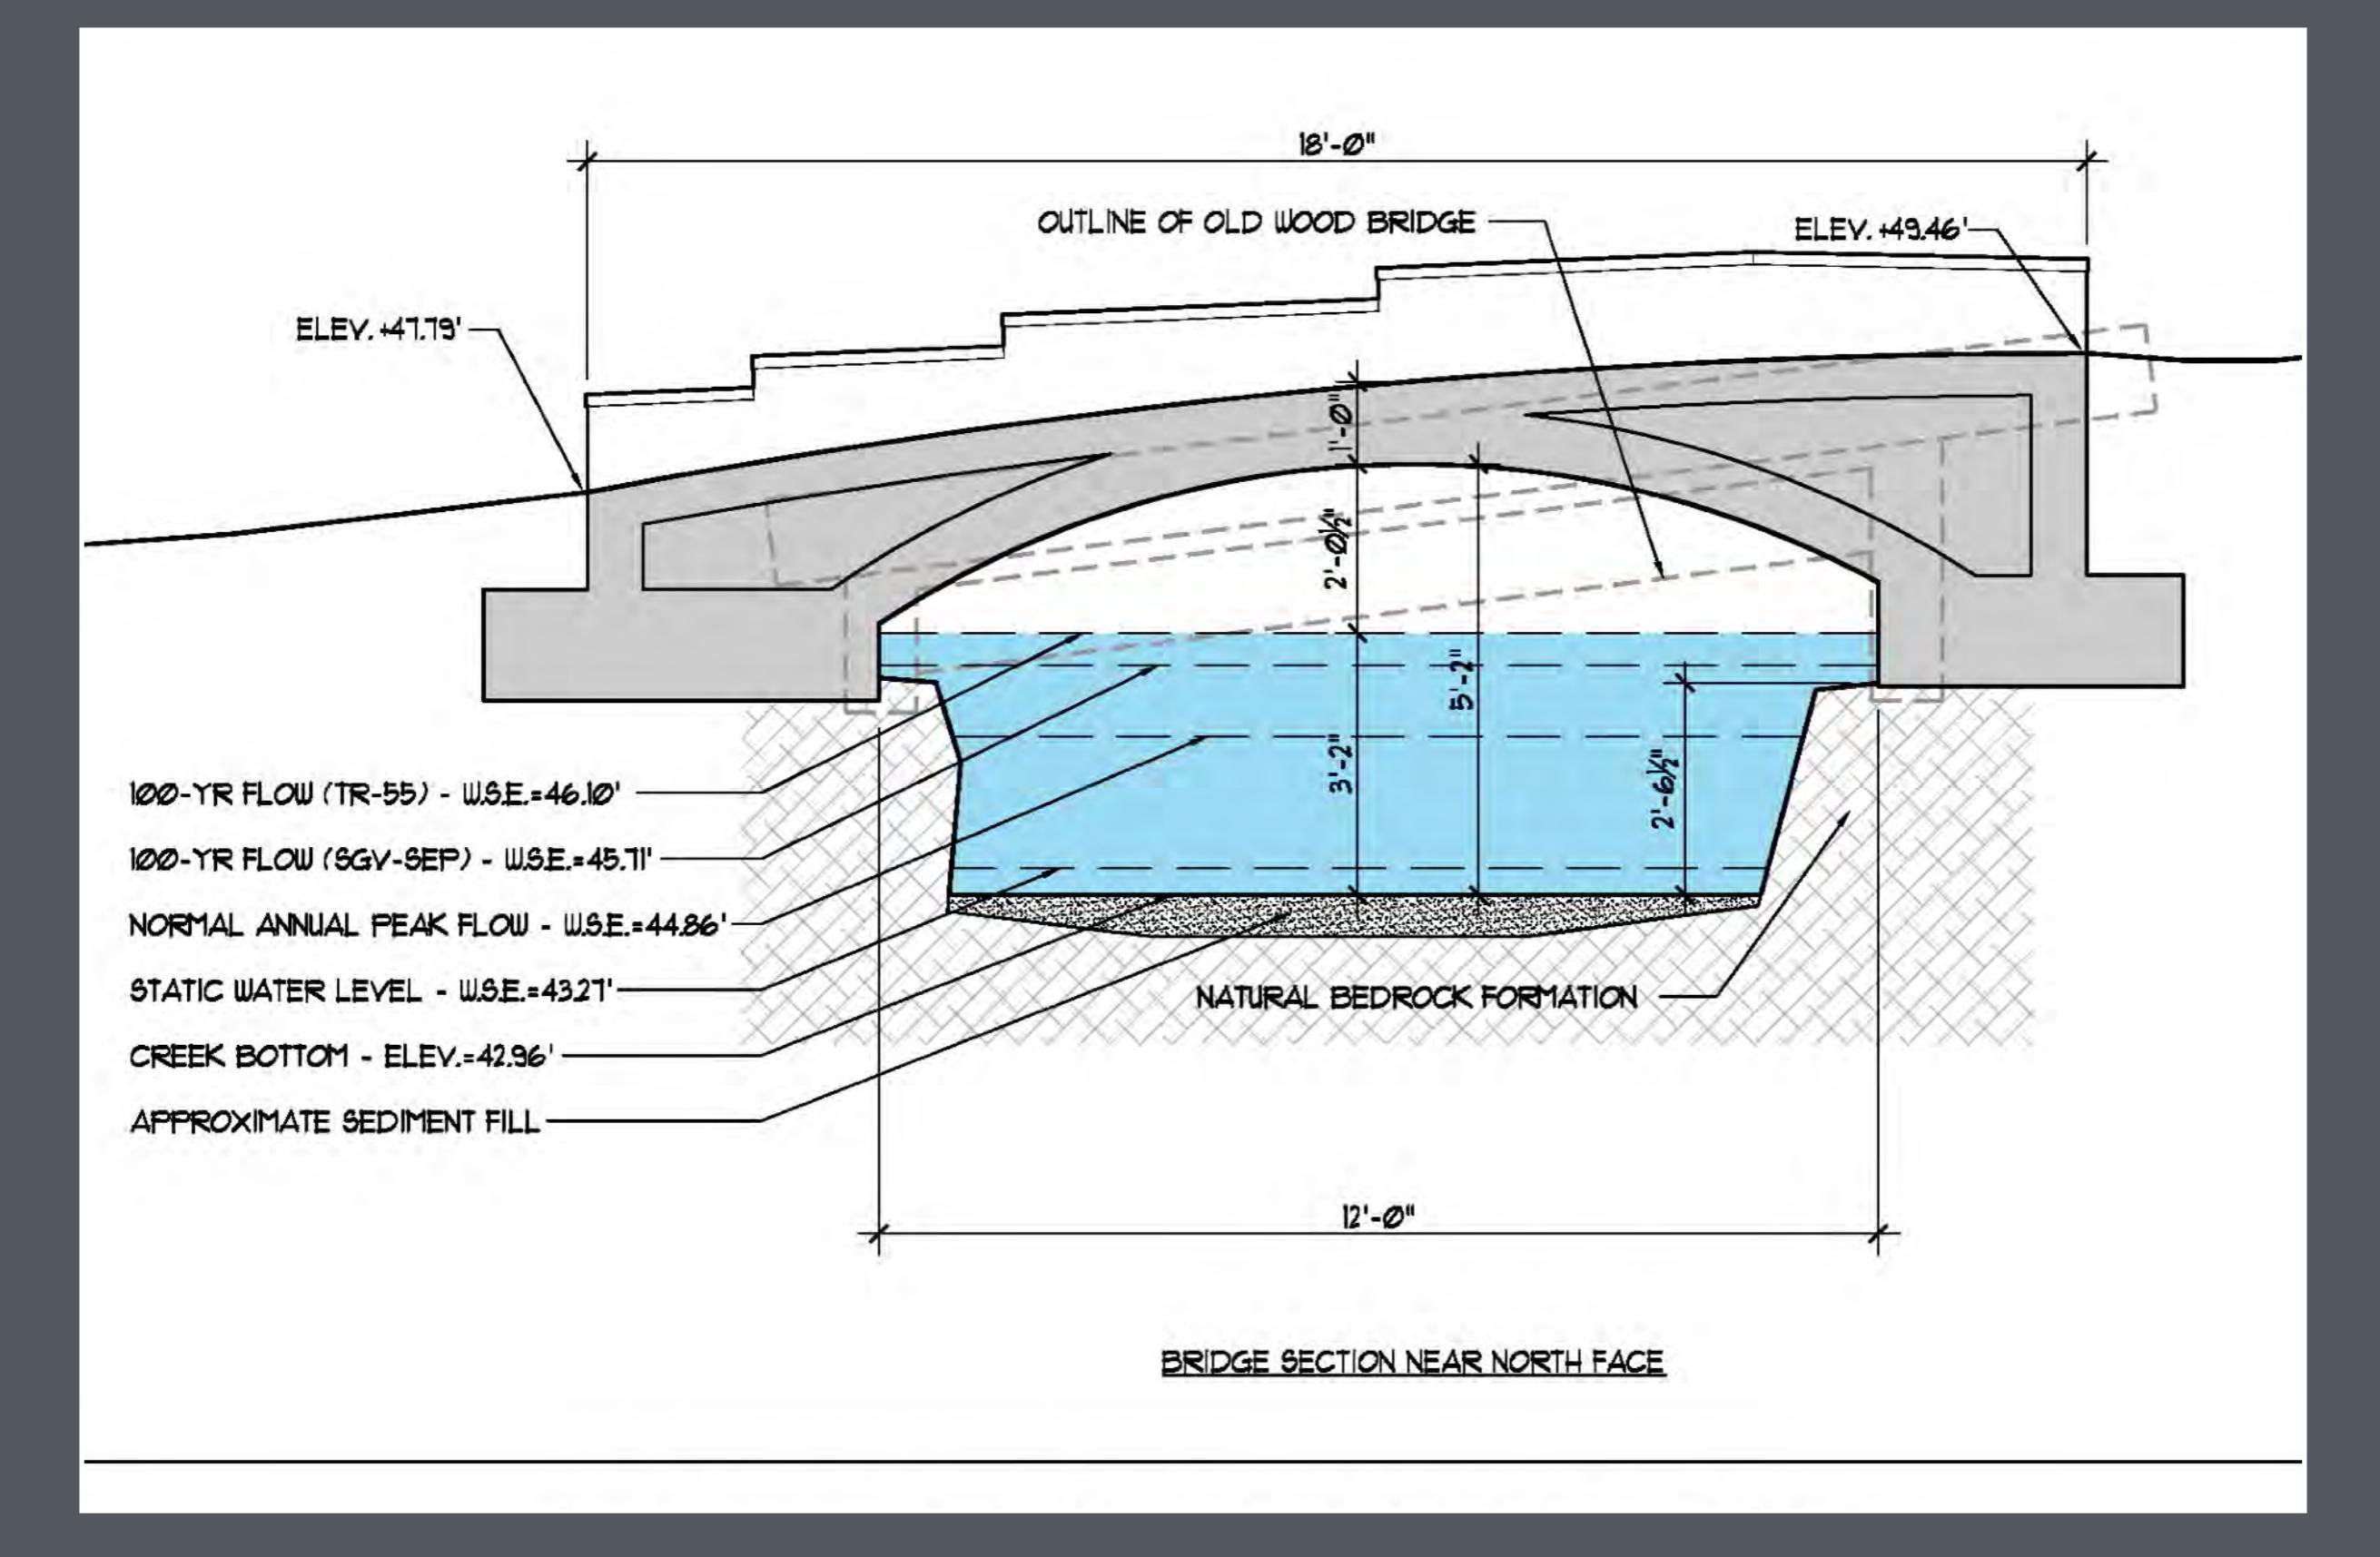
100-yr Flow at Concrete Bridge

Water surface elevation based upon TR-55 and SGC-SEP models by CSW/ST2.

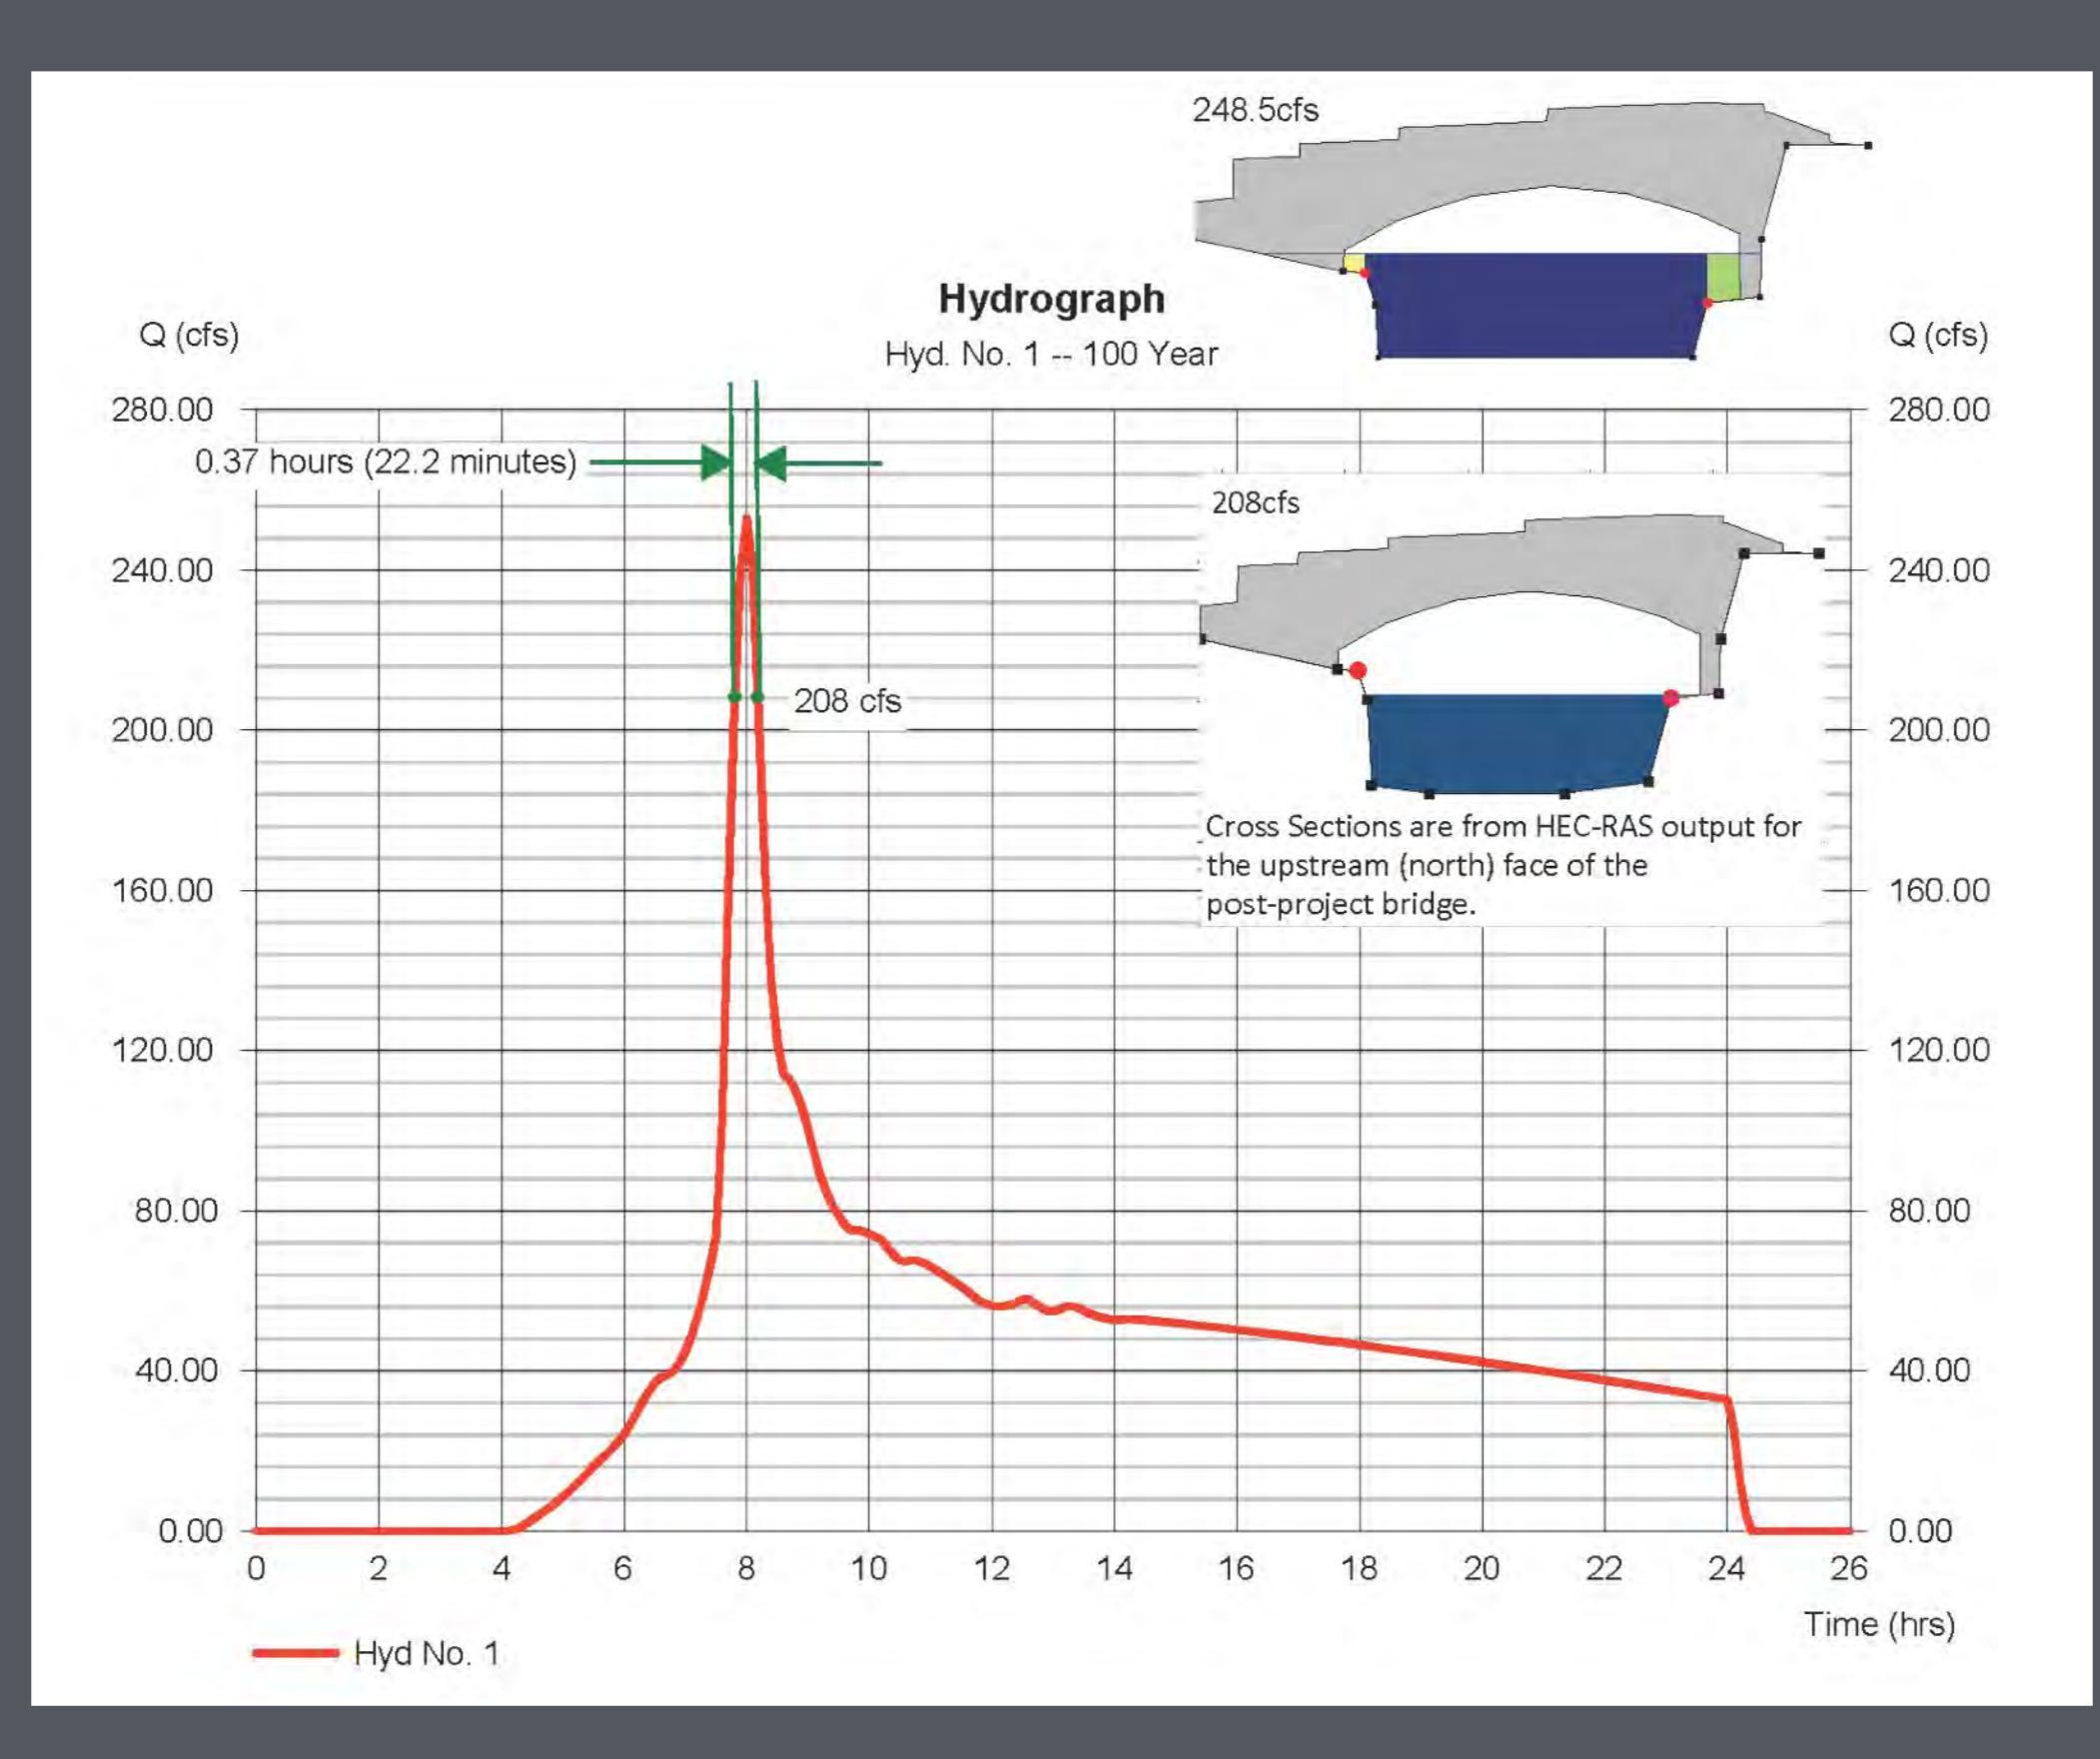
100-yr Hydrograph

Showing time of concentration of the 100-yr event from the TR-55 model.

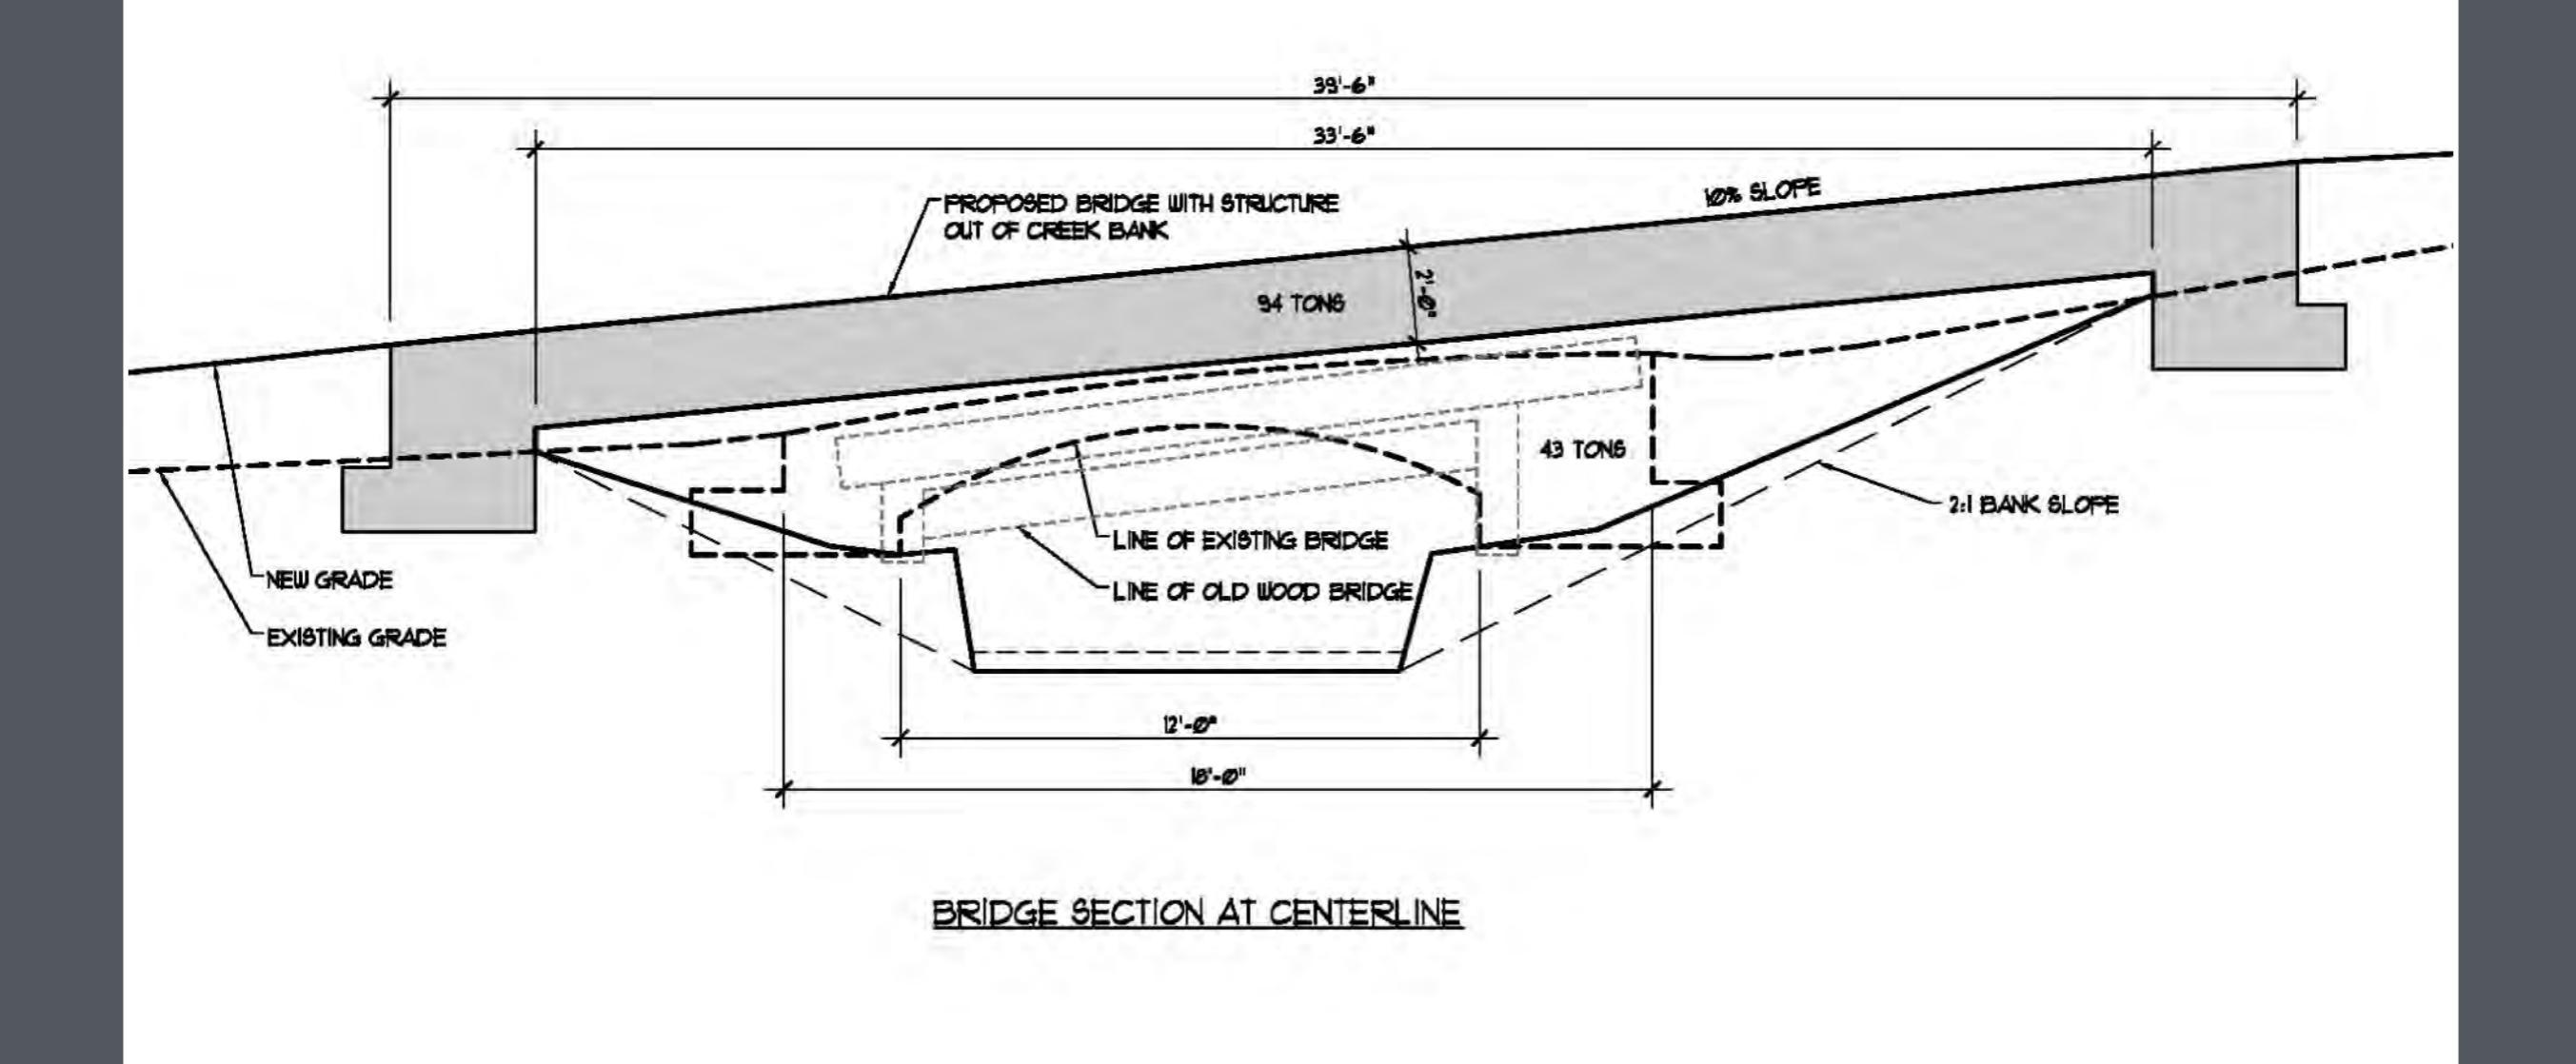
Big Bridge Section

Compares original wood bridge, current concrete bridge, and bridge designed to meet DPW requirements.

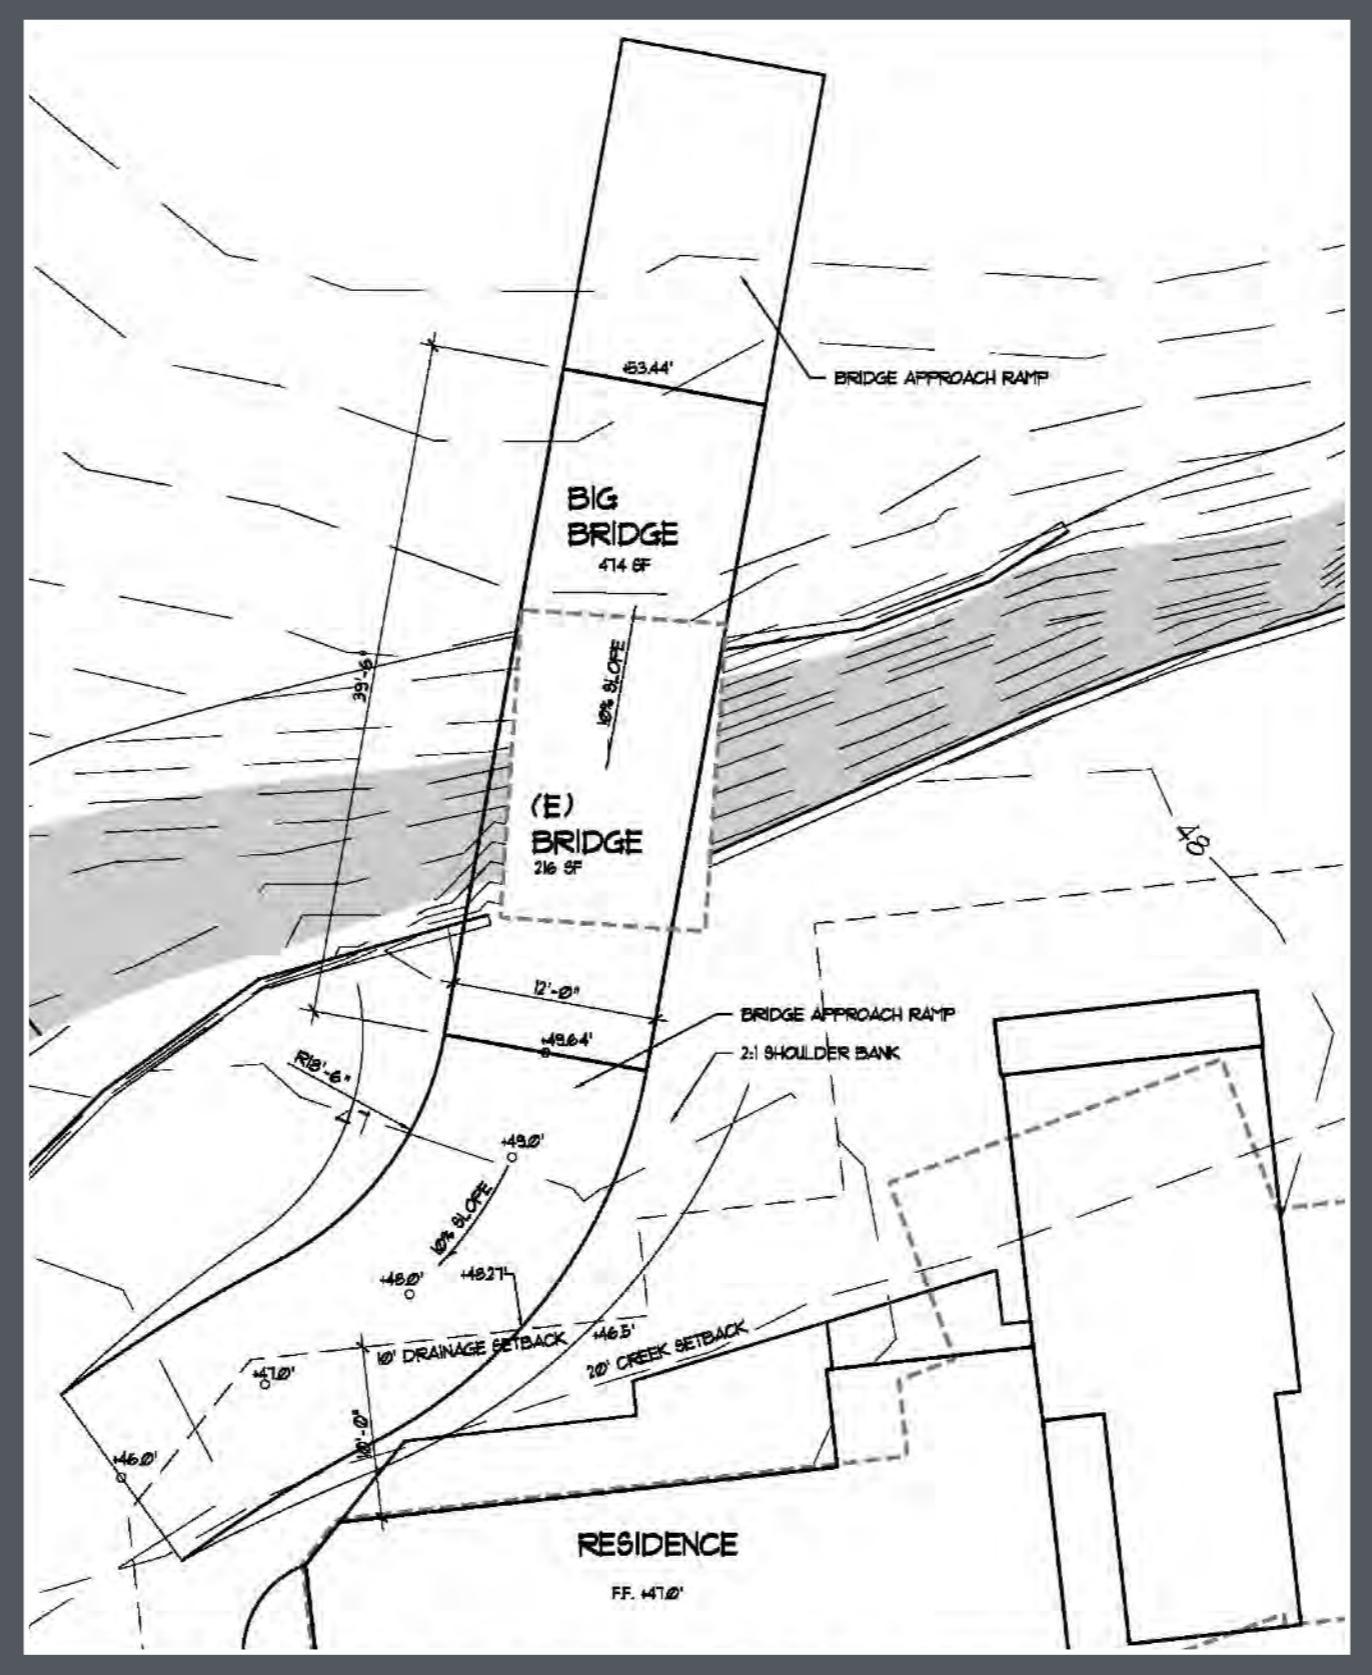
Big Bridge Site Plan

Conflict between ramp and required house drainage - would have to raise house 2ft minimum to meet code.

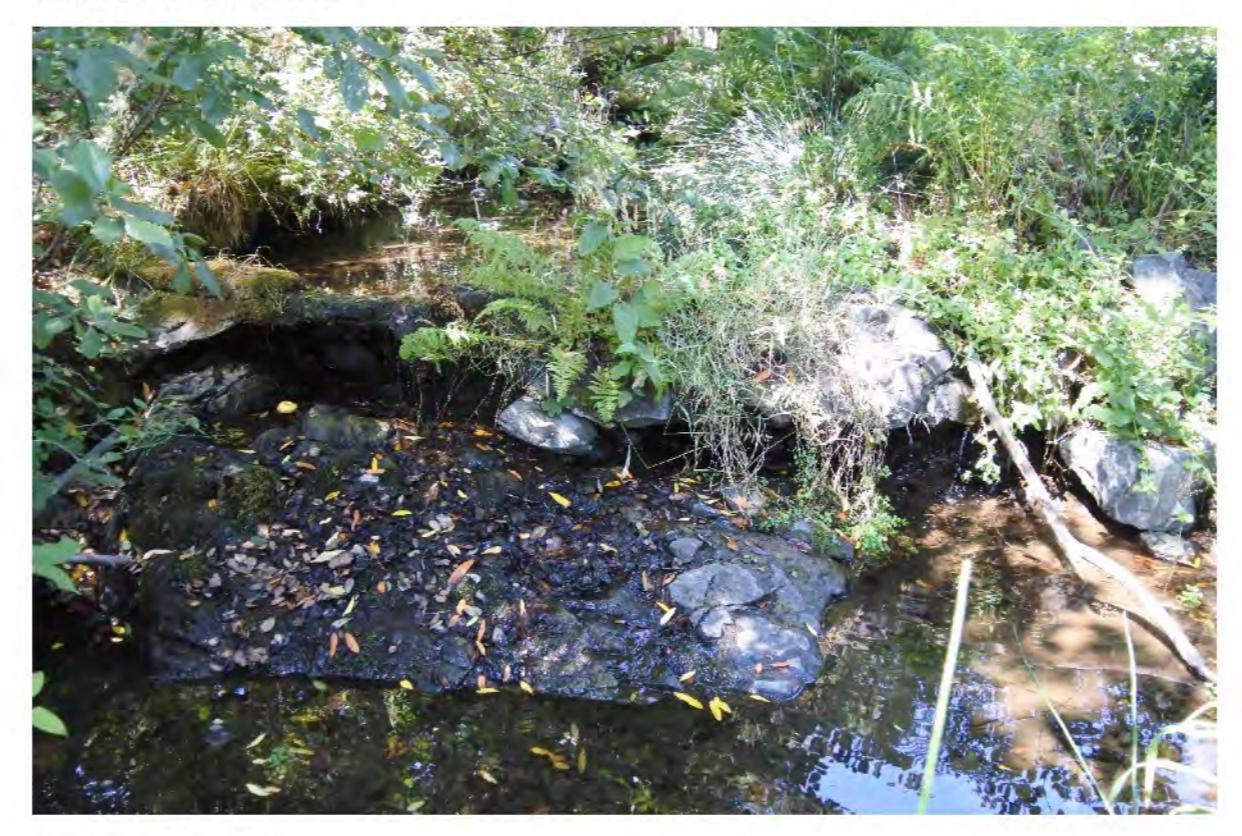
Condition of dam in 2018

The thin layer of cement cover has washed away, causing the underlying stone rubble to erode ever further upstream. The overhang is now as much as 24". Without structural support, collapse is just a matter of time.

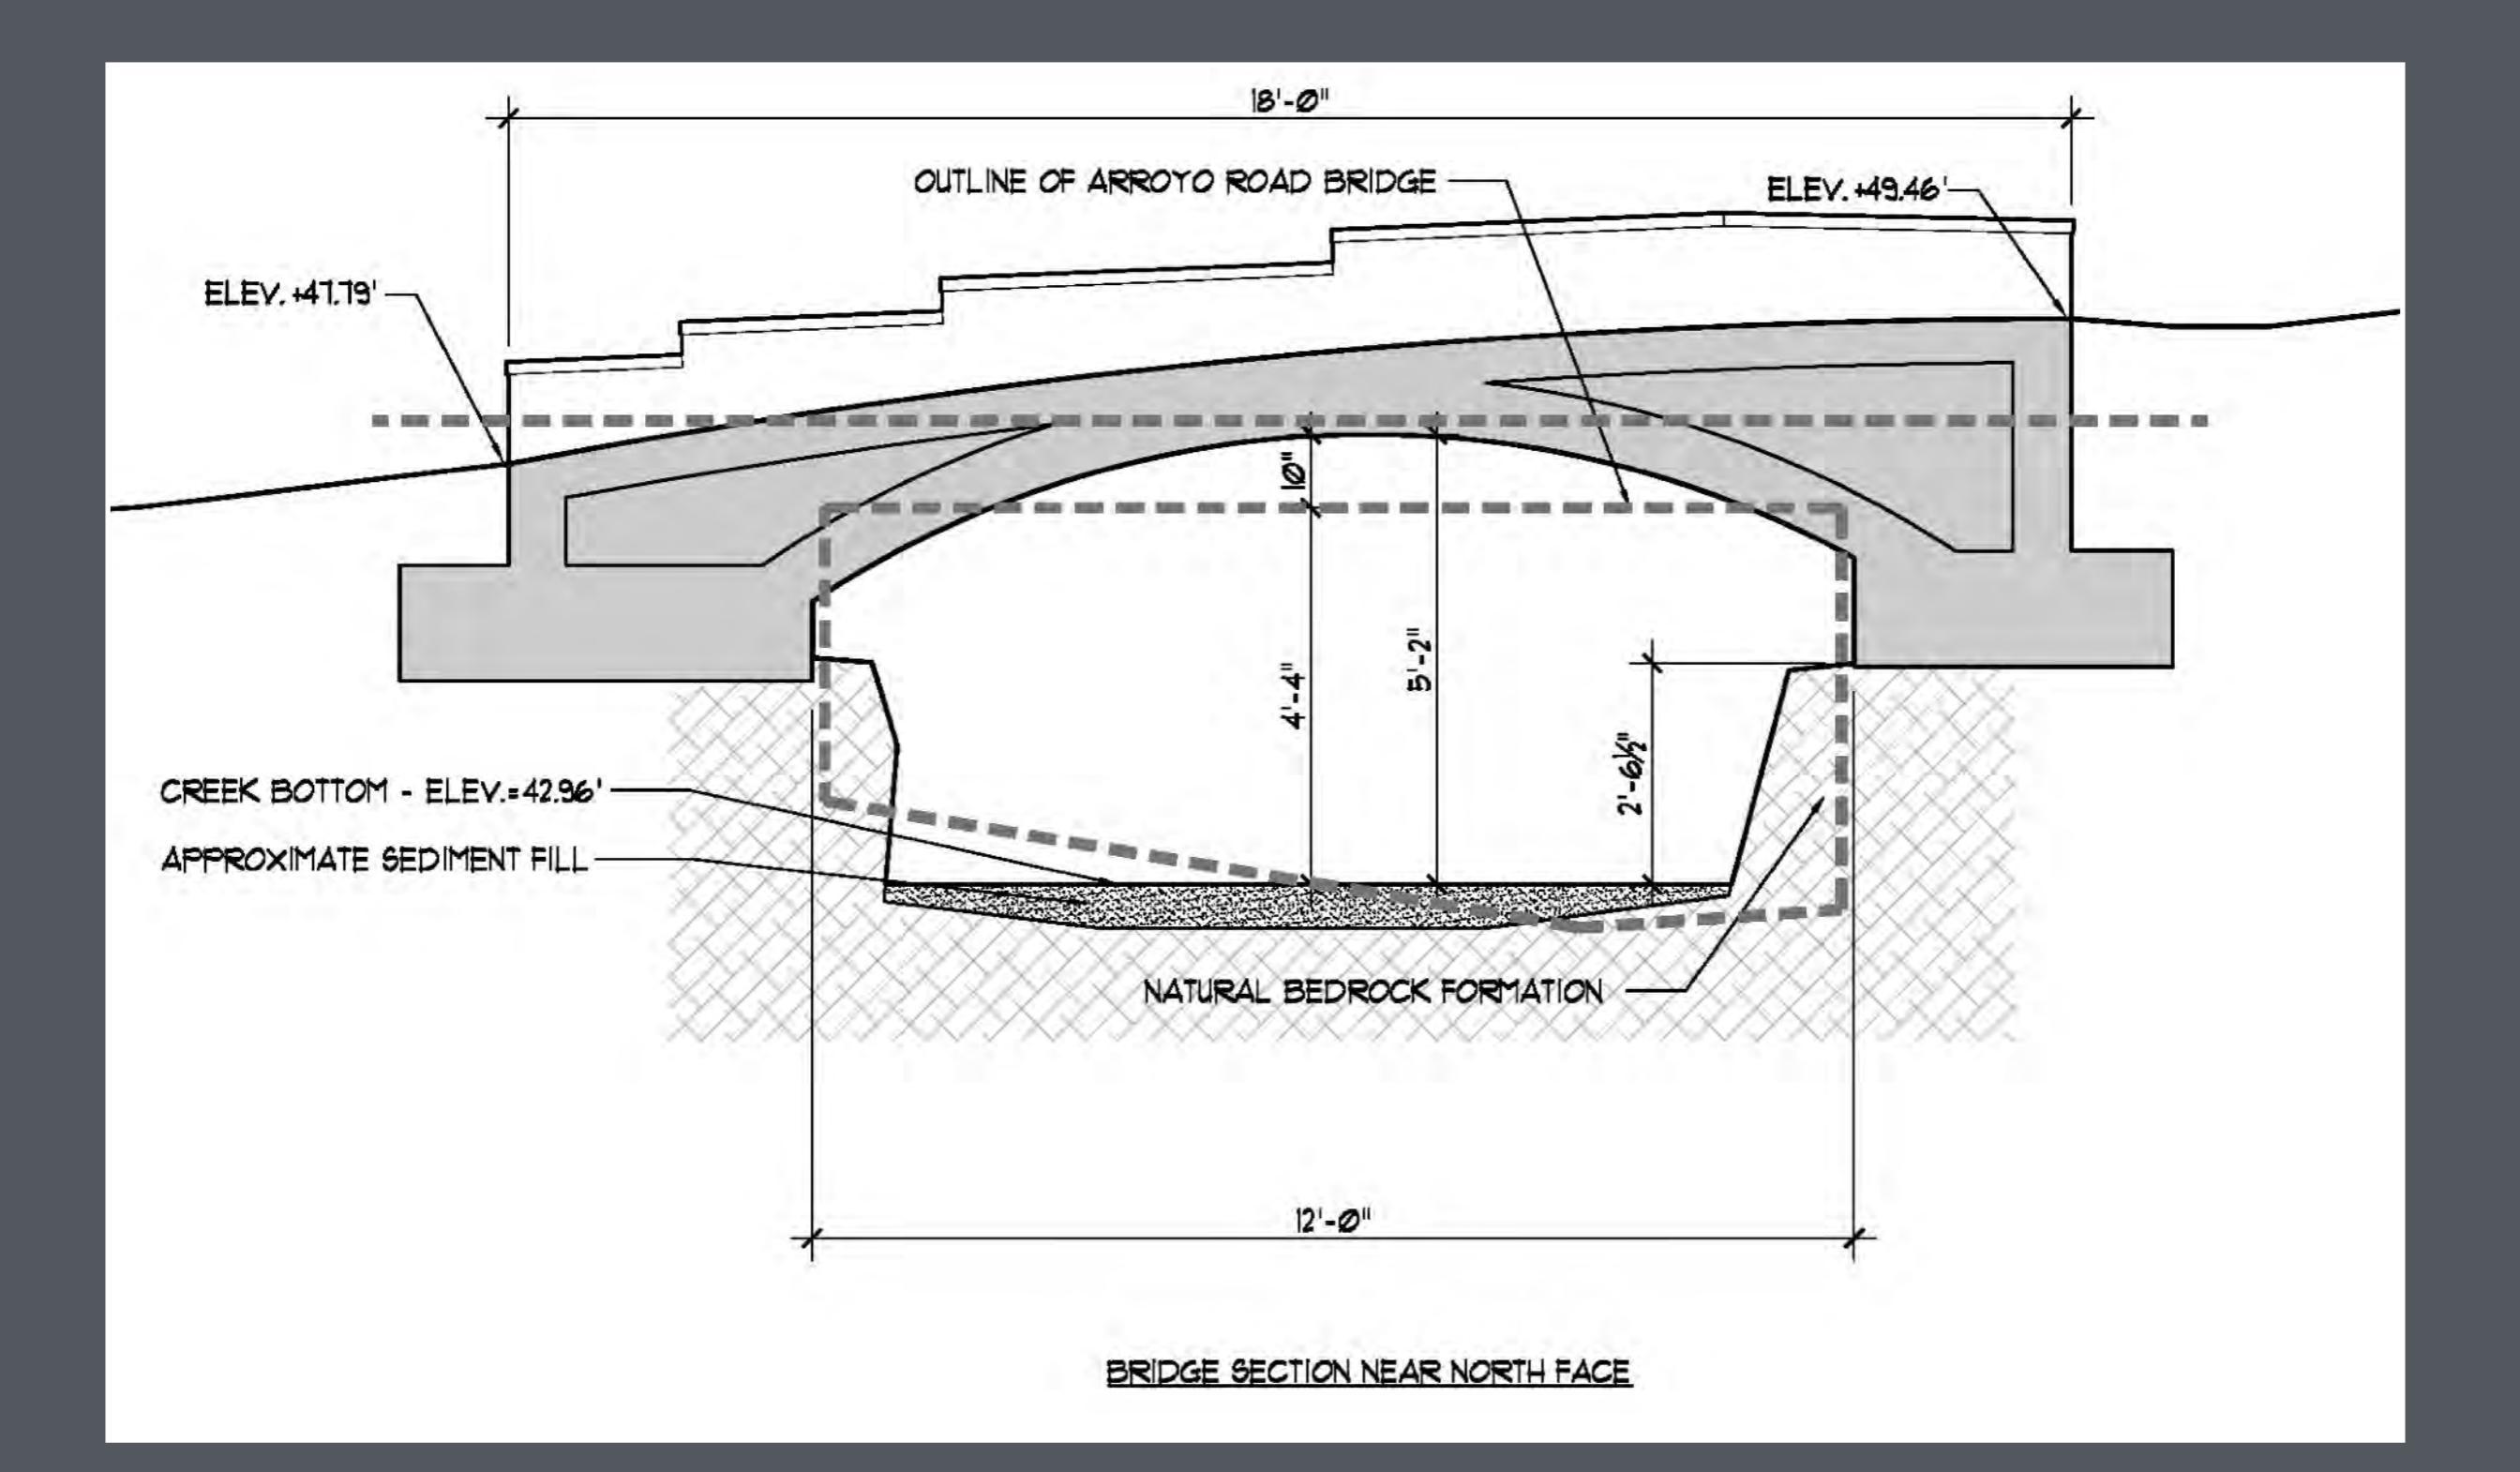
Comparison with Arroyo Road Bridge

Showing cross sectional areas roughly equal. Note that Arroyo Rd bridge must take combined flow of both Barranca Creek and a similarly sized tributary. Barranca Creek bridge has a greater soffit height.

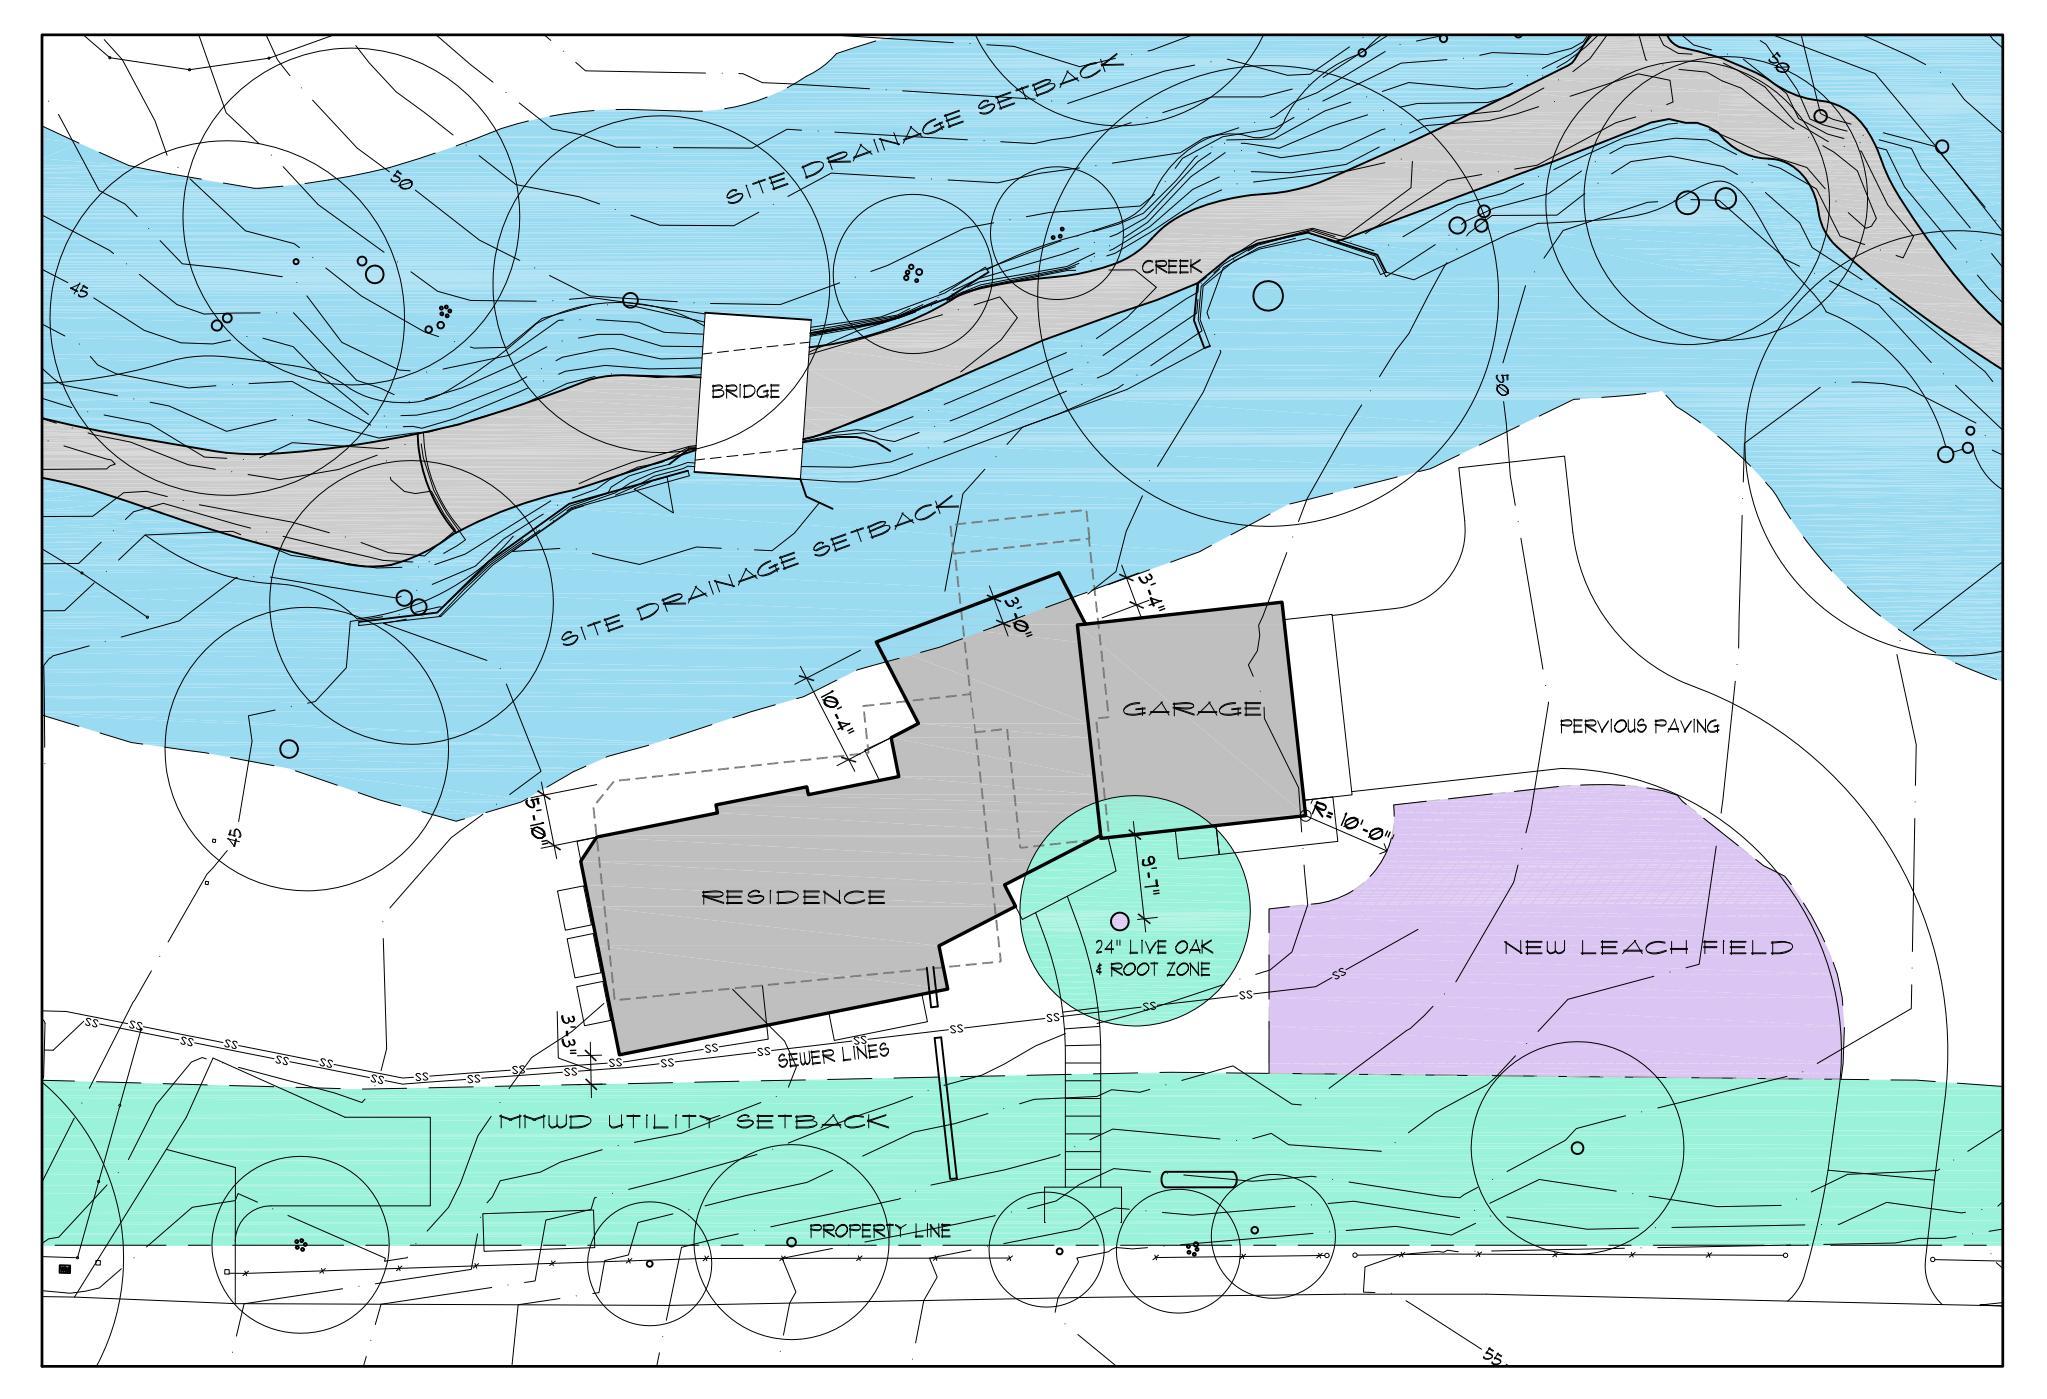
ALTERNATE HOUSE FOOTPRINT SOUTH END ROTATED TO THE EAST 5'-10". DRAINAGE SETBACK ENCROACHMENT REDUCED TO 3'-0".

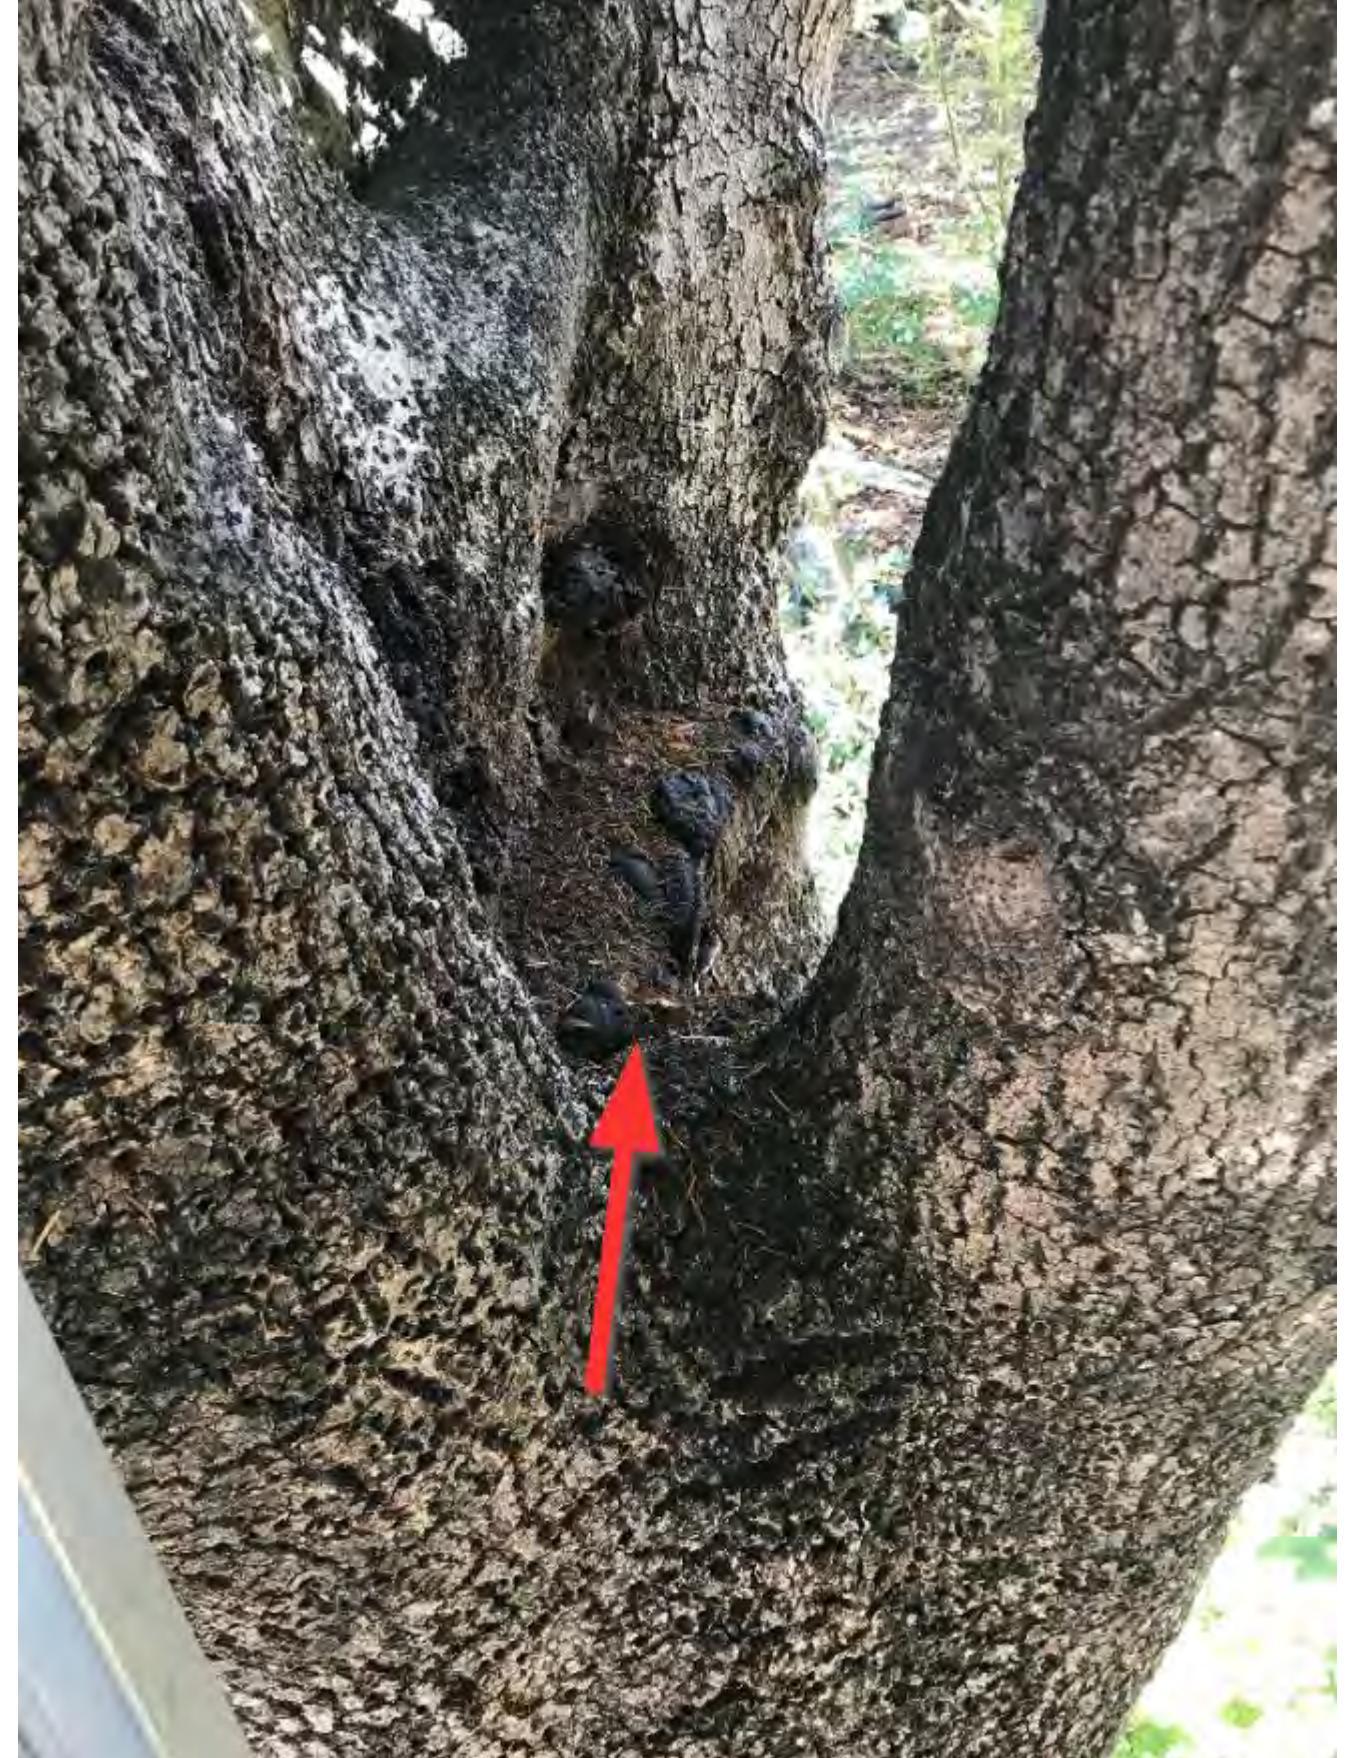
Figure 2. Large decay fungus fruiting body near major limbs. Distinct hollow resonance was produced while sounding this area by hammer.
