COMMUNITY DEVELOPMENT AGENCY PLANNING DIVISION

SUBJECT: Appeal of the Tarigo Design Review and Second Unit Draft Initial Study Assessor's Parcel: 168-034-14 21 Barranca Road, Lagunitas

Tarigo/Terrass Residence Planning Commission Presentation October 22, 2018

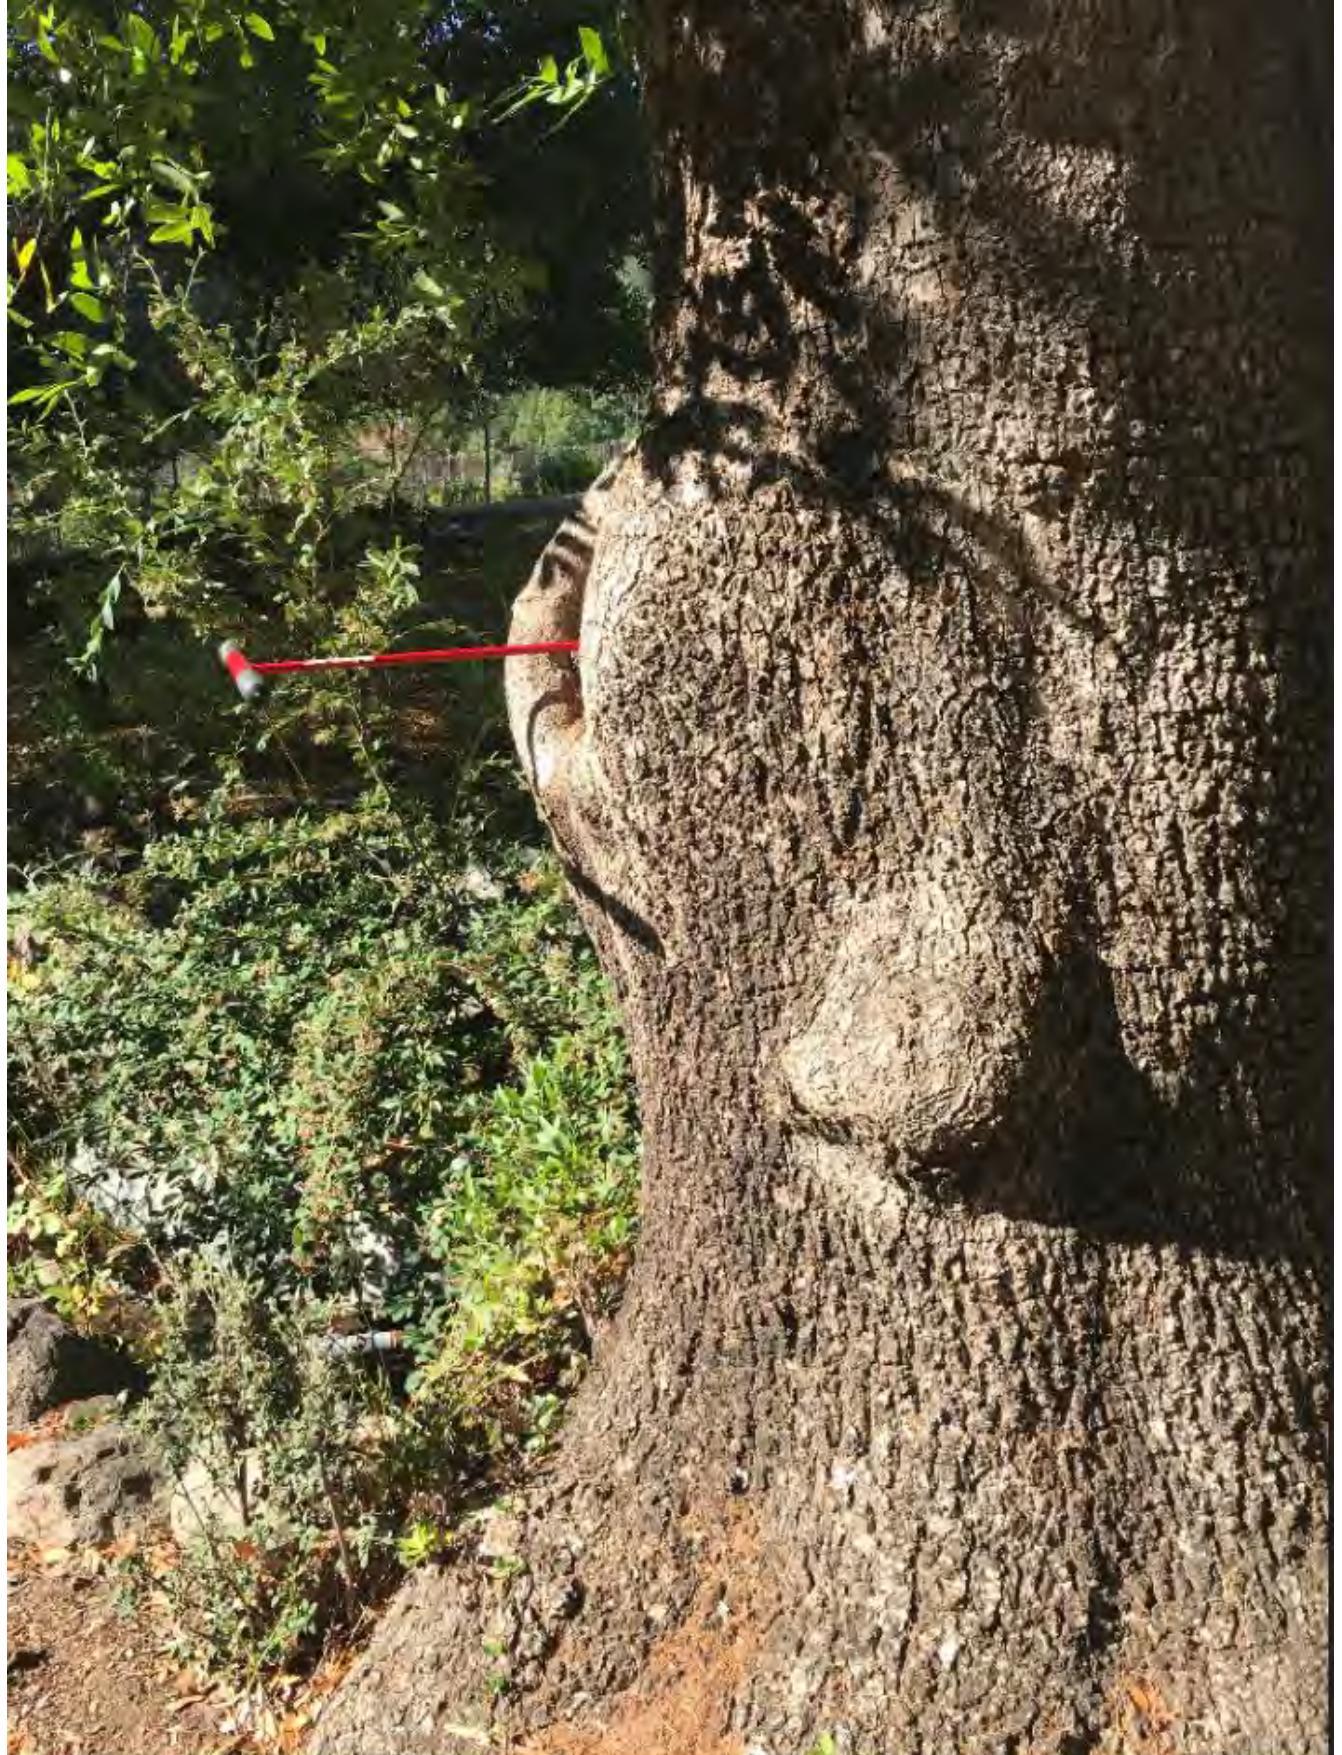
Figure 3. 4-foot long, red metal probe confirming at least 3-foot wide decay column in main trunk.
