# BayWAVE COMMUNITY PROFILES

# SAUSALITO

## Municipality Profile: Sausalito

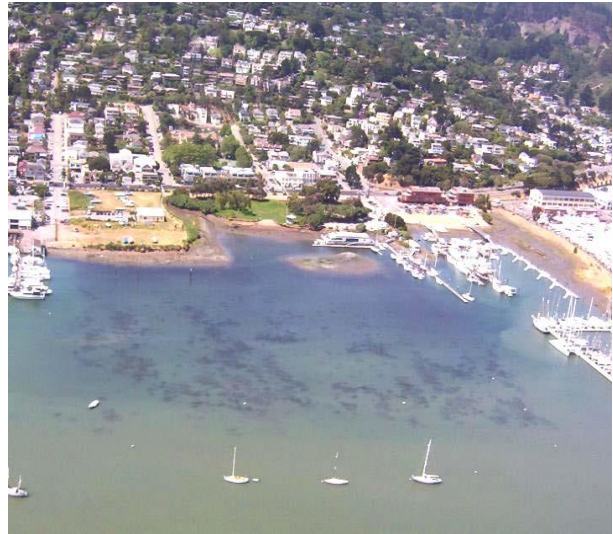
*Eelgrass beds in Sausalito. Credit: Merklen Associates*

A 2008 study found that Richardson's Bay supports extensive beds of eelgrass.<sup>163</sup> Eelgrass was observed in the open water immediately northeast of Dunphy Park and Cass Gidley Marina and within the Richardson Bay Navigation Channel.<sup>164</sup> Eelgrass beds are among the most productive aquatic ecosystems known. Eelgrass beds are recognized by both federal and state agencies as sensitive and essential habitat for Pacific salmon and

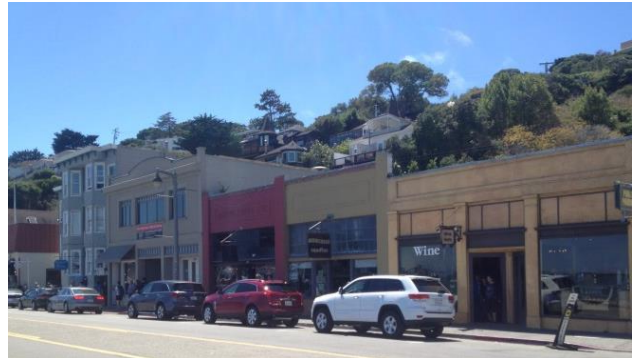
*In the long-term flooding could impact Bridgeway and historic buildings lining its west side. Credit: Marin County CDA*

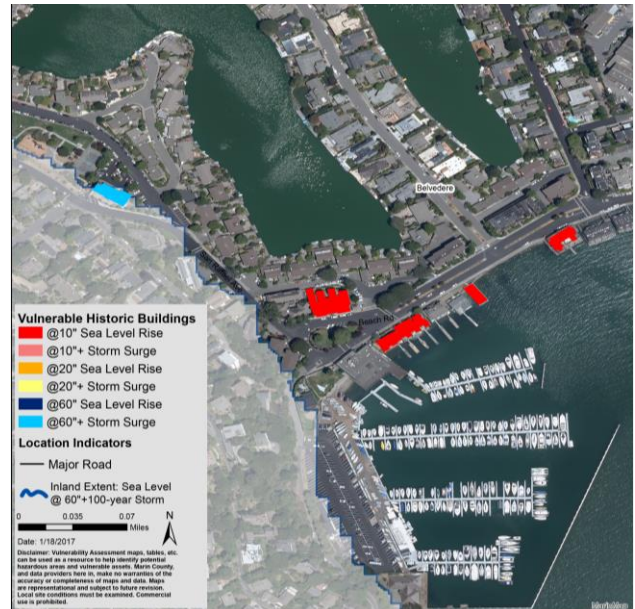
Map 66. Belvedere Vulnerable Cultural Resource Assets

Source: MarinMap, CoSMoS, City of Belvedere General Plan Update. Credit: Marin County CDA

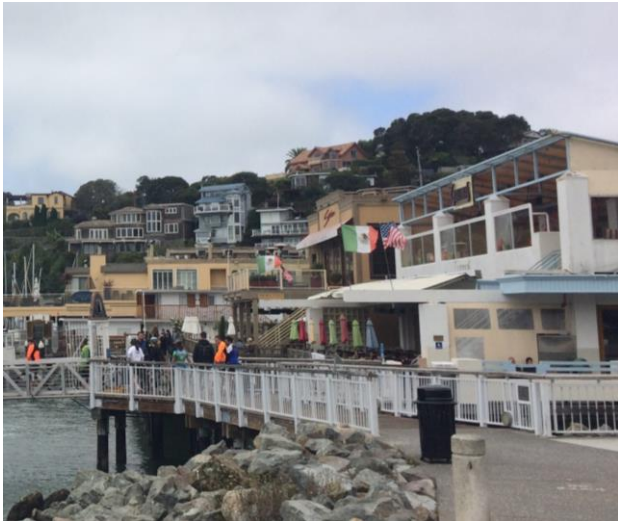
The Tiburon waterfront is vulnerable in the near-term. Source: Marin County CDA.

When taking a closer look at land use, a striking 65 percent of commercial properties could be vulnerable to long-term levels of sea level rise. In this scenario, tidal flooding could extend down Tiburon Boulevard. Additional stormwater from the hillsides would only exacerbate his flooding during storms. Reductions in service or loss due to building or inventory damage could have significant economic and employment repercussions for Tiburon. In earlier scenarios, roughly ten percent of commercial parcels could face tidal flooding at MHHW. While less than three percent of residential parcels in Tiburon could face tidal flooding, several downtown commercial buildings likely feature second story apartments.

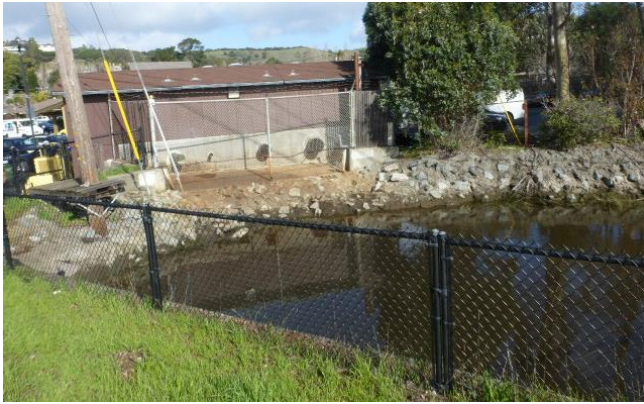
Pump station and overflow pond at the Cove Shopping Center.  
Credit: Marin County DPW
