**Subject: Section 106 review for Emergency Sidewalk Maintenance**

## Finding of Effect Memorandum

Adrian Chorley, MHA	Mike Cutchin, MHA
<b>Date:</b>	December 23, 2022	
<b>Re:</b>	<b>Emergency Sidewalk Maintenance</b>

**Historic Property:** Golden Gate Village  
**Project Name:** Emergency Sidewalk Maintenance  
**Street Address:** 101-429 Drake Avenue & 1-99 Cole Drive  
**Project Applicant:** Marin Housing Authority; County of Marin  
**Lead Agency:** County of Marin, on behalf of the Department of Housing and Urban Development  
**Contact:** Michael Cutchin, Marin Housing Authority

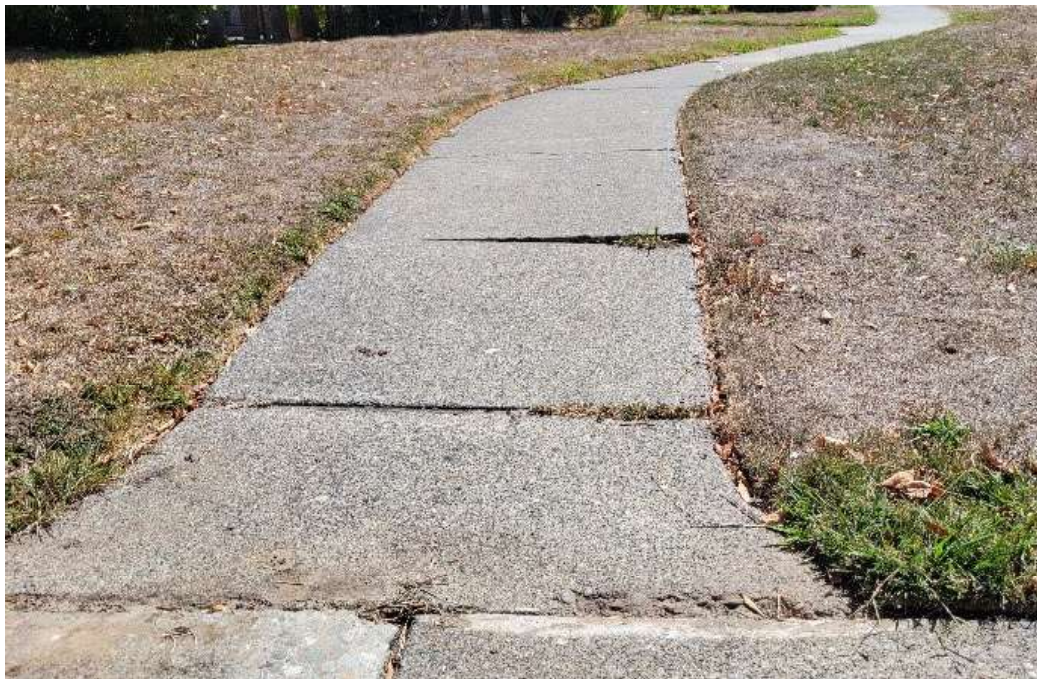
**Figure 1. Representative example of sidewalk trip hazards found across the property.** Source: MHA, 2022.

In a phased effort, MHA will develop a maintenance plan that will cover concrete sidewalks throughout Golden Gate Village that adheres to the SOIS for the Treatment of Historic Properties and would inform MHA’s future sidewalk maintenance activities. As a stop-gap measure, MHA proposes identifying and spot-fixing areas that constitute an imminent threat to human safety, defined as areas where concrete sidewalk pads exceed .50 inches in variable elevation from adjacent concrete pads. To date, MHA and its contractors have identified approximately 100 areas around the district that meet or exceed this threshold and represent a current trip hazard (Figure 1). This emergency maintenance would utilize surface “grinding” of concrete pads to level out the elevations and minimize trip hazards. At areas where concrete pads would need to be elevated, MHA contractors would use foam blocks.

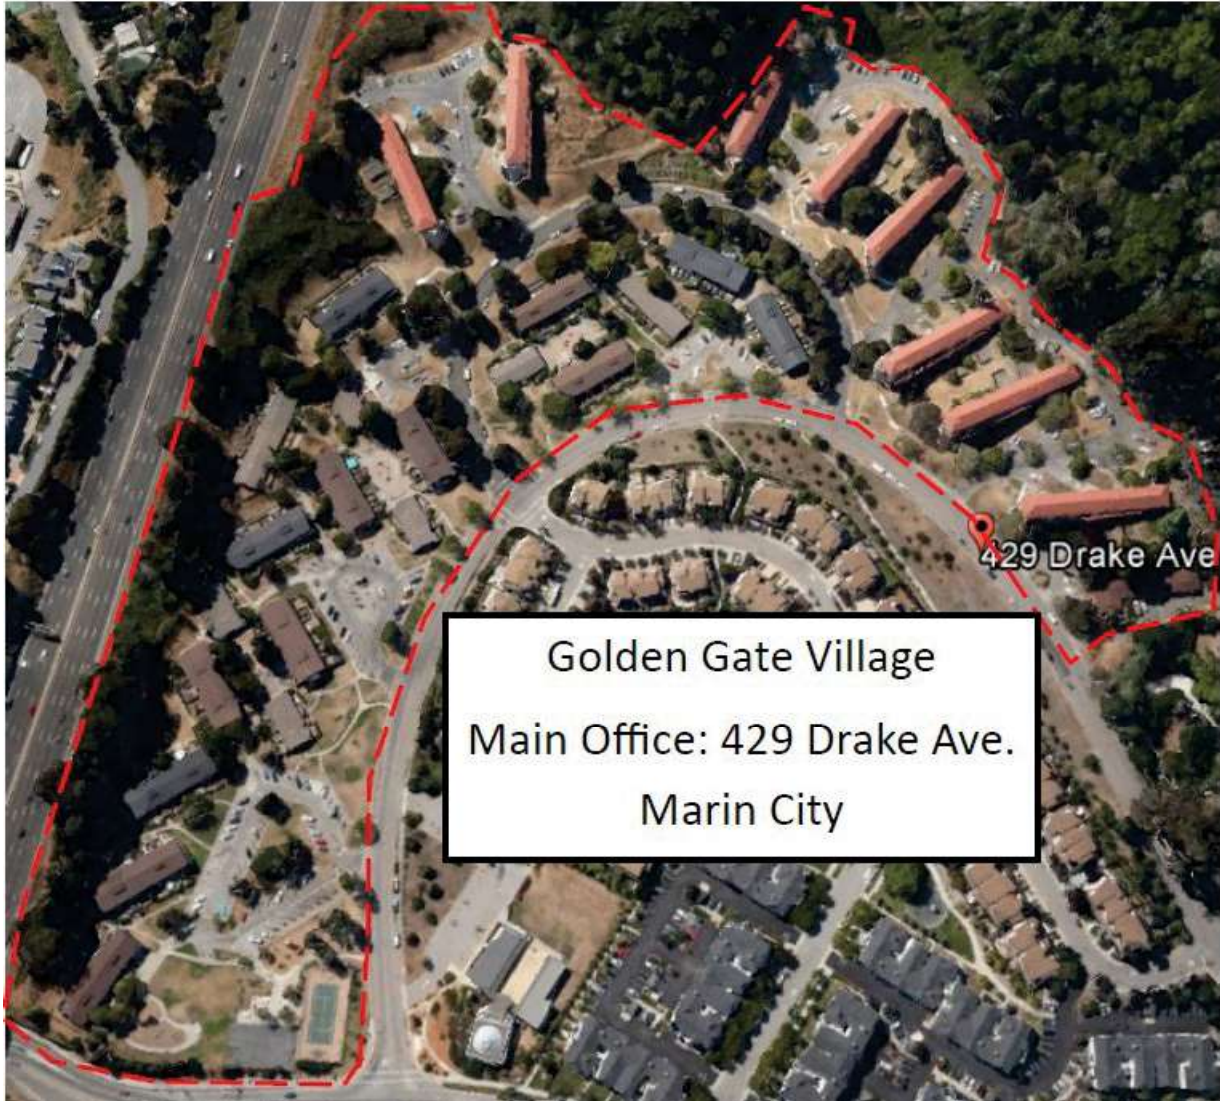
ATTACHMENT A

Repair sidewalks to address unsafe conditions as needed on the property. Work will be site wide and proceed as soon as possible with highest priority given to the most unsafe conditions. Residents will be notified in advance of work at their units. Equipment needed is TBD but may include jackhammers, air compressors, backhoes, concrete trucks, dump trucks and others.

emergency sidewalk maintenance at specific points of the district's sidewalk network that pose an imminent threat to the residents' health and safety (Attachment A). In a future phase of work, MHA will develop a maintenance plan that will cover concrete sidewalks throughout Golden Gate Village that adheres to the Secretary of the Interior Standards (SOIS) for the Treatment of Historic Properties and streamlines future maintenance of concrete sidewalks to best ensure the health and safety of residents. Currently, as an interim measure to address immediate trip hazards, MHA proposes conducting focused emergency maintenance to GGV's concrete sidewalks that pose an imminent threat to the residents' health and safety. For the purposes of this emergency undertaking, MHA has defined "imminent threat to residents' health and safety" as those areas of concrete sidewalk exhibiting a variance of 0.5 inches in elevation difference in concrete surfaces. MHA proposes using the leveling technique of "grinding" the raised concrete surfaces to be level with adjacent concrete pads and thus no longer an imminent trip hazard. MHA proposes use of foam blocks to elevate the concrete surfaces being treated in a controlled manner, where necessary.
