BELVEDERE

Community Profile: Belvedere

Map 63. Belvedere Sea Level Rise and 100-year Storm Surge Scenarios

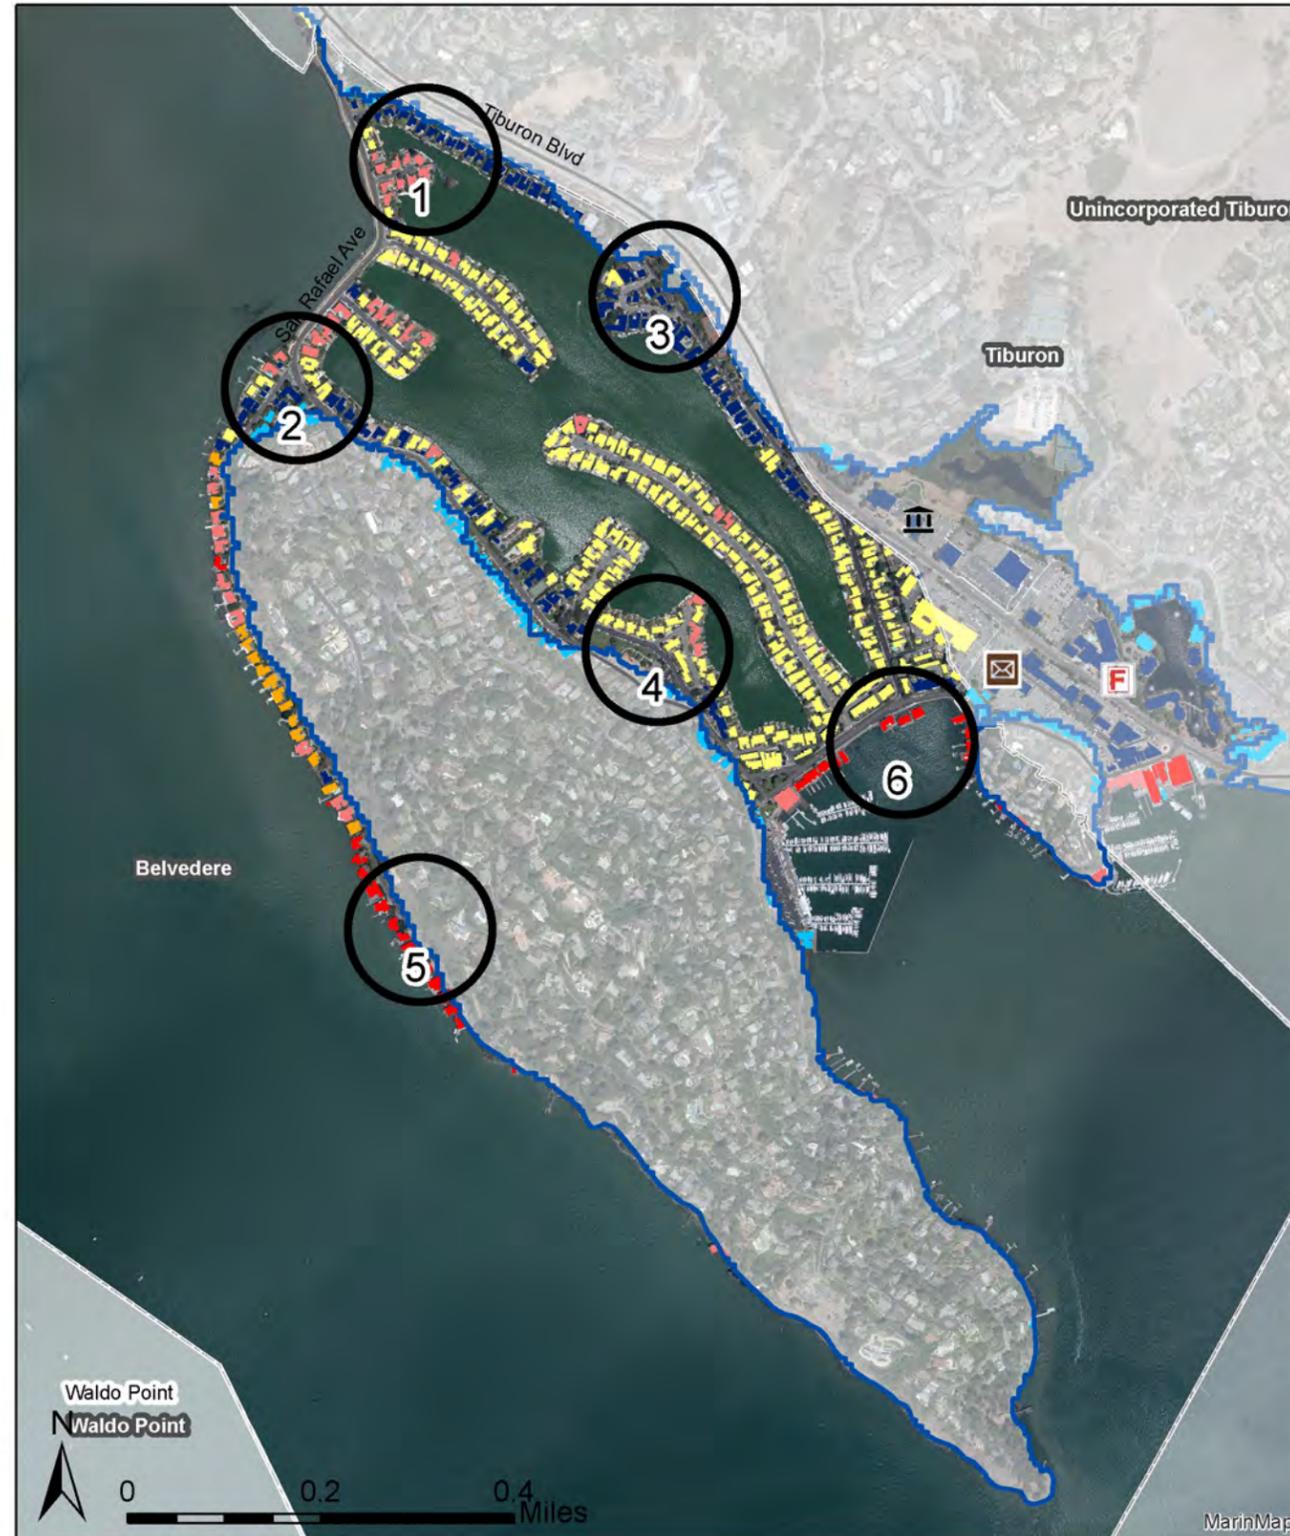
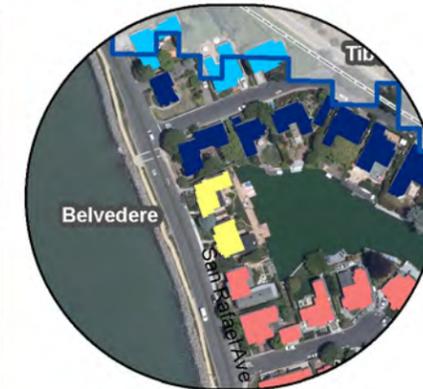
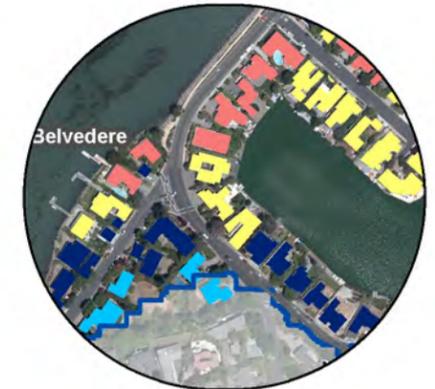
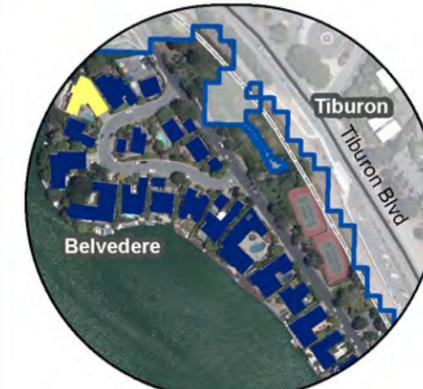
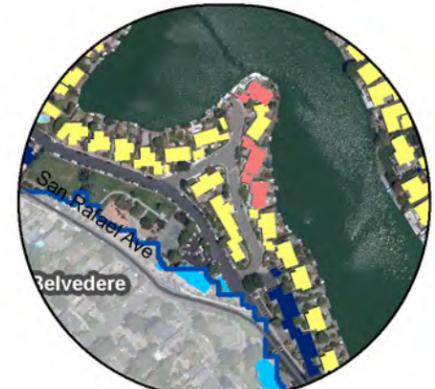
Map 64. Belvedere Vulnerable Buildings

The most vulnerable buildings are in the flats, or lagoon area, and those directly above the bay on the bluff edge on West Shore Road and Beach Road. Some may extend over the water on piers or feature overhanging decks. According to Belvedere managers, some of these homes have vents and other utility lines under the homes that could be vulnerable to increased saltwater exposure. In the low-lying areas, homes in the area could be vulnerable in the medium to long-term time horizon if the levees are overtopped and the lagoon is left under tidal influence. Even if the lagoon is managed well enough to keep those homes bordering it dry, these homes may become isolated if tidewaters overtop the levees lining San Rafael Avenue and Beach Road, or Tiburon's downtown streets. Looking at the CoSMoS model interactive map, the levees surrounding the lagoon area are topped at 3 feet of sea level rise, though significant impacts could occur between scenarios 3 and 5. In the lagoon area, many of the original homes were, or are being, replaced with newer construction.

In addition, the city corporation yard is vulnerable in the medium-term to low levels of flooding and over one foot of flooding at MHHW in the long-term. The remaining community center, police department, and city hall, which share a building, could expect impacts during storms to the surrounding property, face access issues in the medium-term, and flood with up to four feet of tide waters by scenario 5.

As seen in Table 70, in the near-term, 32 buildings could be compromised. The number of buildings impacted by 20 inches of sea level rise doubles, and nearly three times as many are impacted by the 100-year storm surge in scenarios 2 and 4. In the long-term, from sea level rise alone, around 400 buildings could be vulnerable to sea level rise.²⁰ Table 71 divides the vulnerable buildings by flood depth in one-foot intervals, showing how many buildings could flood with one, two, or ten feet of salt water at MHHW. A 100-year storm surge would add 1 to 3 feet of water.

If sea level rise occurs at these levels much a Belvedere's lagoon area could be lost to sea. This would also present major complications for those who travel through the lagoon neighborhood on San Rafael Avenue to get to their homes or jobs on Belvedere Island. The maps on the following pages illustrate vulnerable buildings by scenario. The areas in the call out circles enable the reader the see areas that are difficult to see on the large scale map. The circles do not indicate that these areas are more vulnerable than others along the shoreline.

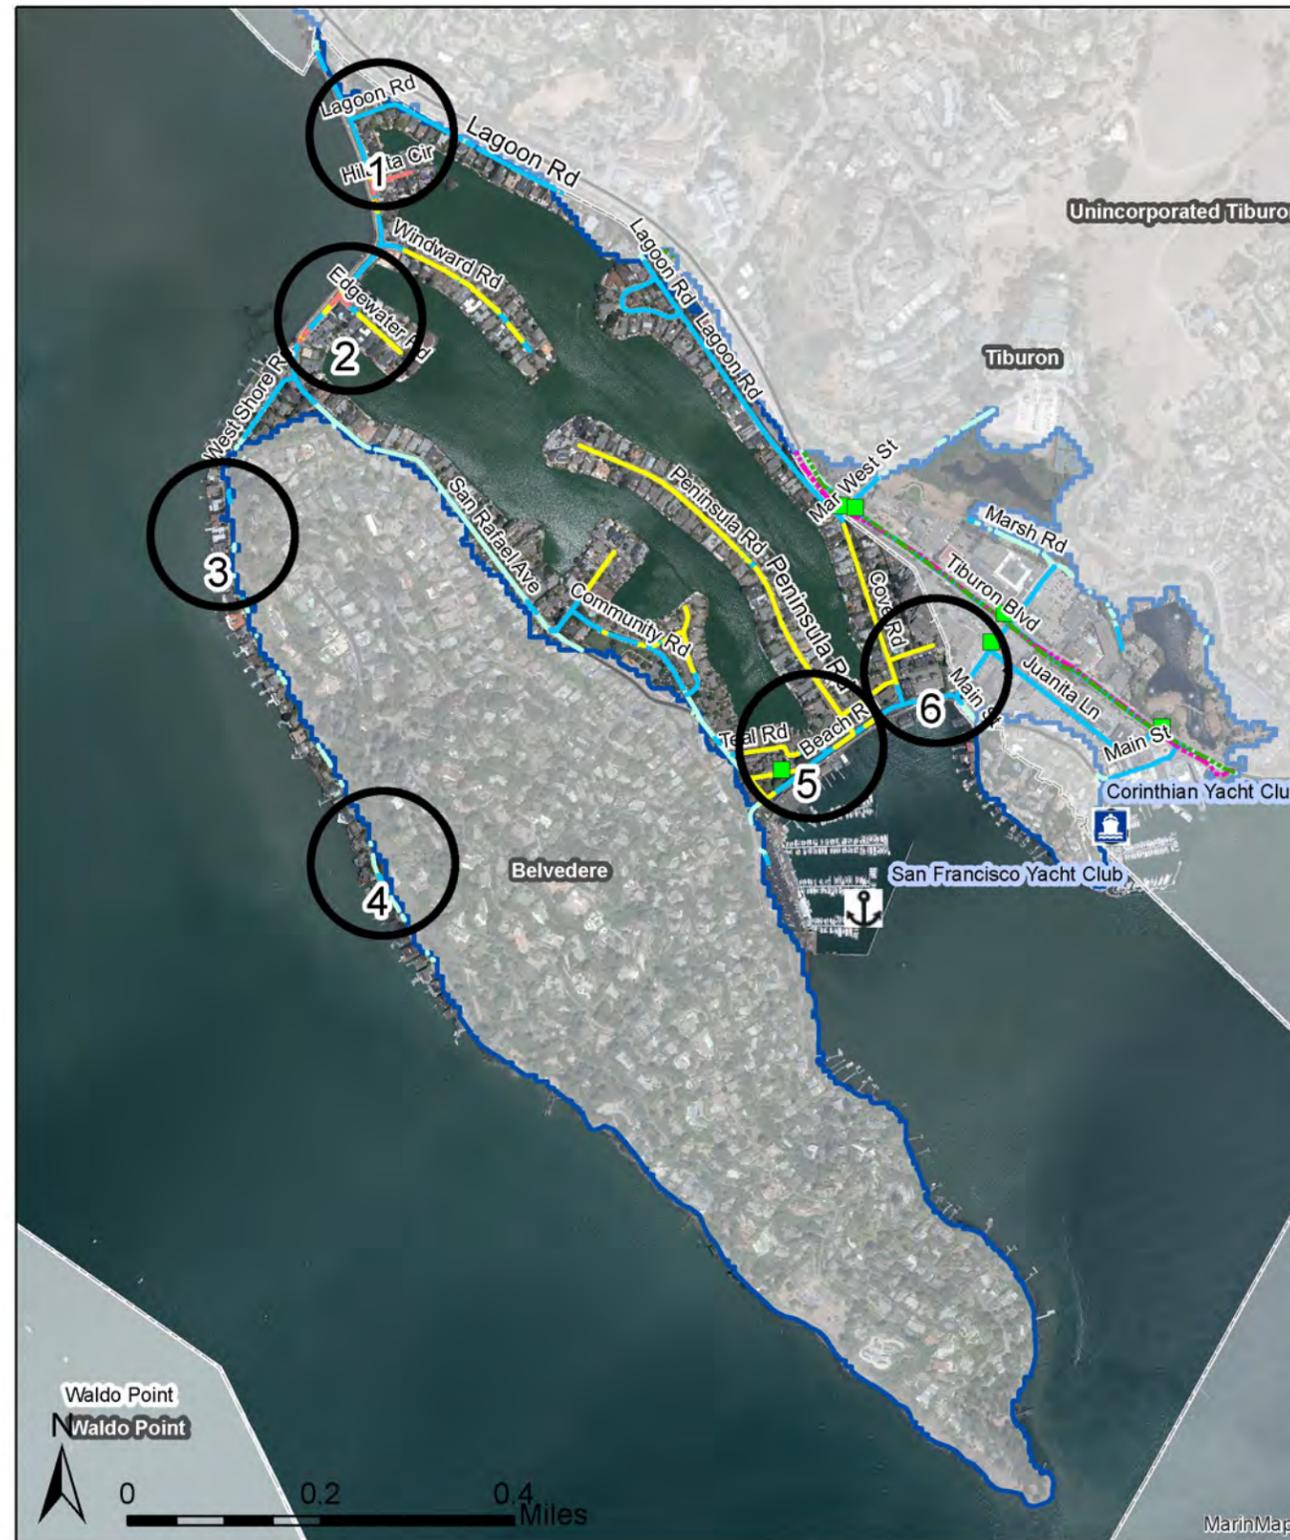
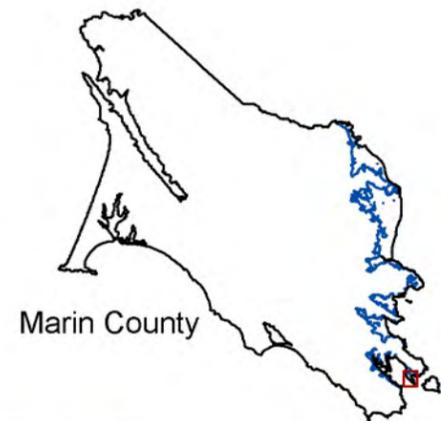
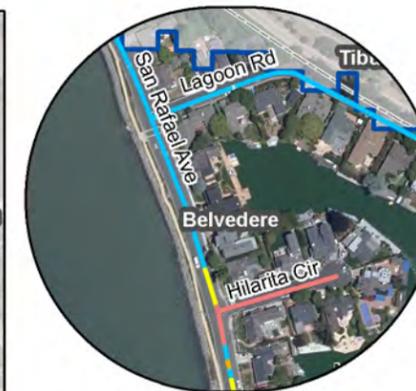
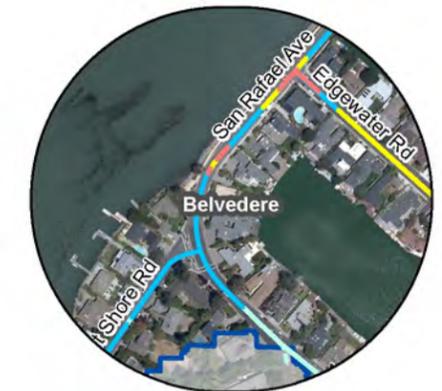
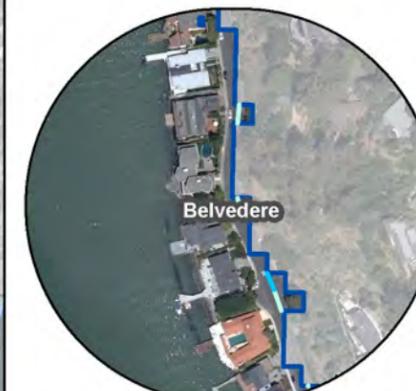
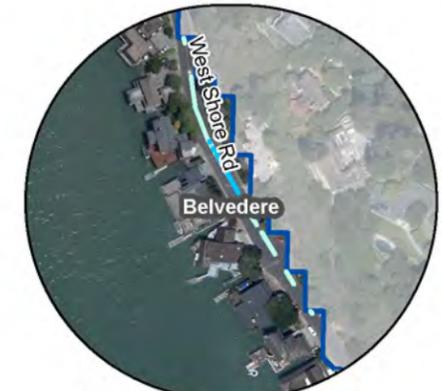
Map 65. Belvedere Vulnerable Transportation Assets

The primary access road to Belvedere, San Rafael Avenue, is vulnerable to overland flooding after three feet of sea level rise. The levee lining the shoreline here may protect the avenue from sea level rise for a couple decades; however, when combined with storm surges, the armoring could be compromised sooner. The lagoon area roads may experience increasing subsidence issues in addition to, and even before, flooding. In time, several additional roads in the lagoon area could be impacted by high tides on a regular basis. If the low lying roads are compromised, people who live in the homes on Belvedere Island could become isolated or prevented through travel for several hours several days a month.

The maps on the following pages illustrate vulnerable transportation features. The areas in the call out circles enable the reader to see areas that are difficult to see on the large scale map. The circles do not indicate that these areas are more vulnerable than others along the shoreline.

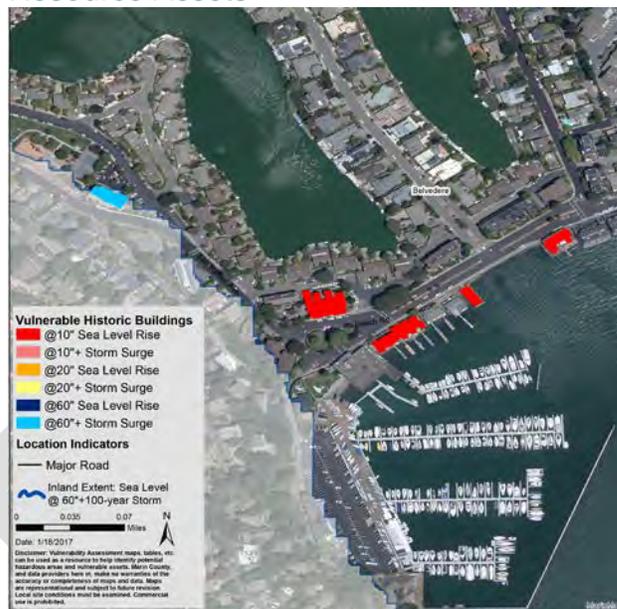
Map 66. Belvedere Vulnerable Cultural Resource Assets

- Properties on Beach Road, along the northwest edge of Belvedere Cove are exposed, including several in the near term. A handful of these properties were designed by well-known architect Albert Farr including the Farr cottages/Farr apartments and the Belvedere Land Company. Additionally the China Cabin lies along this vulnerable waterfront stretch. This saloon was once housed by the S.S. China, built in 1866 to carry passengers from San Francisco to Asia, though the rest of the ship was burned for scrap metal.²⁶
- The Belvedere Presbyterian Church/City Hall/Community Center.

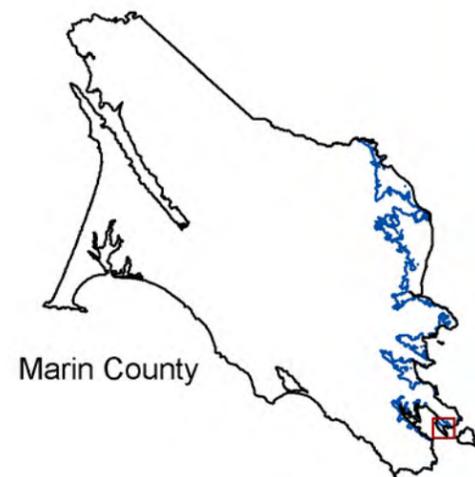
Map 67. Belvedere Vulnerable Natural Resource Assets

Just off the shores of Belvedere Island is a relatively large patch of eelgrass that serves as critical shallower water habitat. Eelgrass beds are recognized by both federal and state agencies as sensitive and highly valuable habitat for a suite of species. They are managed under the Magnuson-Stevens Fishery Conservation and Management Act. Eelgrass beds are listed as a Habitat Area of Particular Concern because they are susceptible to degradation, especially ecologically important, and/or located in an environmentally stressed area. As mean low tide rises, creating deeper waters in the bay, these plants could be denied the sunlight

required to generate energy and sustain them. The loss of eelgrass beds would have significant ripple effects on other species in the Bay eco-system. Eelgrass beds are much larger and closer to shore than the mapped habitats on Map 69.

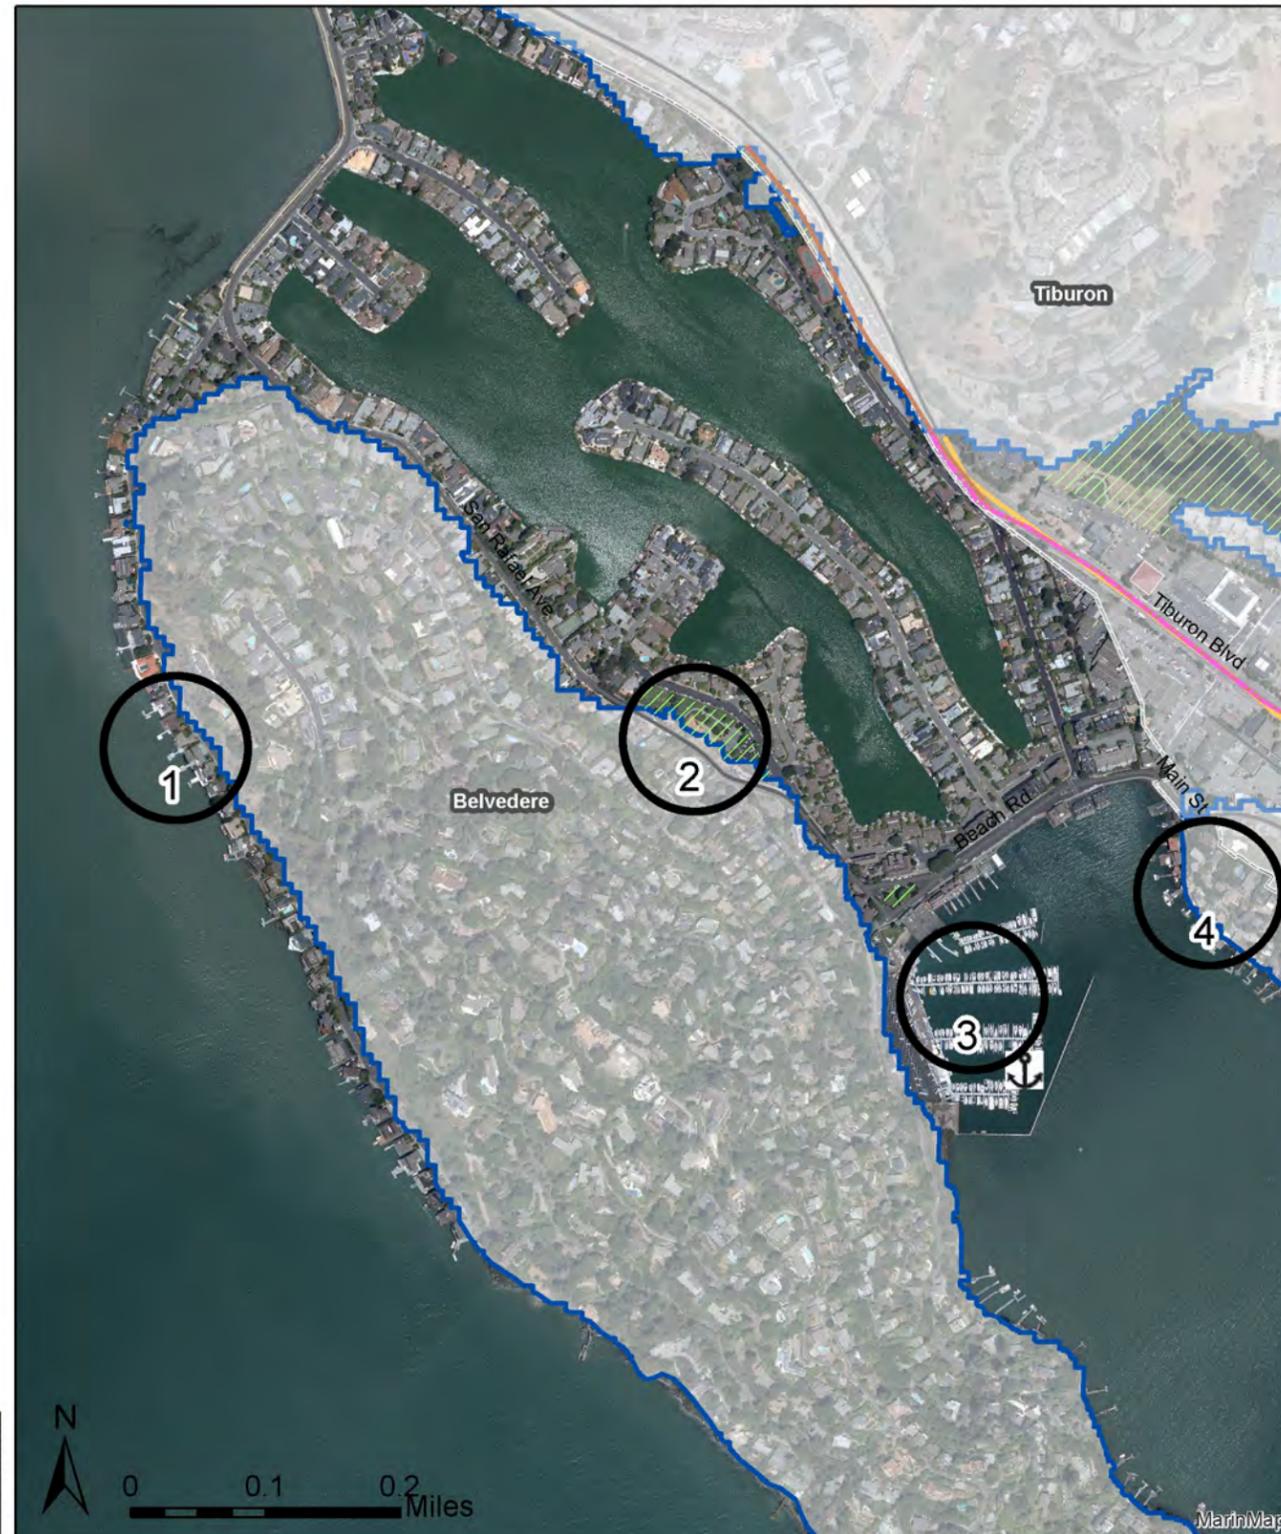
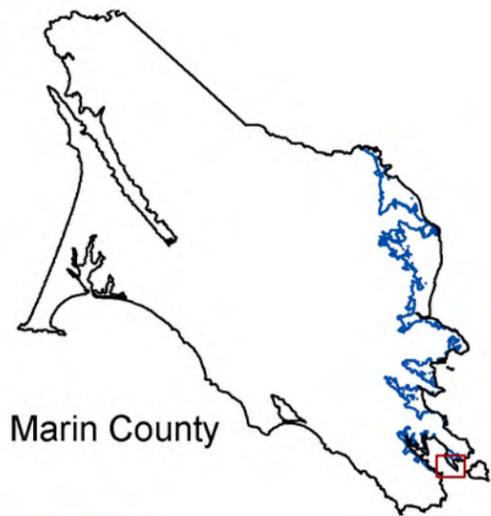
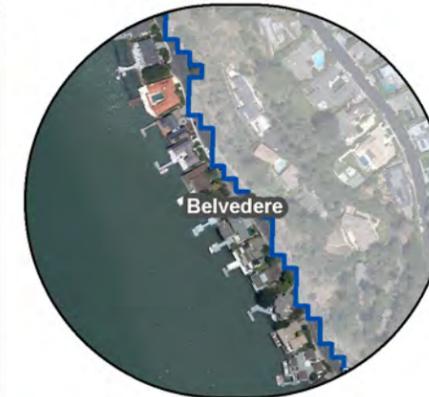
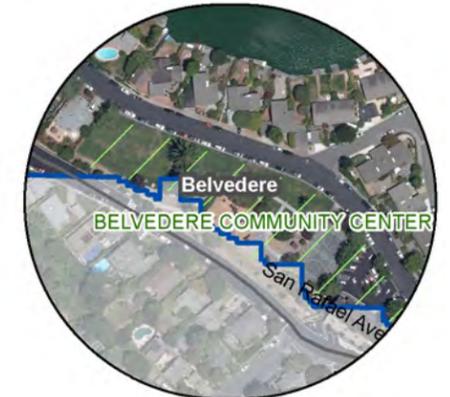
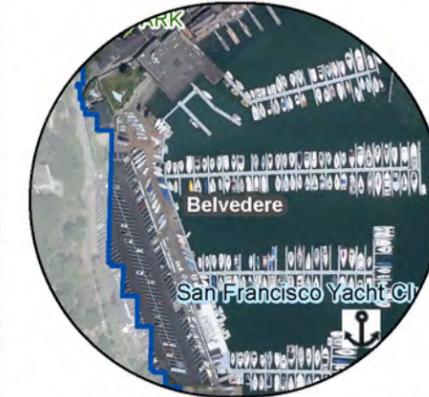
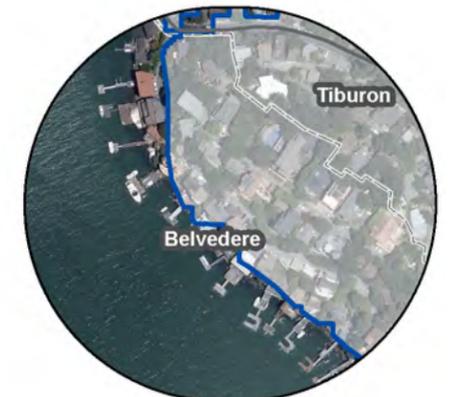
Map 68. Belvedere Vulnerable Recreation Assets

Access to the water could be compromised at the yacht club and private residential facilities. Trails around and leading to the area could also be compromised by flooding and erosion. Finally the Belvedere Community Center and Park could be vulnerable to sea level rise alone in the long-term, especially if the tide gates managing the lagoon water level fail.

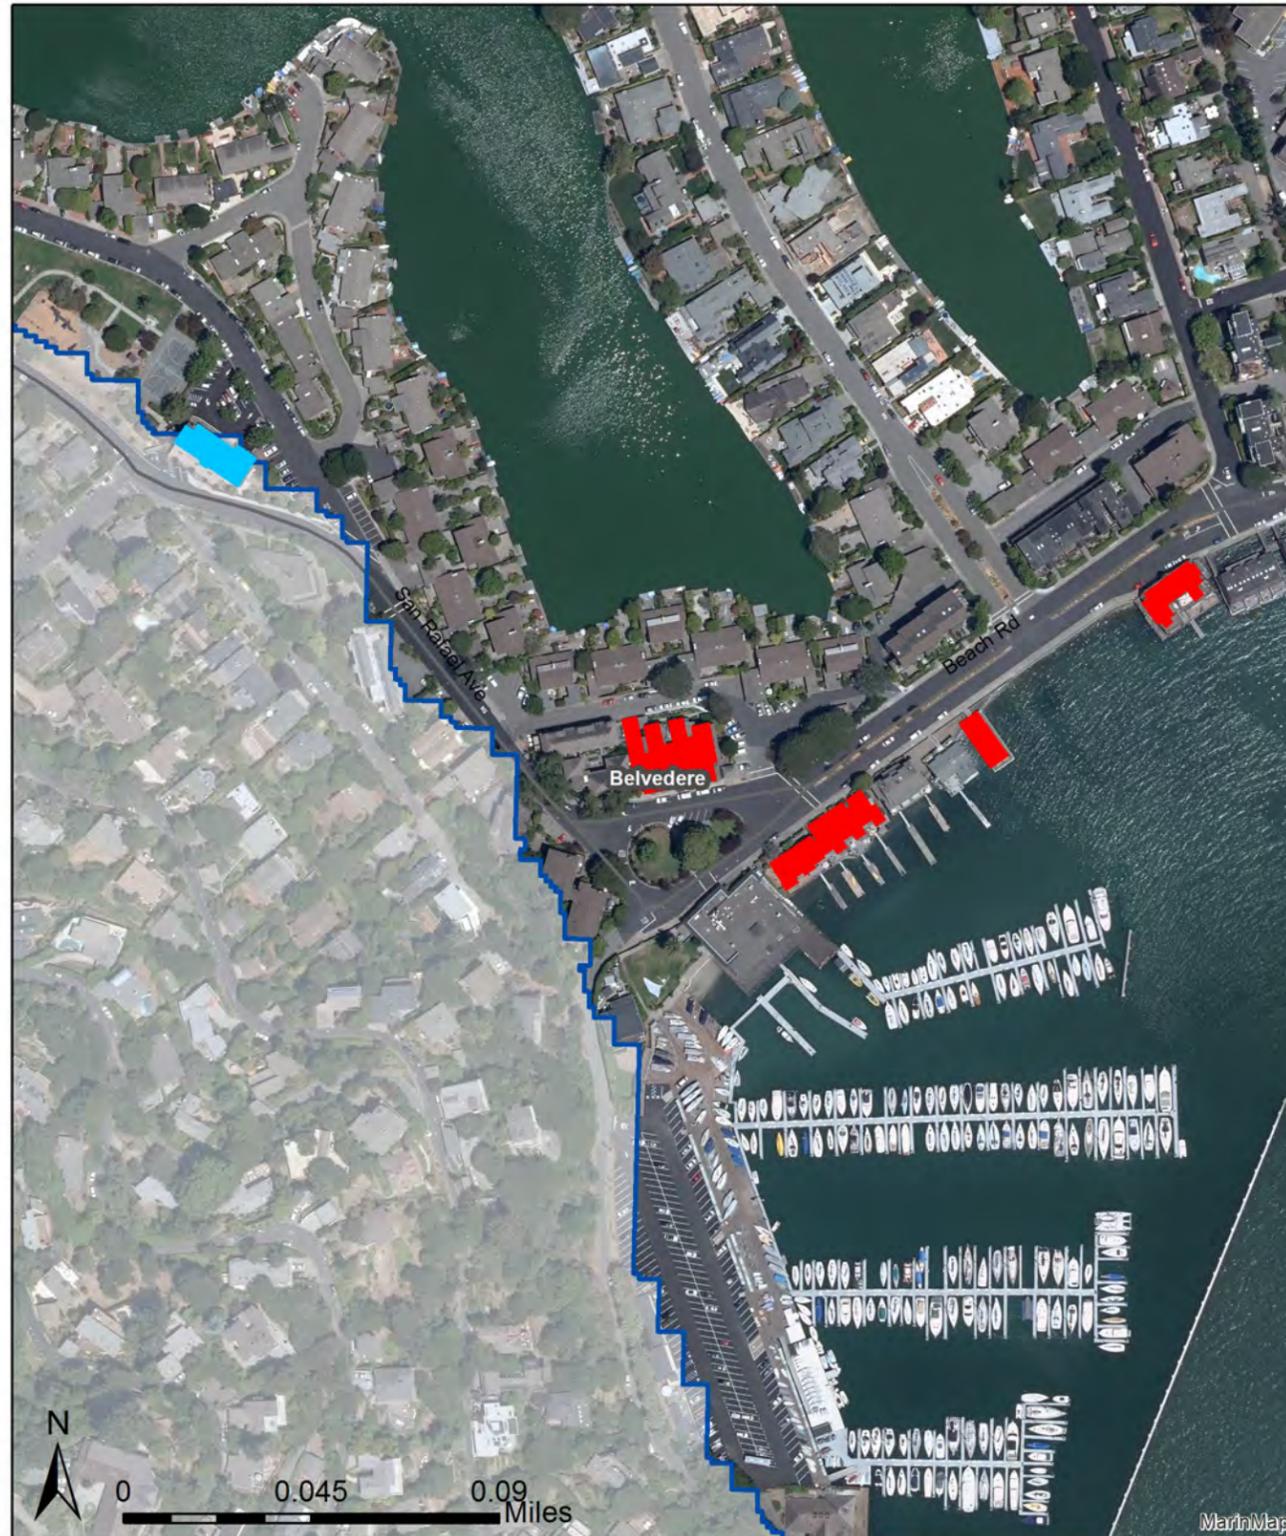
Map 69. Belvedere Cultural Resource Assets

Belvedere was first settled in the late 19th century as a fishing community, and incorporated in 1896.²⁵ Vulnerable historic resources in Belvedere include:
