BayWAVE COMMUNITY PROFILES

Municipality Profile: Sausalito

Map 46. Sausalito BayWAVE Scenarios

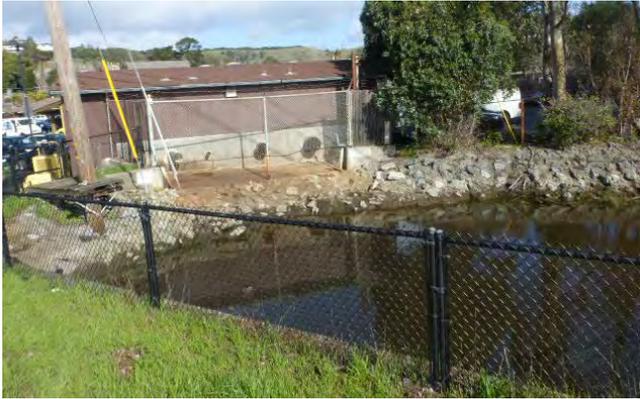
Pump station and overflow pond at the Cove Shopping Center.
Credit: Marin County DPW
