City of San Rafael Cor Brief Legal Description Lot 36, 10 RM 126 CORNER TYPE	erol [] erty [stablished [stab	Marin N. E. Zoo Ele Reestab used to estab uments at	coo (Coo nev. lished [] lish or rees the n	ortheasterly
Brief Legal Description Lot 36, 10 RM 126 CORNER TYPE Government Corner Control Neander Proper Rancho Other Date of Survey Corner — Left as found Found and tagged Estended Found and type of corner found: Evidence used to identify of Found nail and tag in concrete in we and southwesterly terminus of the control on the centerline of Dominican Drive A description of the physical condition of the monument as found	trol	N. E. Zoo Ele Reestab e used to estab uments at	coo //cone v lished [] lish or rees the n	DRDINATES Deptional) Datum Rebuilt [] Stablish the comer: ortheasterly
Government Corner Control Neander Property Rancho Other Date of Survey	erty x er stablished g or procedure ell monu ourse No	E. Zoo Ele Reestab e used to estab uments at	lished lish or rees	DatumRebuilt [] stablish the comer: ortheasterly

JOB BREAUX PROPERTY

JOB NO. 6999 DESIGN BY JRH CHECKED BY ILS

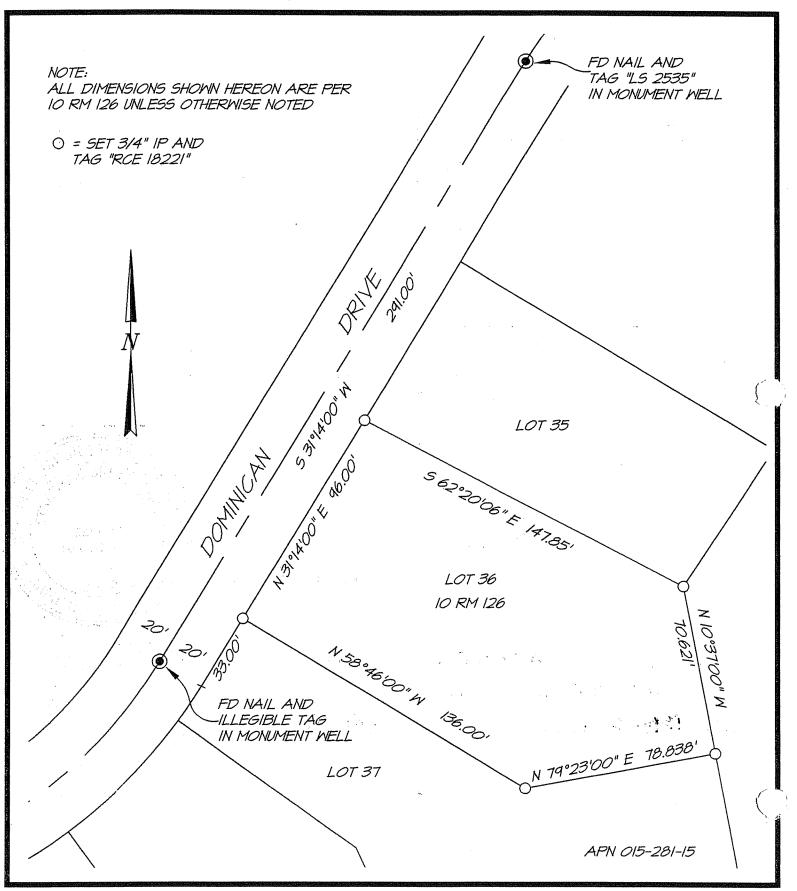
SHEET NO. 1 OF 1 DATE 8-03-99 DATE 8-03-99

Rancho Other Date of Survey Corner — Left as found Found and tagged Est Identification and type of corner found: Evidence used to identify of Found nail and tag in concrete in we and southwesterly terminus of the coon the centerline of Dominican Drive A description of the physical condition of the monument as found	er stablished graphor procedure ell monuourse Note per 10	E. Zoo Ele Reestab e used to estab uments at	lished [] lish or rees the n	Rebuilt stablish the comer: ortheasterly
Identification and type of corner found: Evidence used to identify of Found nail and tag in concrete in we and southwesterly terminus of the coon the centerline of Dominican Drive	or procedure ell monu purse No e per 10	e used to estab uments at orth 31°1	lish or rees the n	stablish the comer: ortheasterly
Found nail and tag in concrete in we and southwesterly terminus of the coon the centerline of Dominican Drive A description of the physical condition of the monument as found	ell monu purse No e per 10	uments at orth 31°1	the n	ortheasterly

A description of the physical condition of the monument as found				
and tag RCE 18221 at all angle point shown on 10 RM 126.	and as set :s in th	or reset: She bounda	et 3/4 ry of	" iron pipe Lot 36 as
SURVEYOR'S STATEMENT				PROFESSION OF SCHOOL
This Corner Record was prepared by me or under my direction the Land Surveyors' Act on 75 19			A REGI	No. 18221 Exp. 6-30-01
COUNTY SURVEYOR'S STATEMENT				
This Corner Record was receivedAUGUST	19 99 and	d examined	(3)	BOROFESSION PLANTED
and filed $AUGUSTII$ 19 99 . Signed $Title$ D)EPUTY		* REGIST	SEAL NO. C 30212 N
County Surveyor's Comment				OF CALIFORNIE
