CORNER RECORD

City of SAN RAFAEL

Brief Legal Description NW COR., LOT 65 10 RM 126

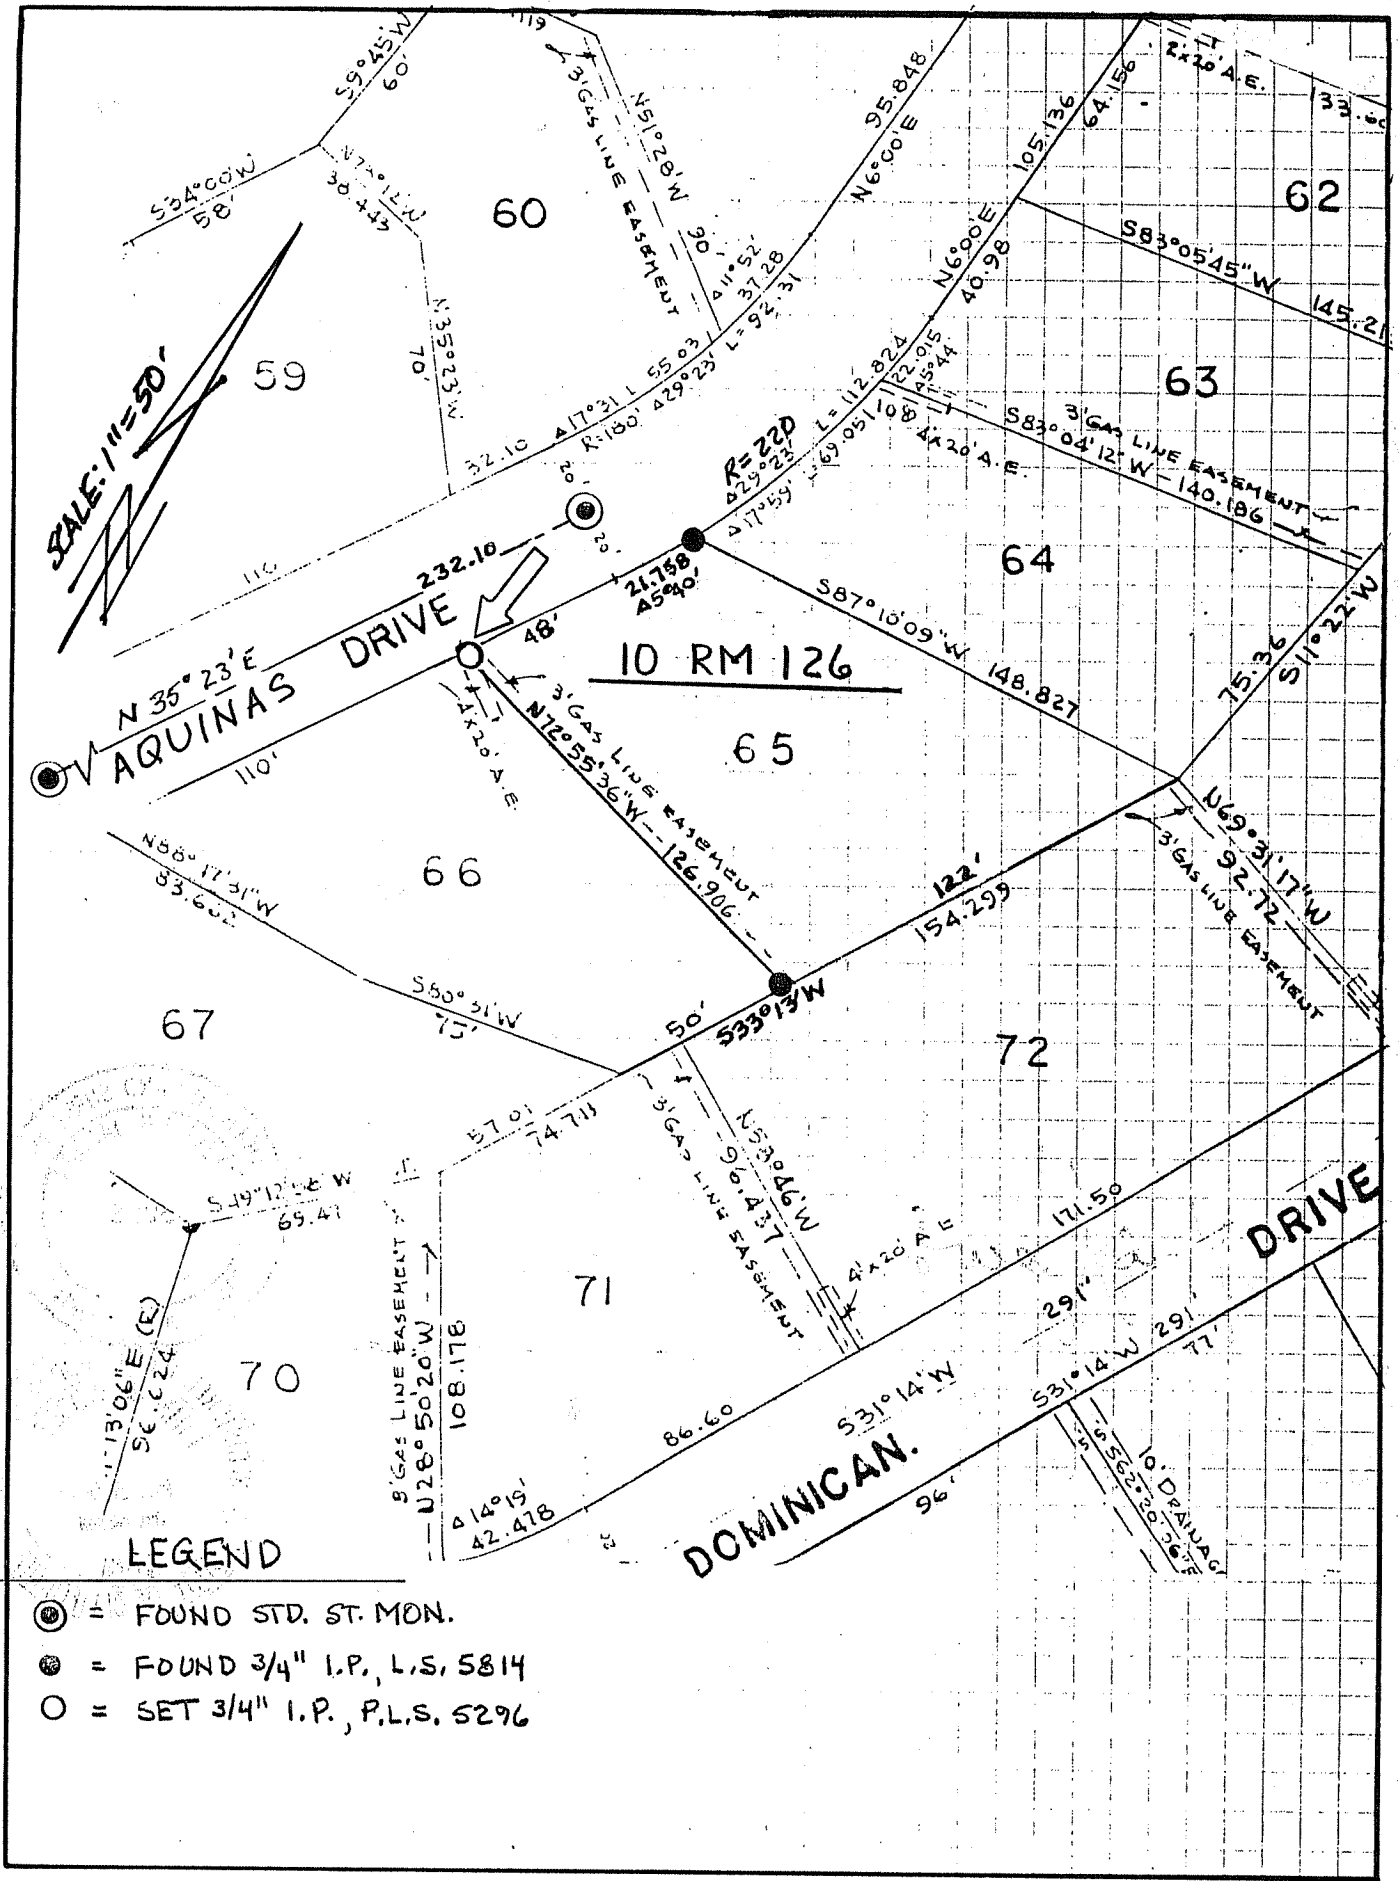
Identification and type of corner found: Evidence used to identify or procedure used to establish or reestablish the corner:
END STD CENTERLINE MONUMENTS AS SHOWN ON 10 RM 126 AND
END 3/4" I.P.'S TAGGED LS 5814 PER FILED CORNER RECORDS AS
SHOWN ON REVERSE.

A description of the physical condition of the monument as found and as set or reset: _____
SET 3/4" I.P. AND TAG P.L.S. 5296 NEAR END OF FENCE, APPROX
7.1' FROM FACE OF CURB AS SHOWN ON REVERSE.
