CORNER RECORD

City of KENTFIELD

Brief Legal Description PARCEL 96B, 8 PM 16

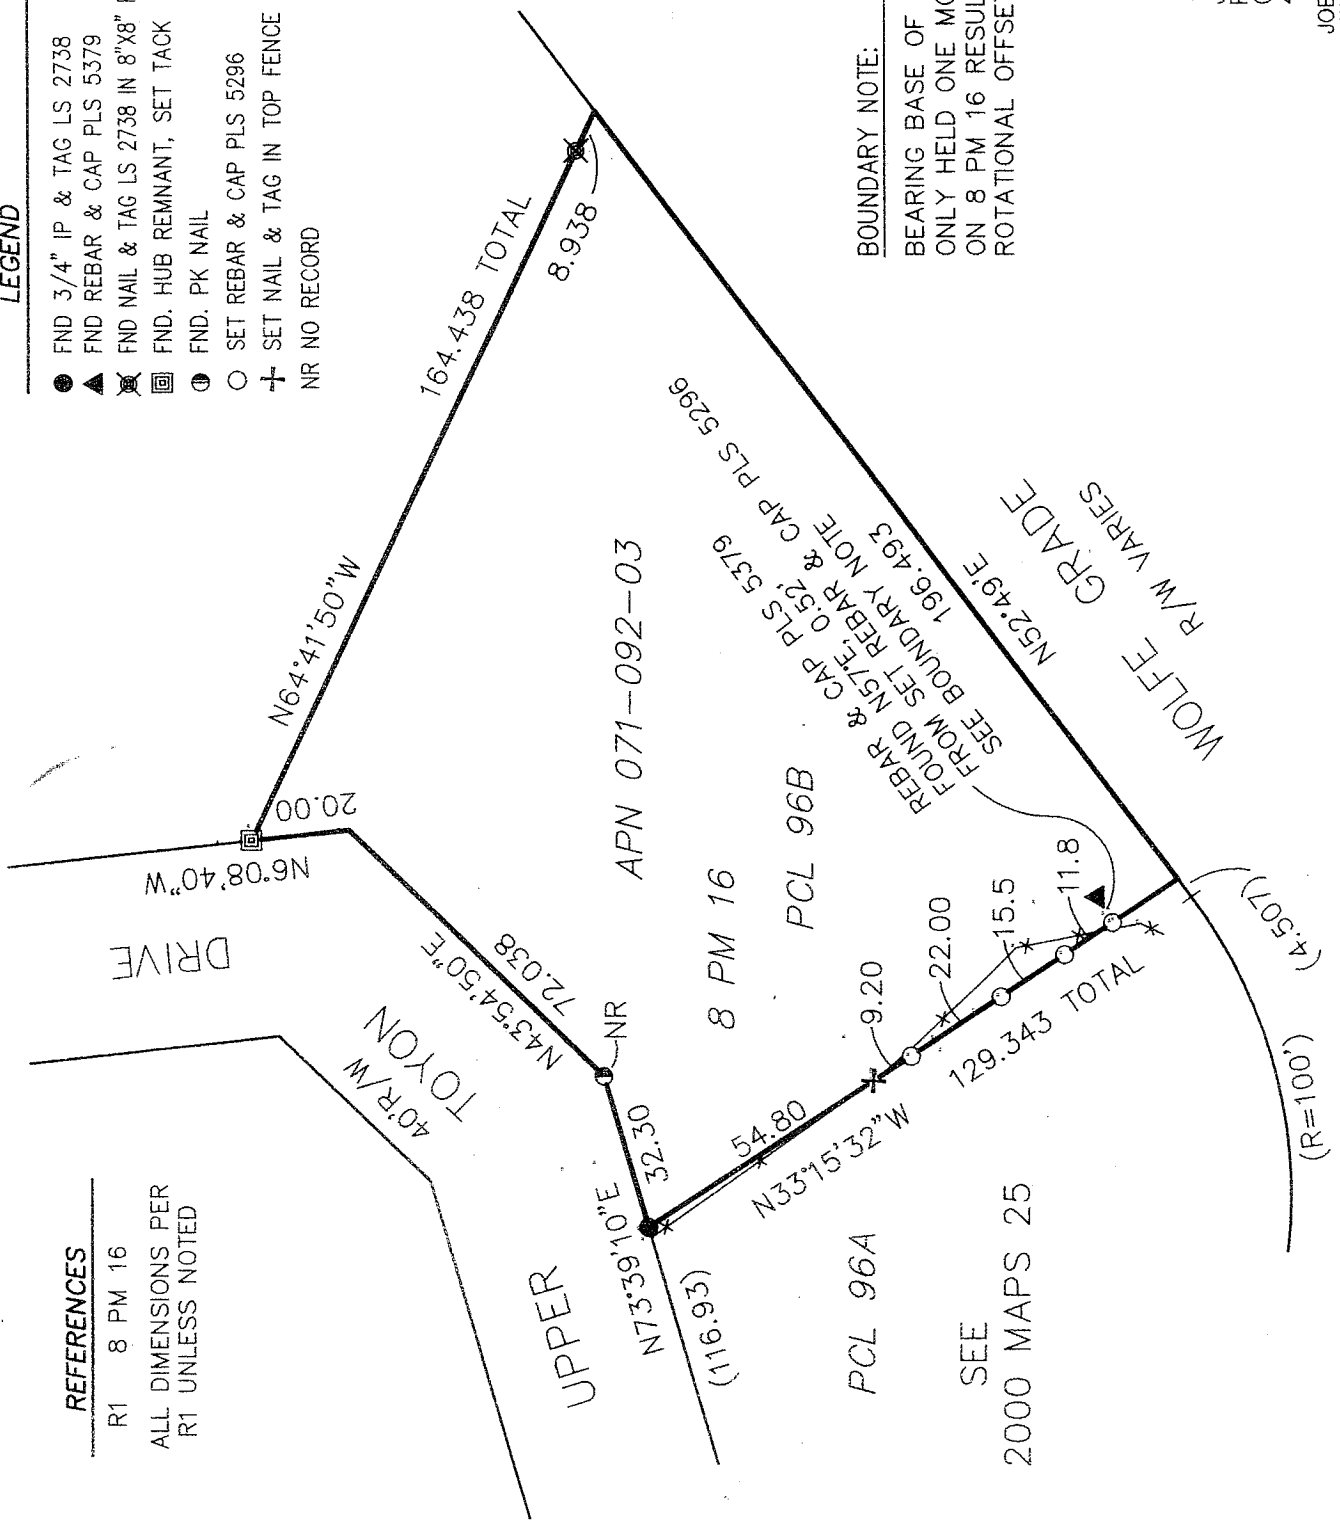
Identification and type of corner found: Evidence used to identify or procedure used to establish or reestablish the corner:  
FOUND MONUMENTS: 3/4" IP TAGGED LS 2738, HUB REMNANT AND NAIL & TAG IN 8"X8", AS SHOWN ON 8 PM 16 AND ON REVERSE.

A description of the physical condition of the monument as found and as set or reset:  
SET REBARS & CAPS, PLS 5296 AS LINE POINTS, AS SHOWN ON REVERSE.

BEARING BASE OF 2000 MAPS 25 ONLY HELD ONE MONUMENT SHOWN ON 8 PM 16 RESULTING IN THE ROTATIONAL OFFSET SHOWN.
