**JERRICO ASSOCIATES**  
 SUITE 27  
 77 MARK DRIVE  
 SAN RAFAEL, CA 94903

**CORNER RECORD**

Lot 18 and 20, Block 7, Map of Inverness 1 R.M. 80

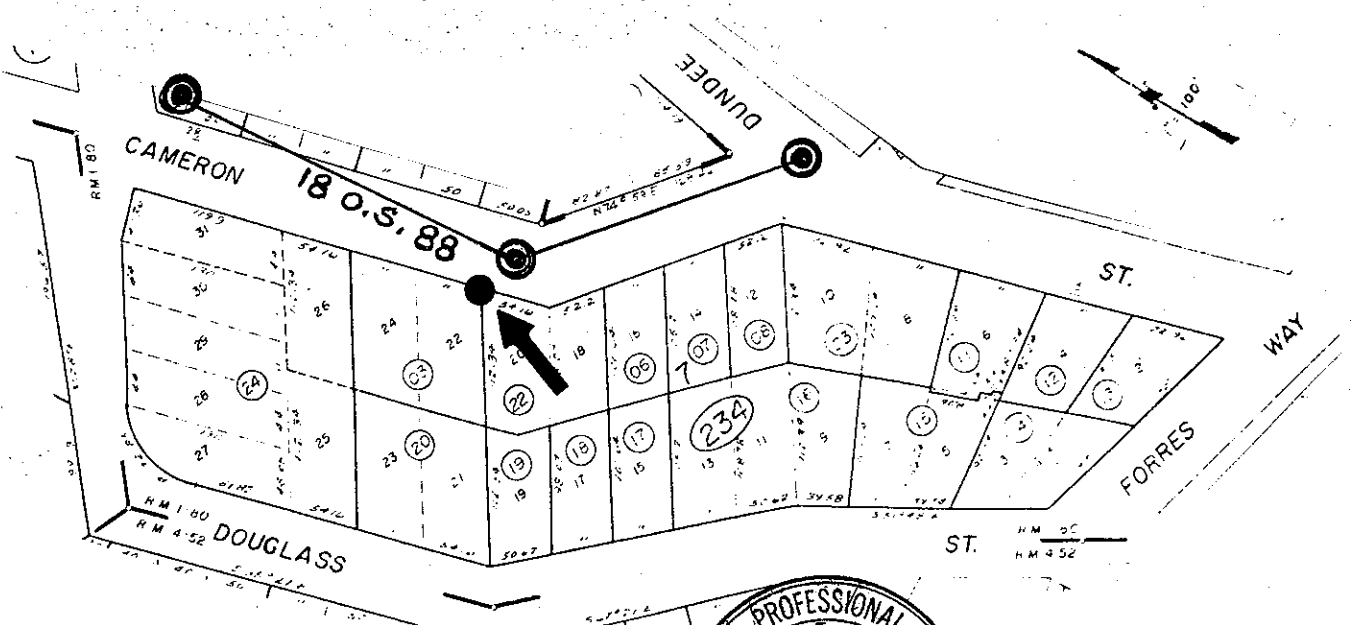
SKETCH: (Include reference tie or witness points, remarks and topo of area)

County monument (RR Spike) control line on Cameron Street per. 18 O.S. 88 controls northerly side of street.

(Ref: 1889 Bush map of Inverness)

Set rebar and cap L.S. 3887

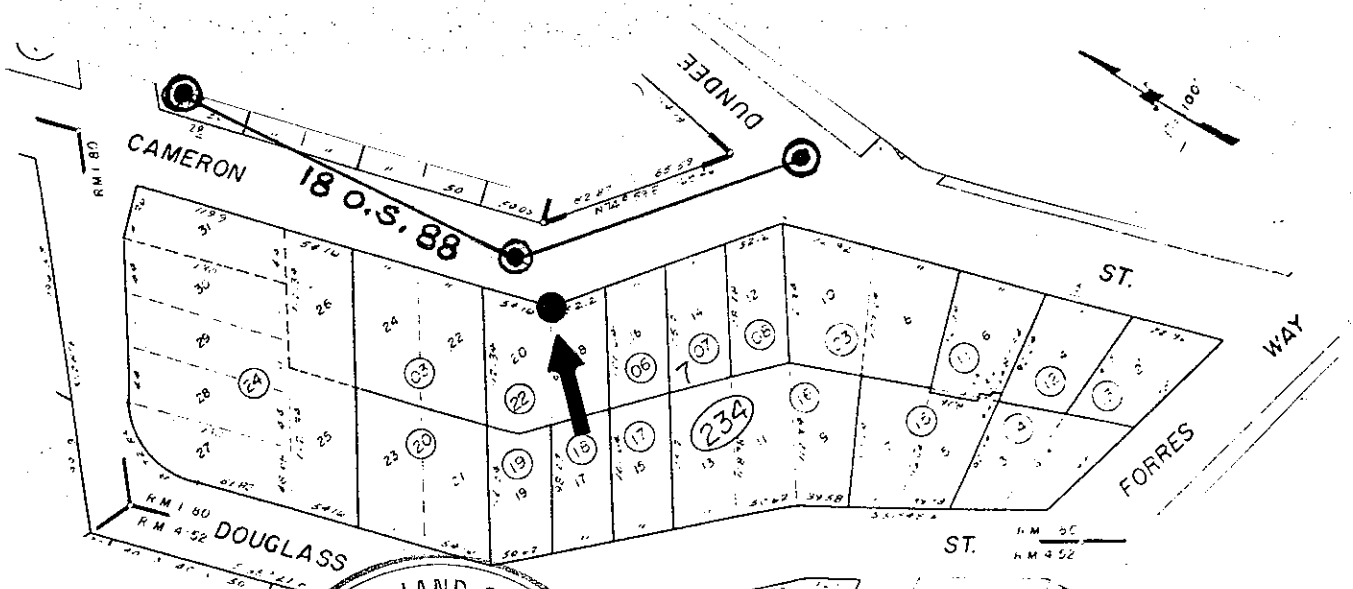
SKETCH: (Include reference tie or witness points, remarks and topo of area)

County monument ( RR Spike) control line on Cameron Street per.  
 18 O.S. 88 controls northerly side of street.

(Ref: 1889 Bush map of Inverness)

Lot 18 and 20, Block 7, Map of Inverness 1 R.M. 80

Set nail and tag L.S. 3887 in brick walk

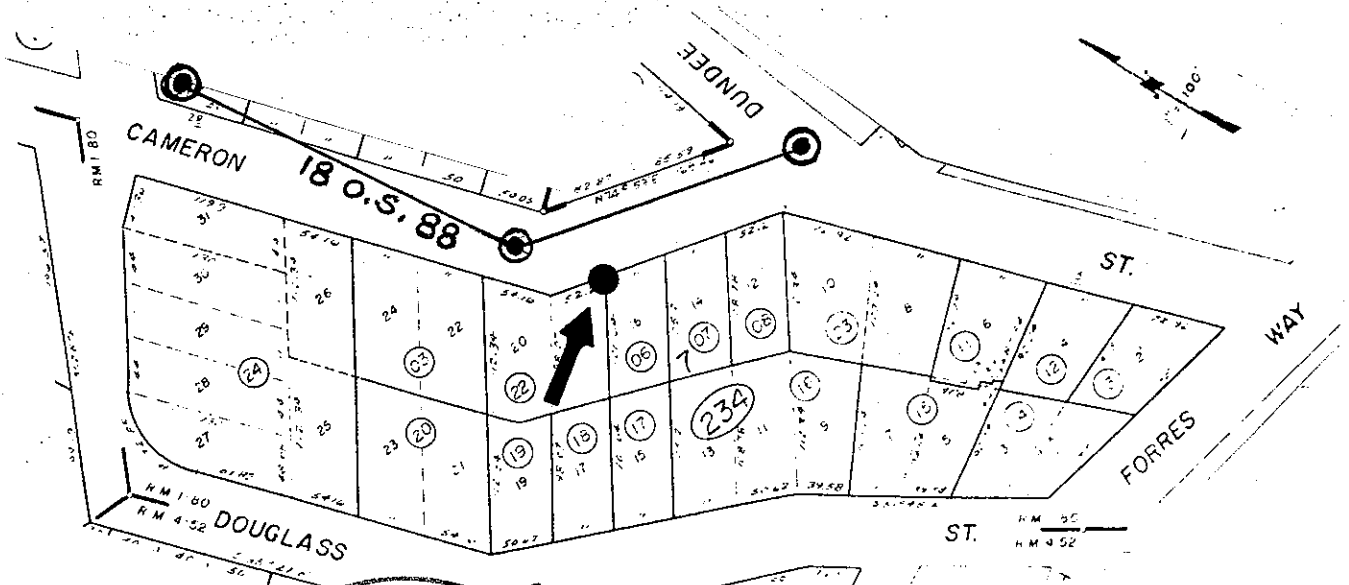
SKETCH: (Include reference tie or witness points, remarks and topo of area)

County monument ( RR Spike) control line on Cameron Street per.  
18 O.S. 88 controls northerly side of street.

(Ref: 1889 Bush map of Inverness)

Lot 18 and 20, Block 7, Map of Inverness 1 R.M. 80

Set rebar and cap L.S. 3887

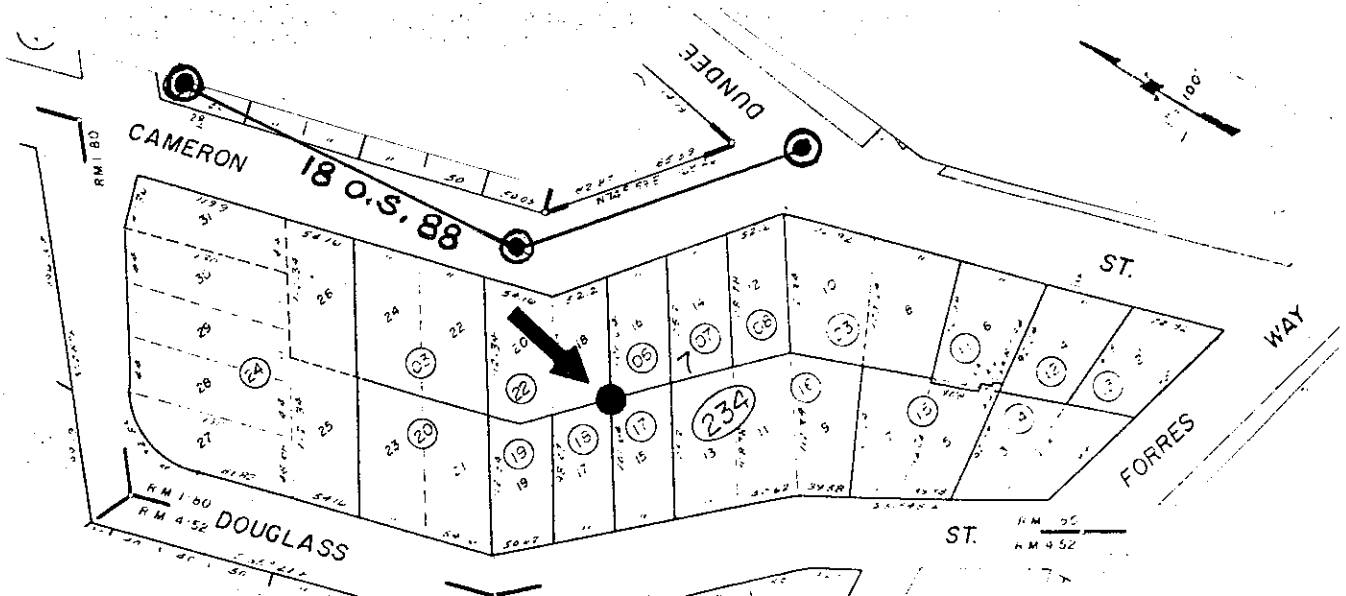
SKETCH: (Include reference tie or witness points, remarks and topo of area)

County monument ( RR Spike) control line on Cameron Street per.  
 18 O.S. 88 controls northerly side of street.

(Ref: 1889 Bush map of Inverness)

Lot 18 and 20, Block 7, Map of Inverness 1 R.M. 80

Set rebar and cap L.S. 3887

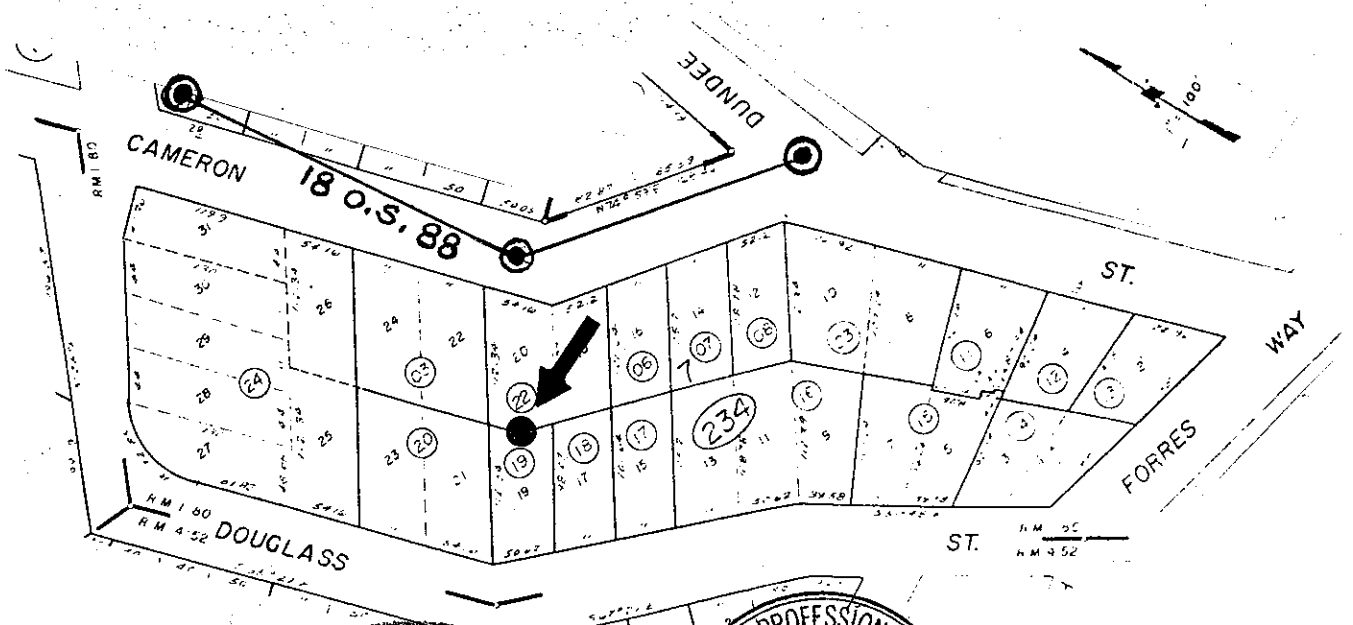
SKETCH: (Include reference tie or witness points, remarks and topo of area)

County monument ( RR Spike) control line on Cameron Street per.  
18 O.S. 88 controls northerly side of street.

(Ref: 1889 Bush map of Inverness)

Lot 18 and 20, Block 7, Map of Inverness 1 R.M. 80

Set rebar and cap L.S. 3887

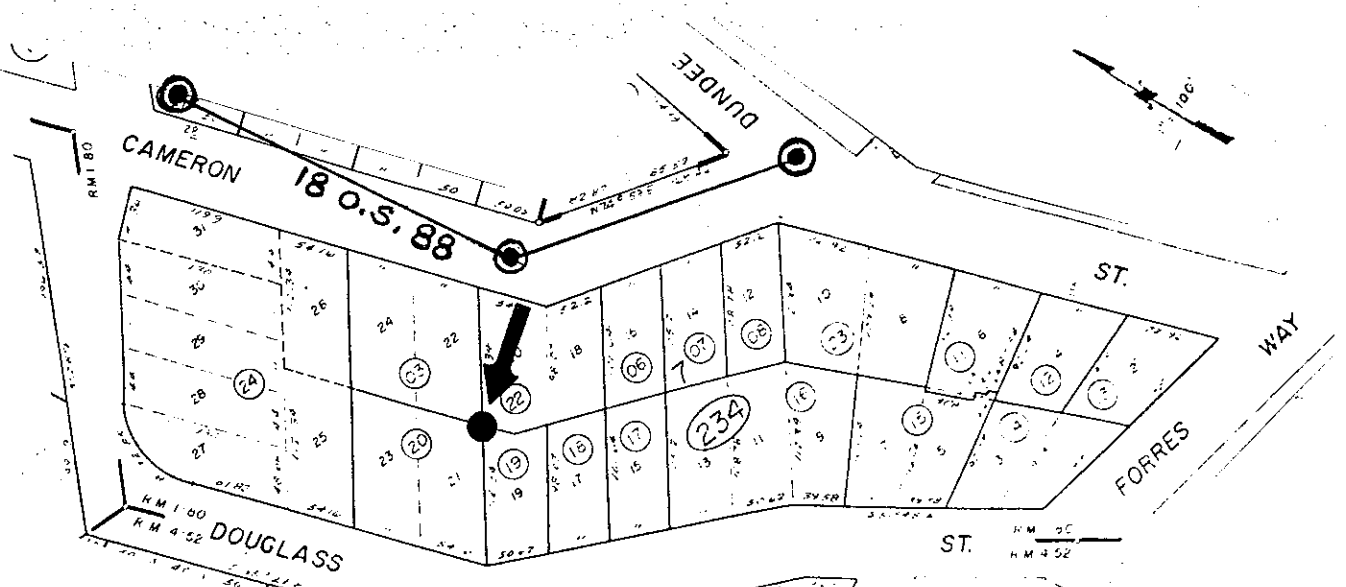
SKETCH: (Include reference tie or witness points, remarks and topo of area)

County monument ( RR Spike) control line on Cameron Street per.  
 18 O.S. 88 controls northerly side of street.

(Ref: 1889 Bush map of Inverness)

Lot 18 and 20, Block 7, Map of Inverness 1 R.M. 80

Set rebar and cap L.S. 3887
