CORNER RECORD

MAP of SAN MARIN EAST (18 RM 20)

SITUS:
42 SPINOSA WAY
NOVATO, CA

A.P.N.
125-411-08

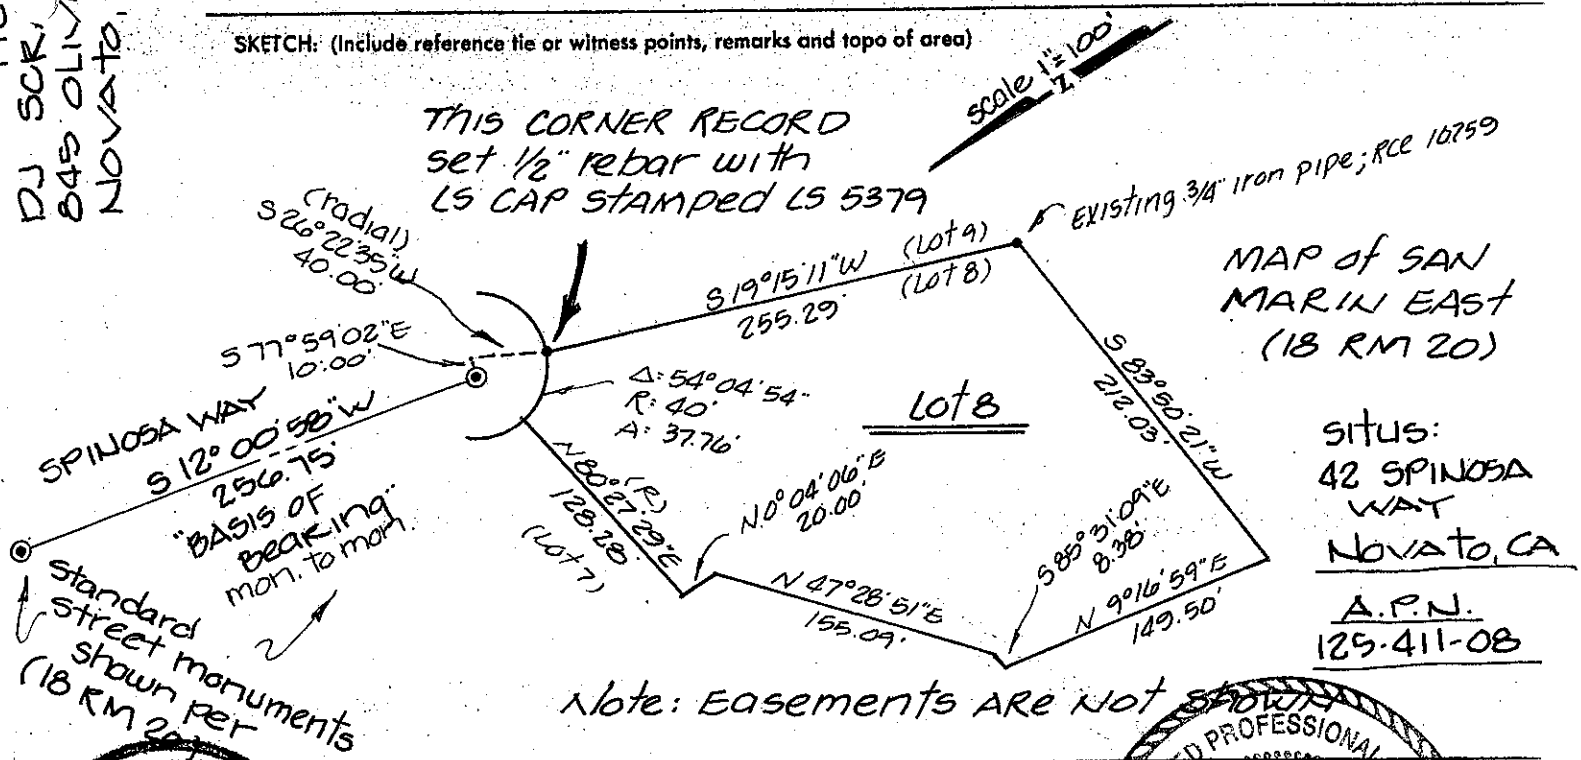
SKETCH: (Include reference tie or witness points, remarks and topo of area)

set 1/2" rebar with LS CAP 5379 at the right-of-way corner on SPINOSA WAY at the corner of Lots 8 & 9 of the MAP of SAN MARIN EAST (18 RM 20), MARIN COUNTY RECORDS. 1/2" rebar set falls on the westerly base of an existing wood fence - fence clears property line ±12' southerly of CORNER SET.

Note: Easements ARE NOT SHOWN
