JERRICO ASSOCIATES
 SUITE 27
 77 MARK DRIVE
 SAN RAFAEL, CA 94903

CORNER RECORD

Found standard subdivision monuments on Eagle Drive as shown in Marin Golf & Country Club Estates :- 10 R.M. 18

Marin Golf and Country Club Estates Unit 2
 R.M. Bk. 10-Pg. 18

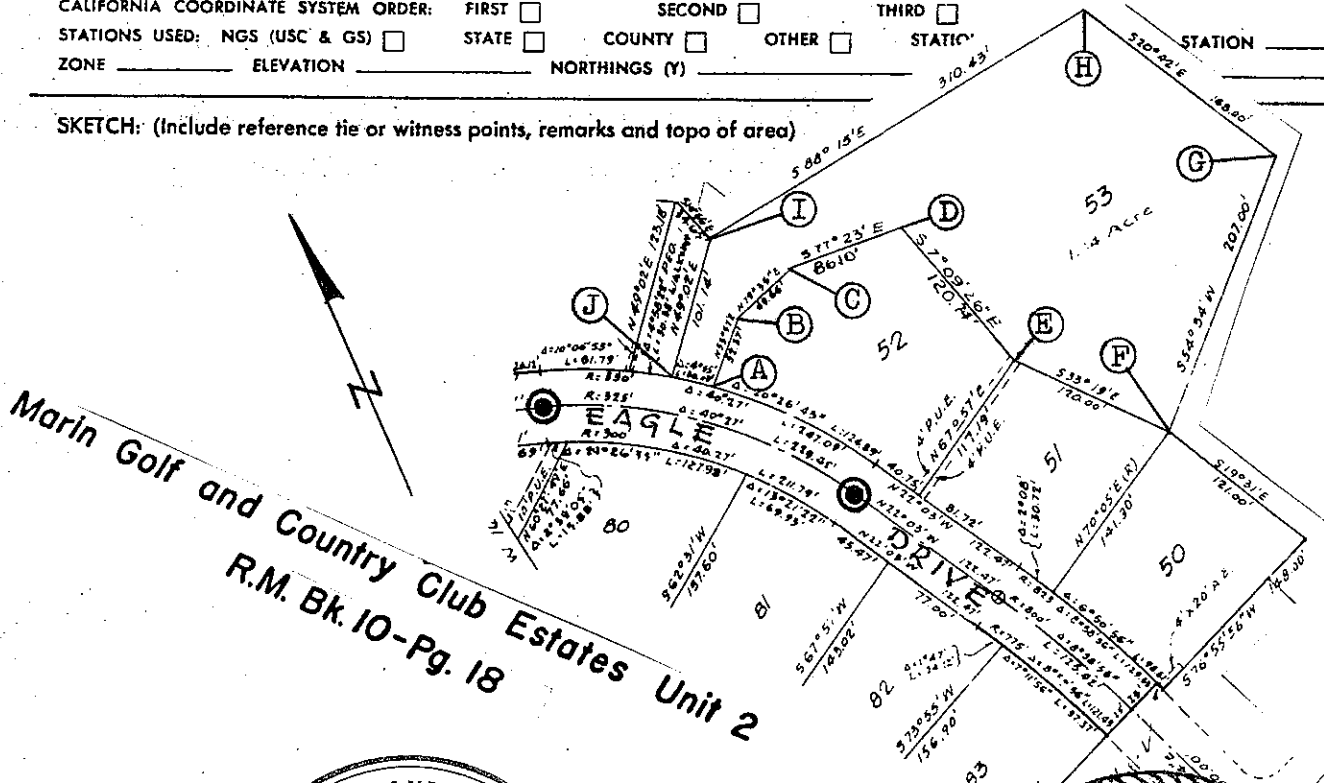
SKETCH: (Include reference tie or witness points, remarks and topo of area)

- (A) Set rebar and cap LS 3887.
- (B) Set nail & tag LS 3887 @ toe of rock wall.
- (C) Set hub and LS 3887 tag.
- (D) Set nail & tag LS 3887 @ toe of rock wall.
- (E) Set rebar and cap LS 3887. Fd. 3/4" I.P. (tag illegible).
- (F) Set rebar and cap LS 3887. Fd. 3/4" I.P. & RCE 14689
- (G) Set rebar and cap LS 3887. Fd. 3/4" I.P. & tack.
- (H) Set rebar and cap LS 3887. Fd. 1" I.P. & tack.
- (I) Set rebar and cap LS 3887. Fd. 1" I.P. & tack.
- (J) Set hub & tag LS 3887.
