# CORNER RECORD

Documented Number 160-105-01

City of Novato

Brief Legal Description Lot 33, Marin Golf & Country Club Estates, Unit One, 10 RM 6

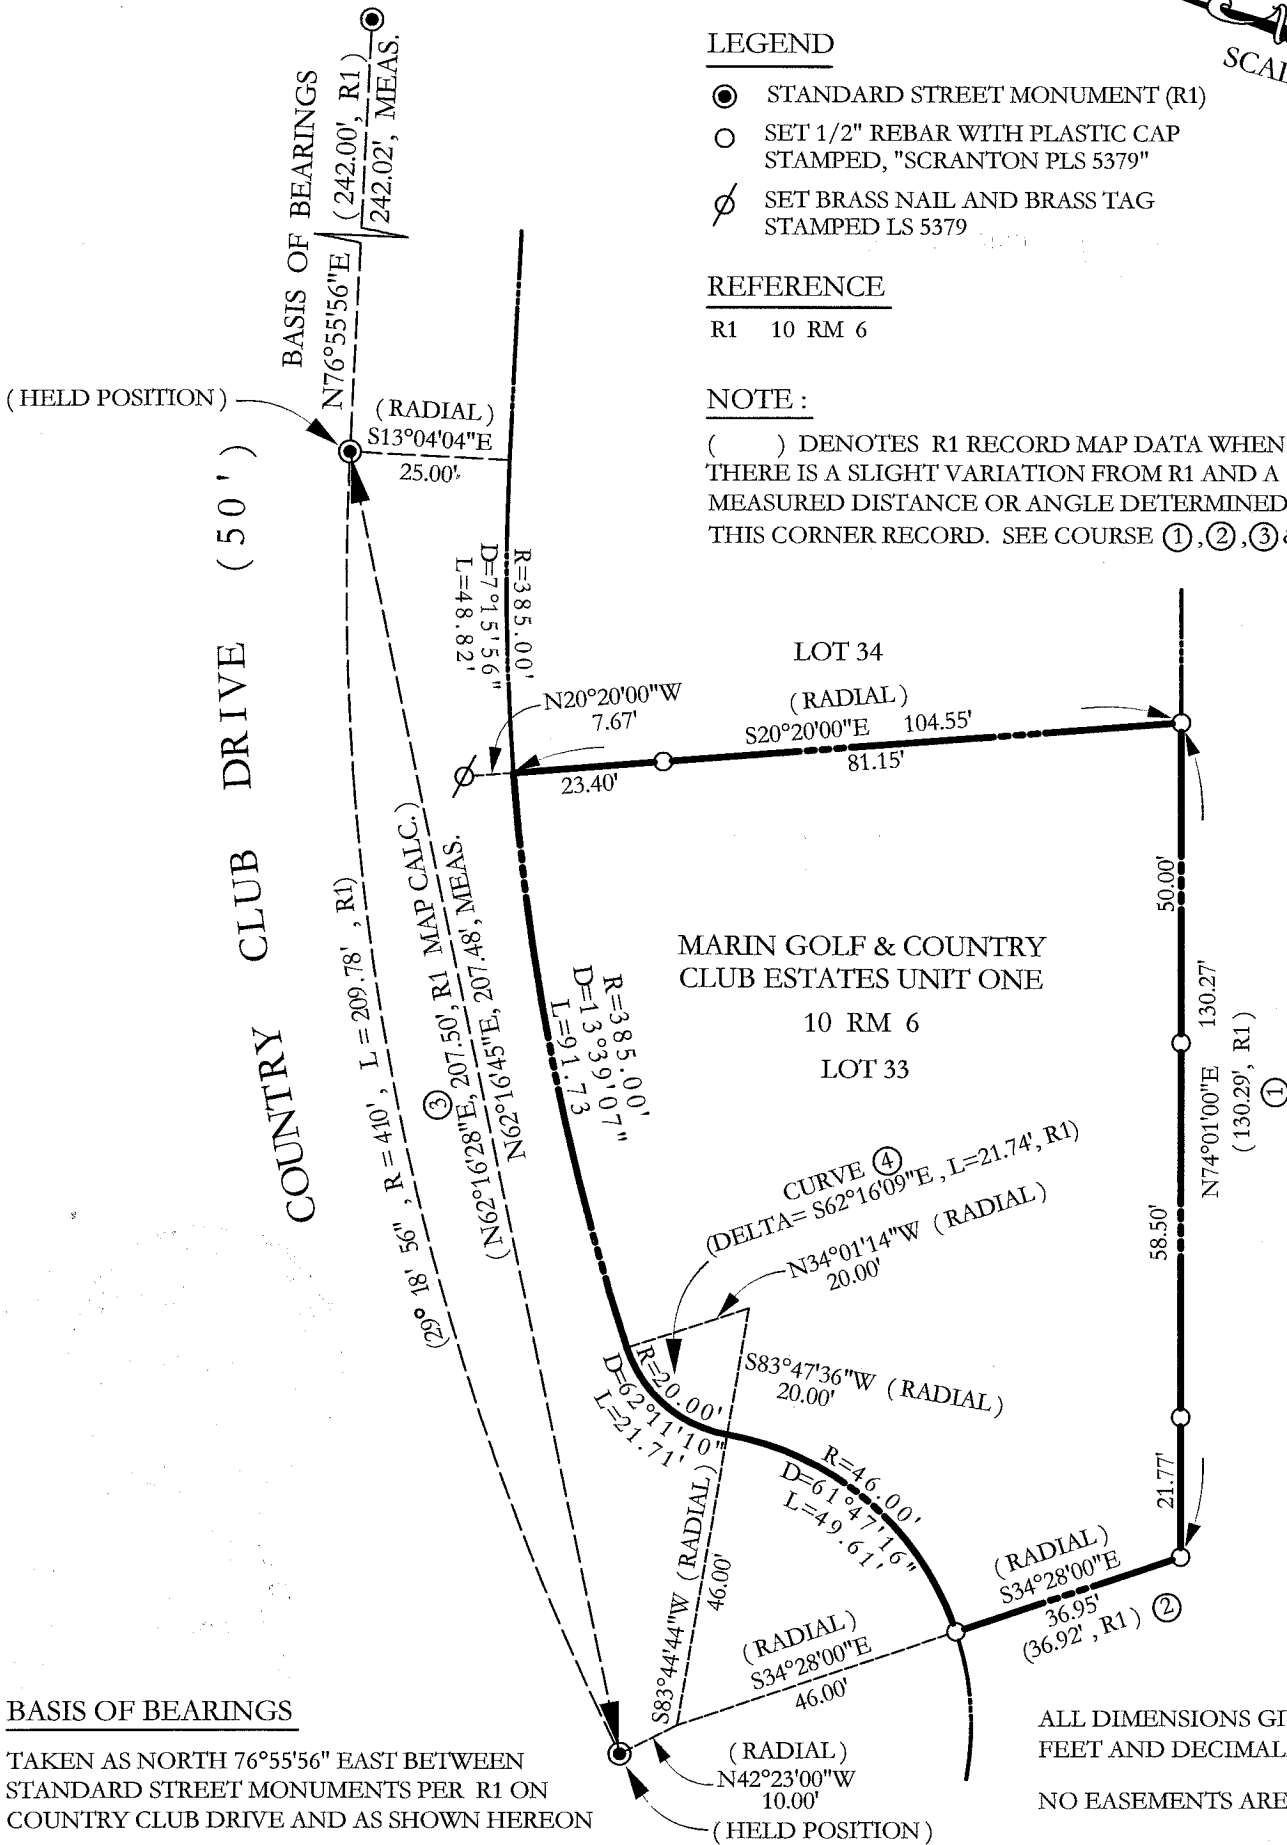
Identification and type of corner found: Evidence used to identify or procedure used to establish or reestablish the corner: **Reestablish the rear and side property lines for Lot 33, Map of Marin Golf & County Club Estates, Unit One, 10 RM 6, from existing standard street monuments on County Club Drive that are depicted upon said map. This survey held the position of both the cul de sac monument and the next monument Easterly of the cul de sac monument to place the position of the lot lines on the ground. See sketch on reverse side for details.**

A description of the physical condition of the monument as found and as set or reset: **Set either a one half inch rebar with yellow plastic cap attached to top of rebar with the top driven flush to surrounding grade (cap is stamped "Scranton, PLS 5379"), or 2) set brass nail with brass tag stamped "LS 5379" in top of the Southerly curb line of Country Club Drive on a North projection of the Easterly lot line. See sketch on reverse side for specific locations of points set per this survey.**

TAKEN AS NORTH 76°55'56" EAST BETWEEN STANDARD STREET MONUMENTS PER R1 ON COUNTRY CLUB DRIVE AND AS SHOWN HEREON
