# Fairfax Branch

## Marin County Free Library

# Inspection Report

Report Number:  
**150909.1**

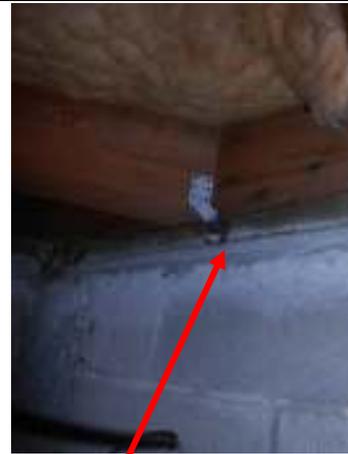
- 1. The hardware used to seismically-tie floor joist to the pressure treated mud sill were made of galvanized steel and has progressive corrosion, see pic 1.2. We recommend replacement of all clips with the correct stainless steel hardware type recommended by a competent, licensed structural engineer and general contractor. Review attached white paper: “Corrosion of Steel Hardware Caused by Pressure-Treated Lumber” prepared by Thor Matteson**

1.2 Replace all clips to Pressure Treated mud sill

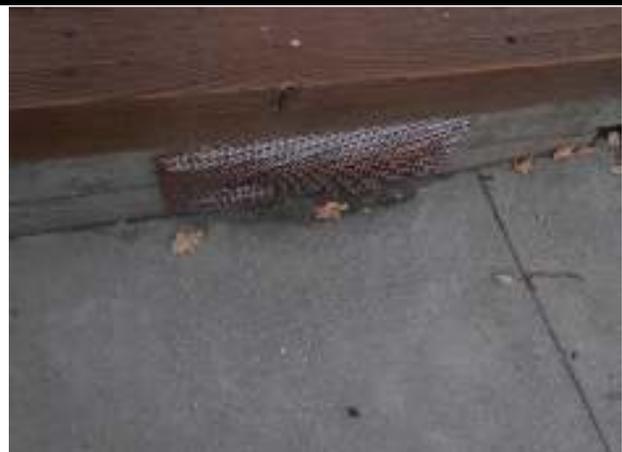
1.6 Correct drainage pipe challenge(s)

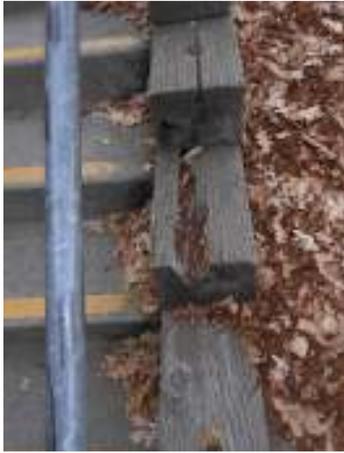
2.1 Replace all damaged retaining wall parts

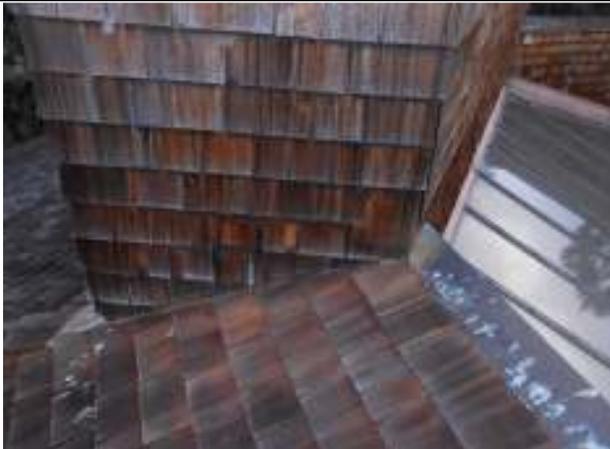
2.5 Replace siding as required

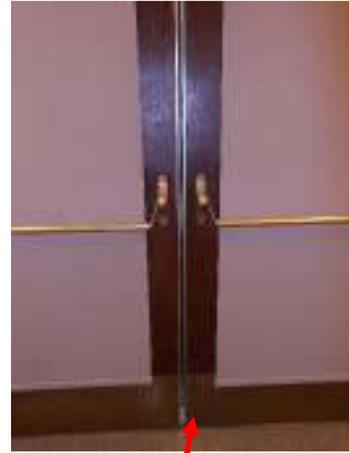
5.2 Correct weather strip at Entry door astragal

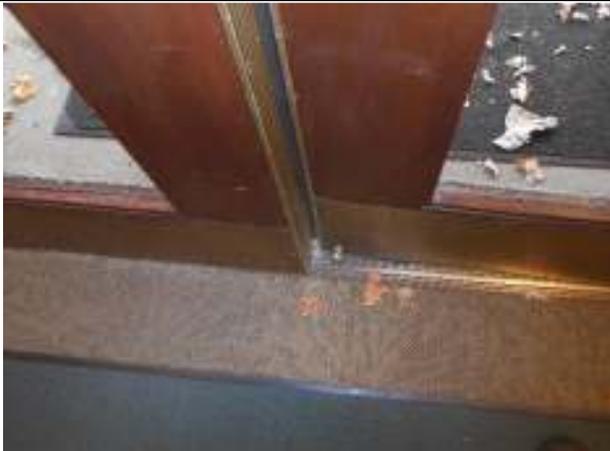
5.3 Correct Entry door closure adjustment

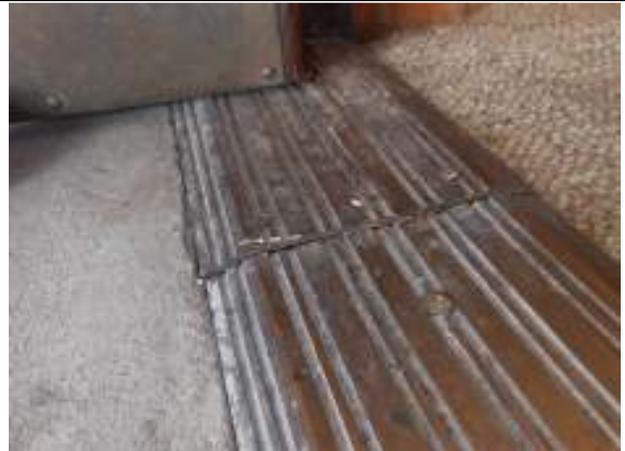
5.4 Correct Entry Threshold

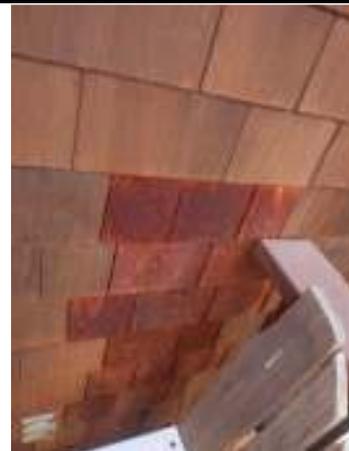
5.6 Noted recent repair to siding at deck rail?

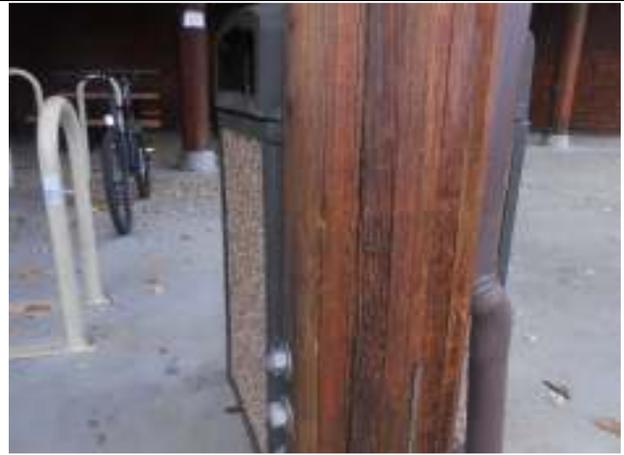
6.2 Fill and seal all gapes in structural post

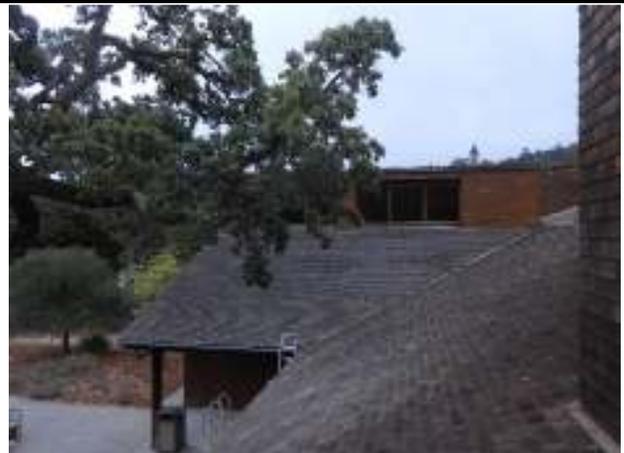
6.4 Remove all vegetation above or touching

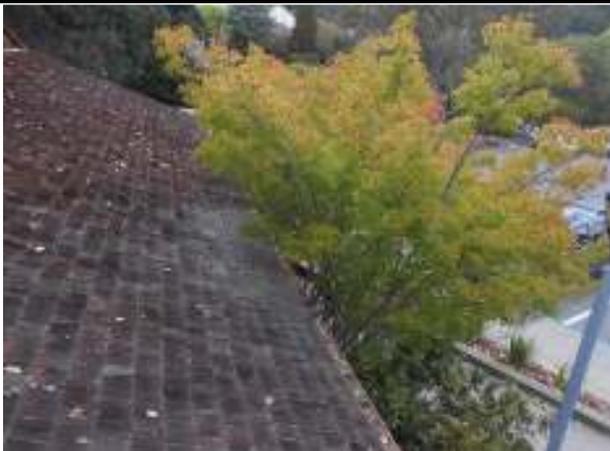
6.5 Remove all vegetation above or touching

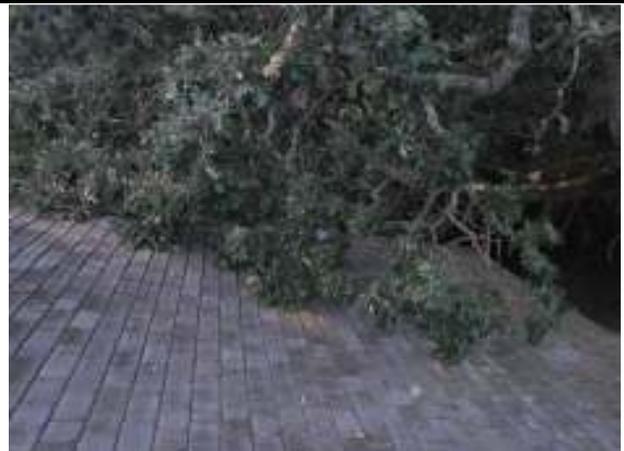
6.6 Remove all vegetation above or touching

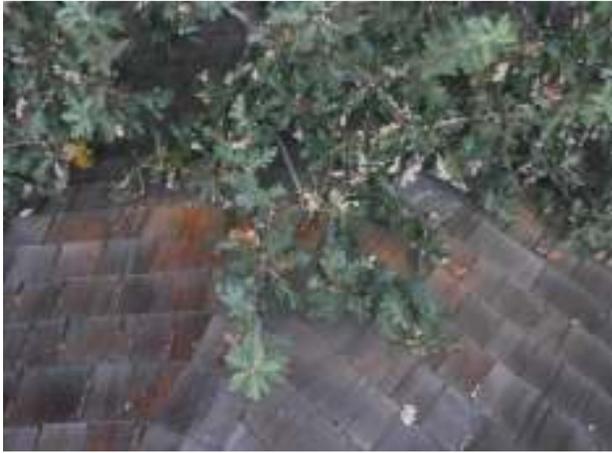
7.1 Remove all vegetation above or touching

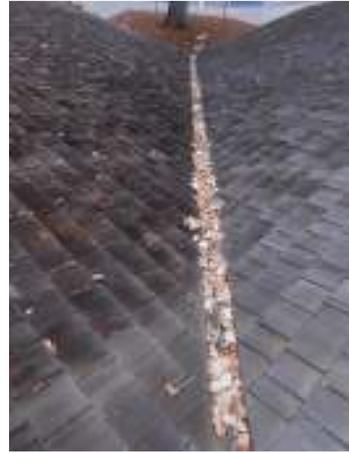
8.2 Remove a debris from roof, gutters, downspouts

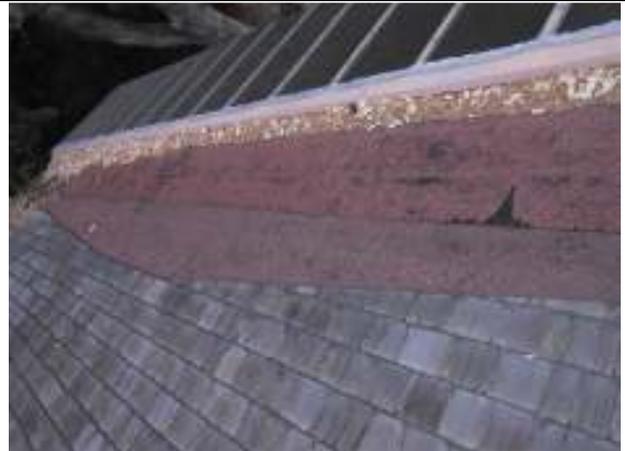
8.4 Remove a debris from roof, gutters, downspouts

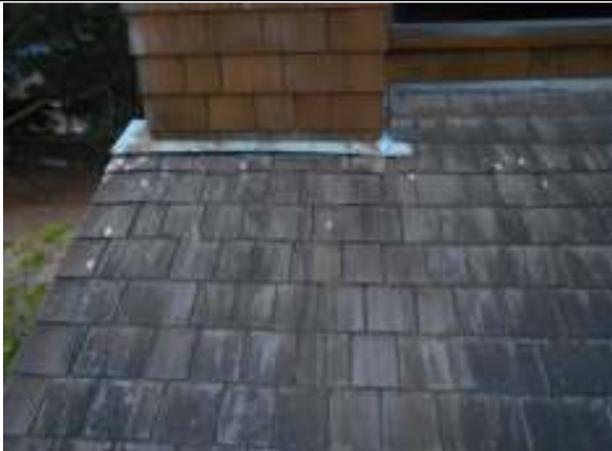
8.5 Correct all flashing details

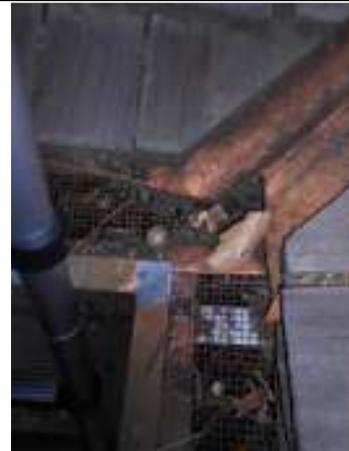
9.4 Clean all gutters above and below screen

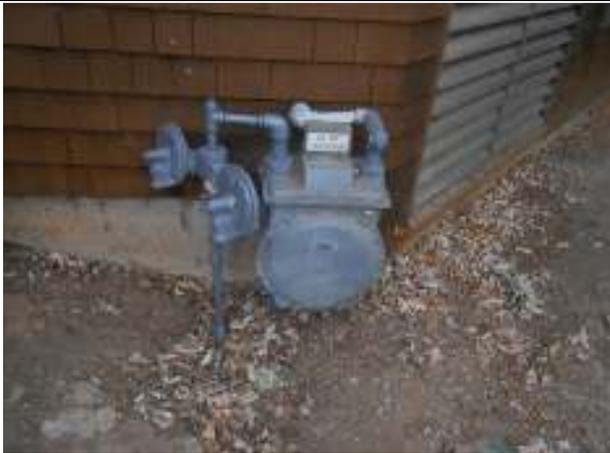
10.1 Gas Valve and Meter, add wrench on chain

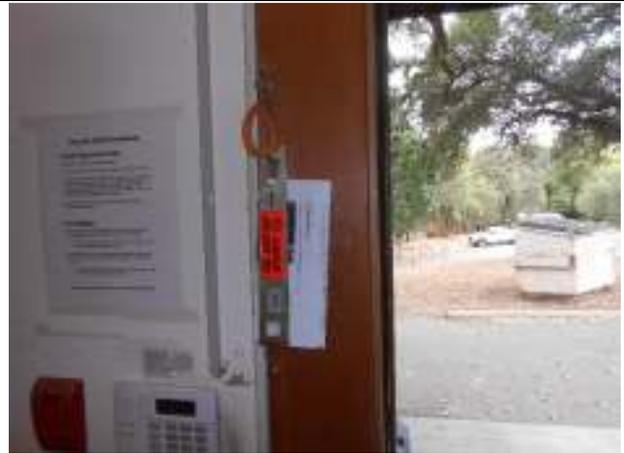
10.2 Relocate gas valve wrench to meter

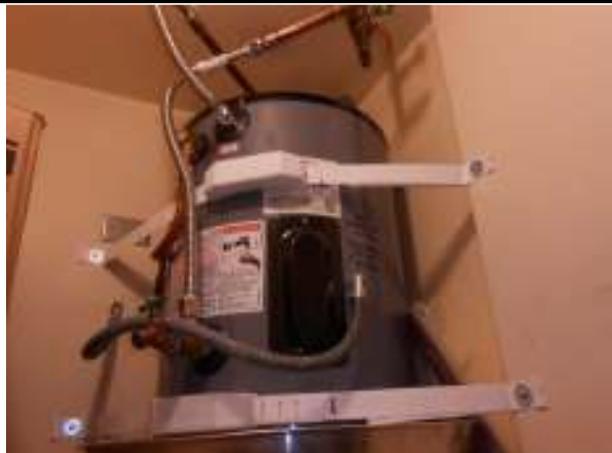
11.3 Add blocking to stabilize h2o heater

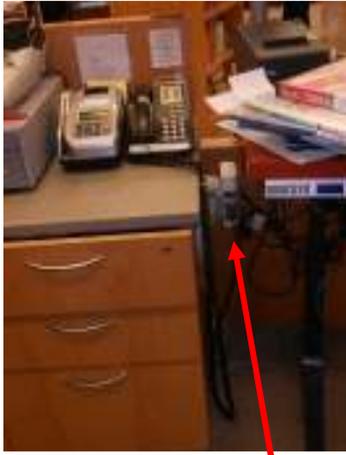
12.1 Provide additional conditioned power outlets

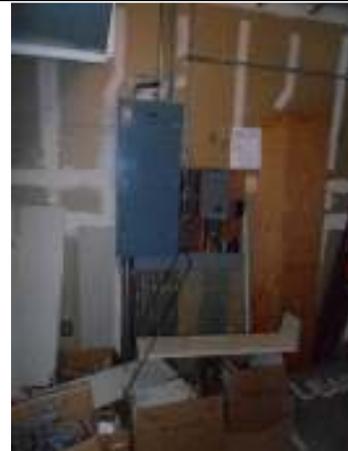
12.4 Provide signage to "Keep area clear 36"

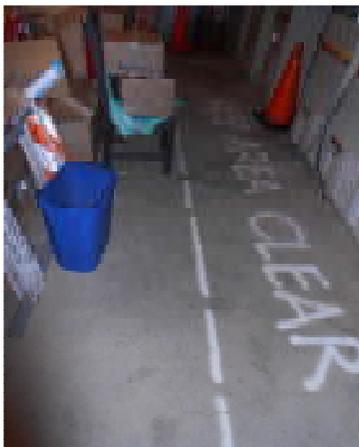
12.5 Signage to "Keep area clear >36"

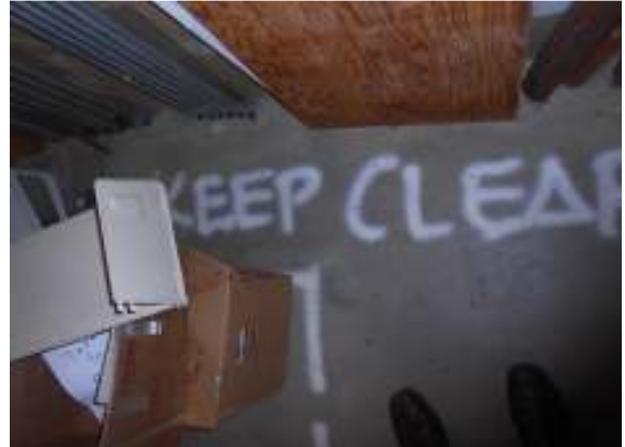
12.6 Provide signage to "Keep area clear >36"

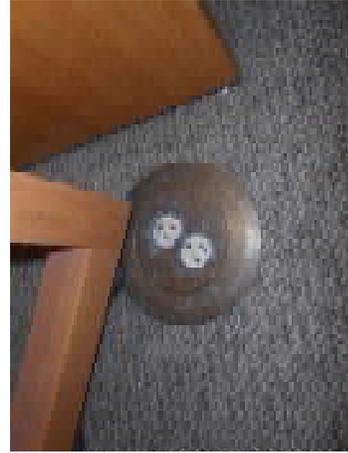
13.2 Replace all damaged floor receptacle plate covers

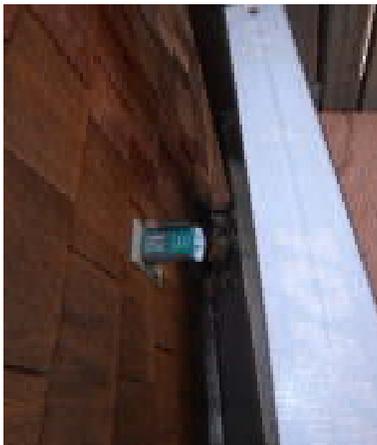
13.5 Correct non-working outlet with GFCI and cover

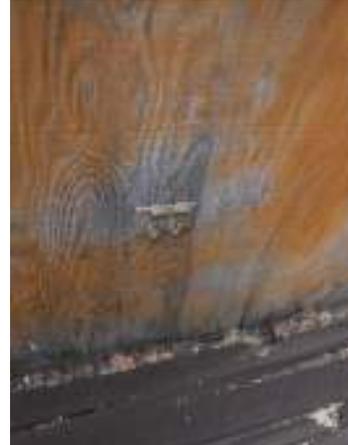
13.6 Correct non-working outlet with GFCI and cover

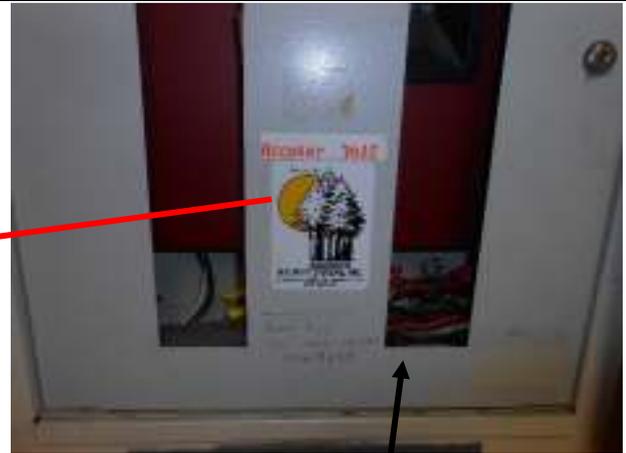
14.2 Provide additional protection from exposed 120v

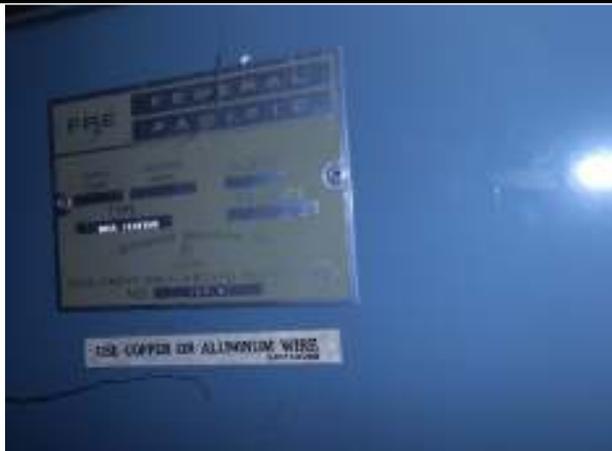
13. **The distribution panels in this structure had been manufactured by the Federal Pacific Company. Federal Pacific panels have not been manufactured for some time. Of greater concern is the fact that, in exhaustive laboratory testing, an unacceptably high proportion of Federal Pacific circuit breakers have failed to trip at their rated amperage. Because such malfunctions could result in serious personal injury or property loss, we recommend further examination of all Federal Pacific equipment in this building by a competent, licensed electrician who should either certify the equipment as safe and adequate or replace it, as appropriate. Because repair parts are not readily available for these panels, and because of their inherently unreliable performance, you should be prepared for the possibility that an electrician will recommend complete replacement of all the panels.**

14.5 Main panel FP label

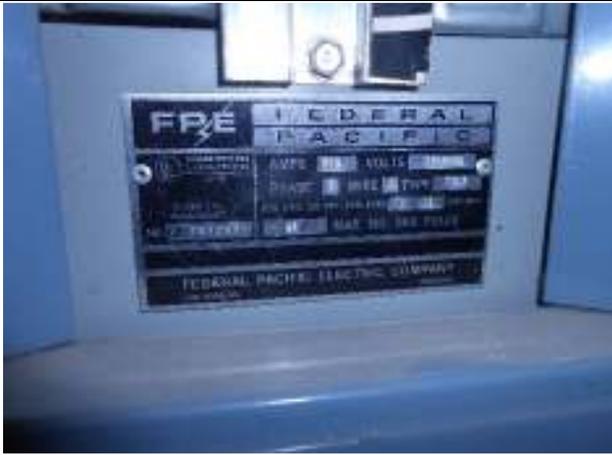
15. **Federal-Pacific Brand Electrical Panels Panel “A” was overheated at the time of the inspection by 30 degrees above ambient and needs replacement as soon as possible**

15.1 Panel "A" 30 degrees hotter than ambient

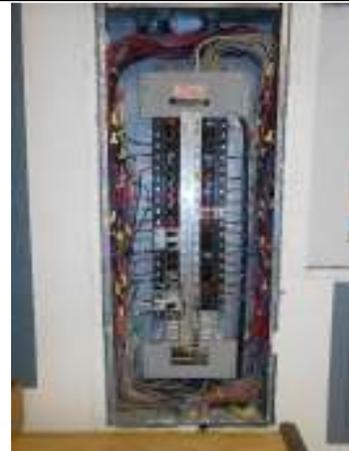
15.3 Panel "A"

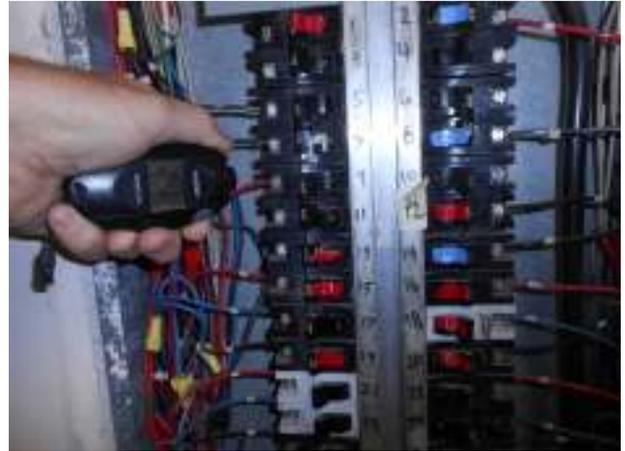
17.1 Panel "A" overheated Naturals and breakers

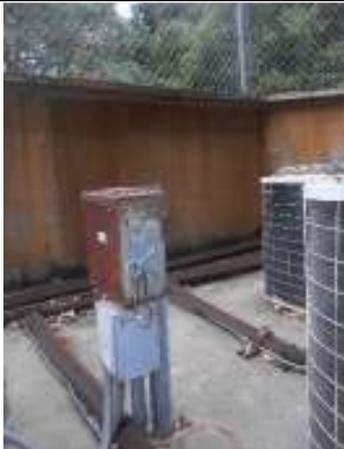
17.4 Replace 5 each, FP panels at AC compressors

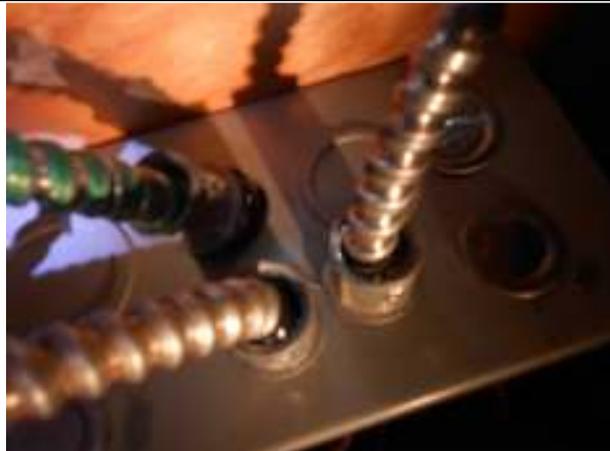
18.2 Substandard installation

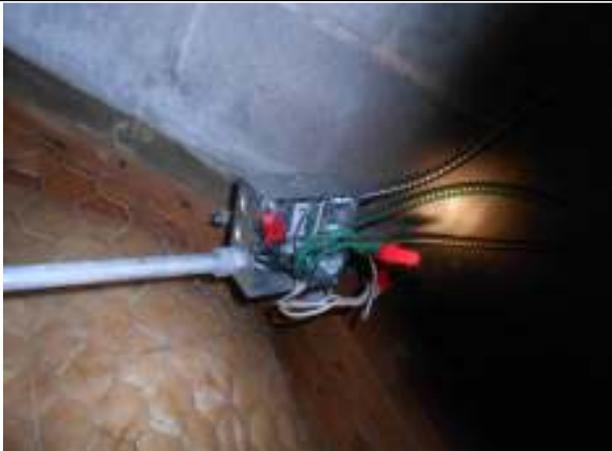
19.2 Substandard install: Overheated wire nut

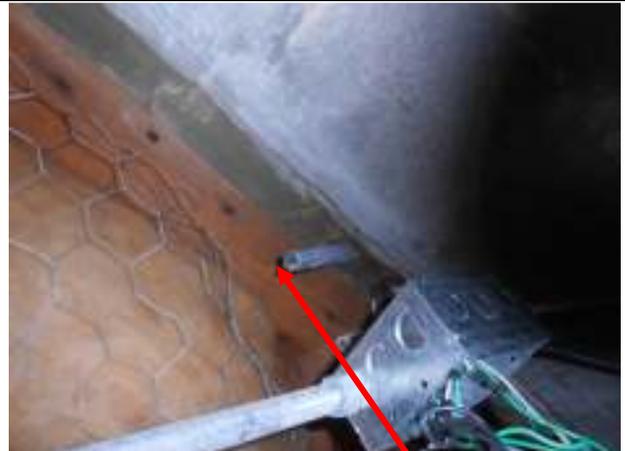
19.3 Substandard: Correct unsupported, open box

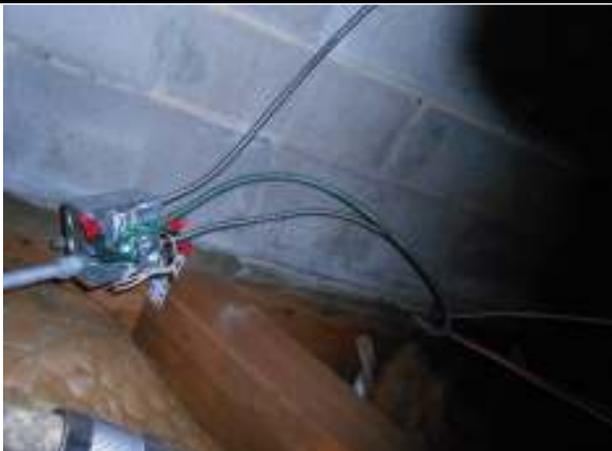
19.4 Substandard: Remove or terminate cut wires

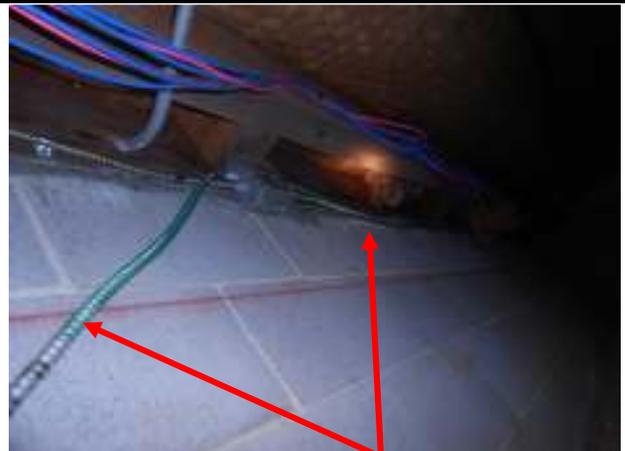
19.5 Substandard: Add cable restraints <12" to box

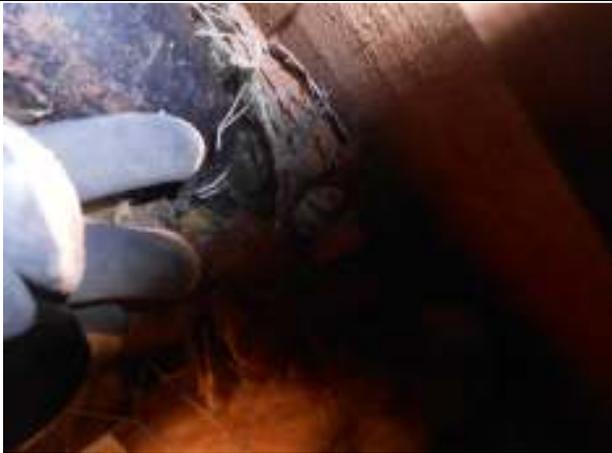
19.5 Substandard: Add cable restraints <12" to box

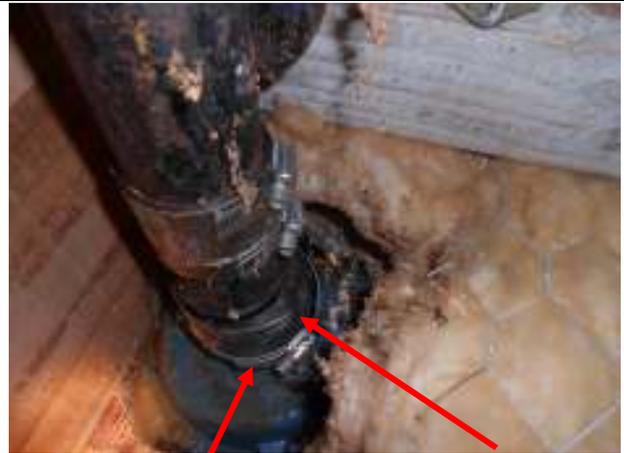
20.1 Air flow? See: [https://youtu.be/apS5c\\_CG5QE](https://youtu.be/apS5c_CG5QE)

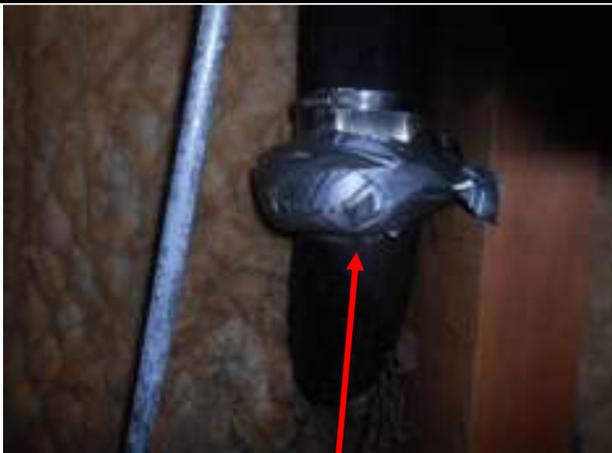
20.2 Substandard Install: tighten clamps

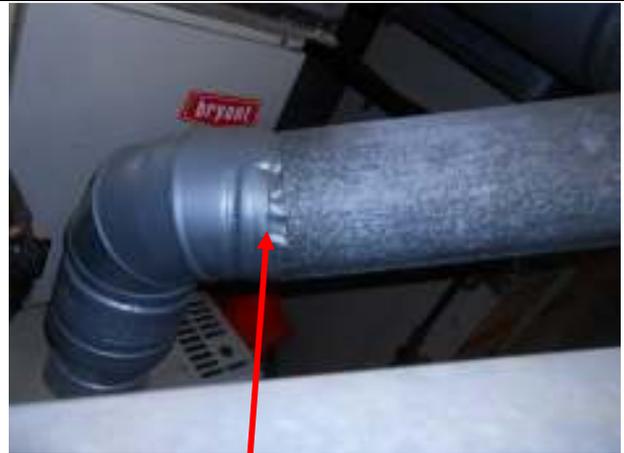
21.1 Substandard vents, add support for correct pitch

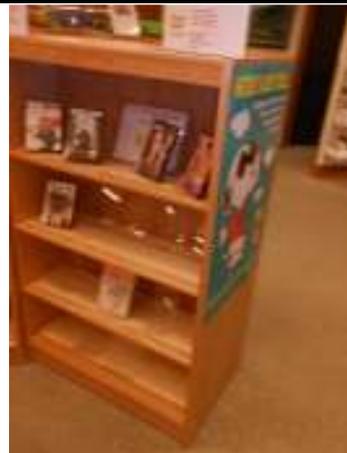
23.5 Seismic brace all cabinets and shelving

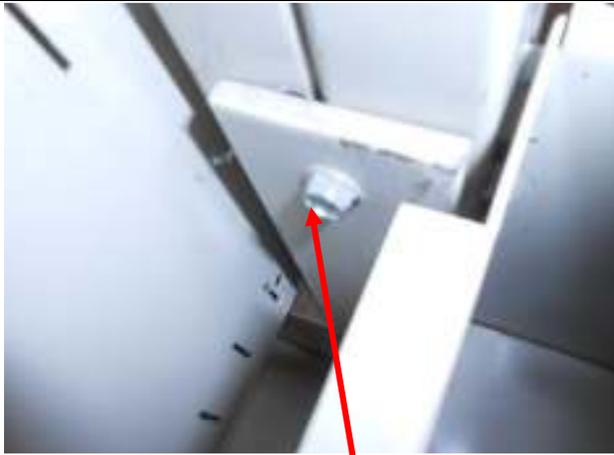
24.1 Seismic shelving braces

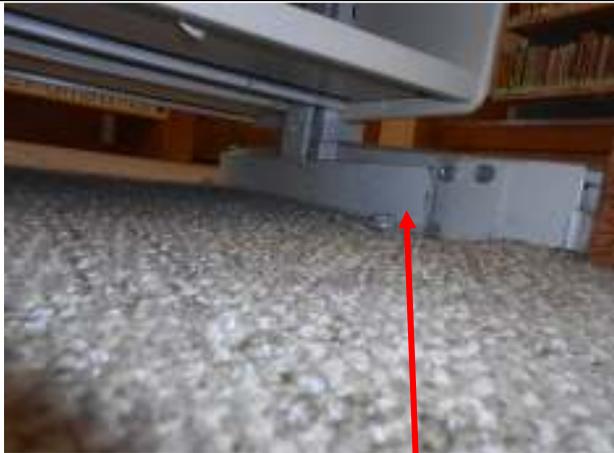
24.3 Seismic shelving braces

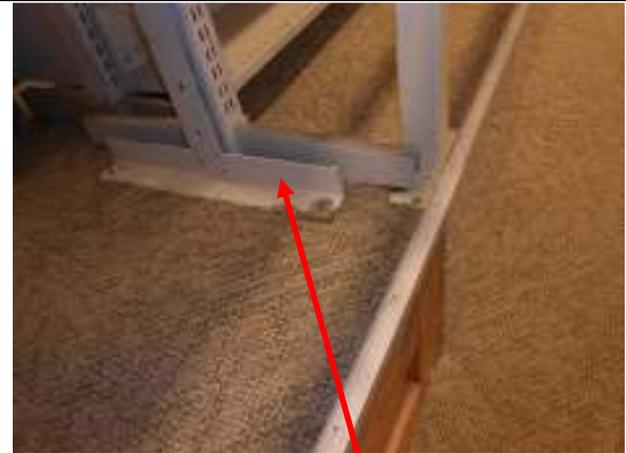
24.4 Seismic shelving braces

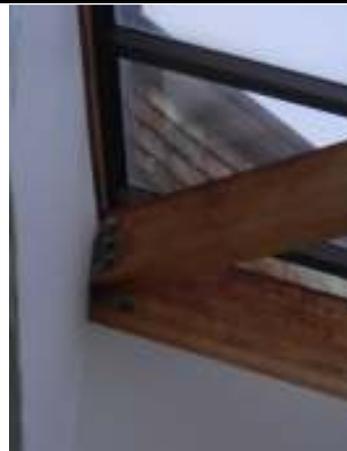
25.6 Correct all water leaks
